Evans Road Cattle Pass Rock Structure  
Spanning Elm Waterhole Creek  
San Antonio  
Bexar County  
Texas

HAER No. TX-118

**Project Information:** Historic American Engineering Record (HAER) Level III documentation was performed in March 2010. Joe C. Freeman, Architect, conducted the on-site recordation and Tanya McDougall compiled historical information. During the on-site recordation, large format photographs were taken of the structure, observations on existing conditions were noted, and sketches were drawn. The HAER recordation serves as mitigation for the demolition of this structure.

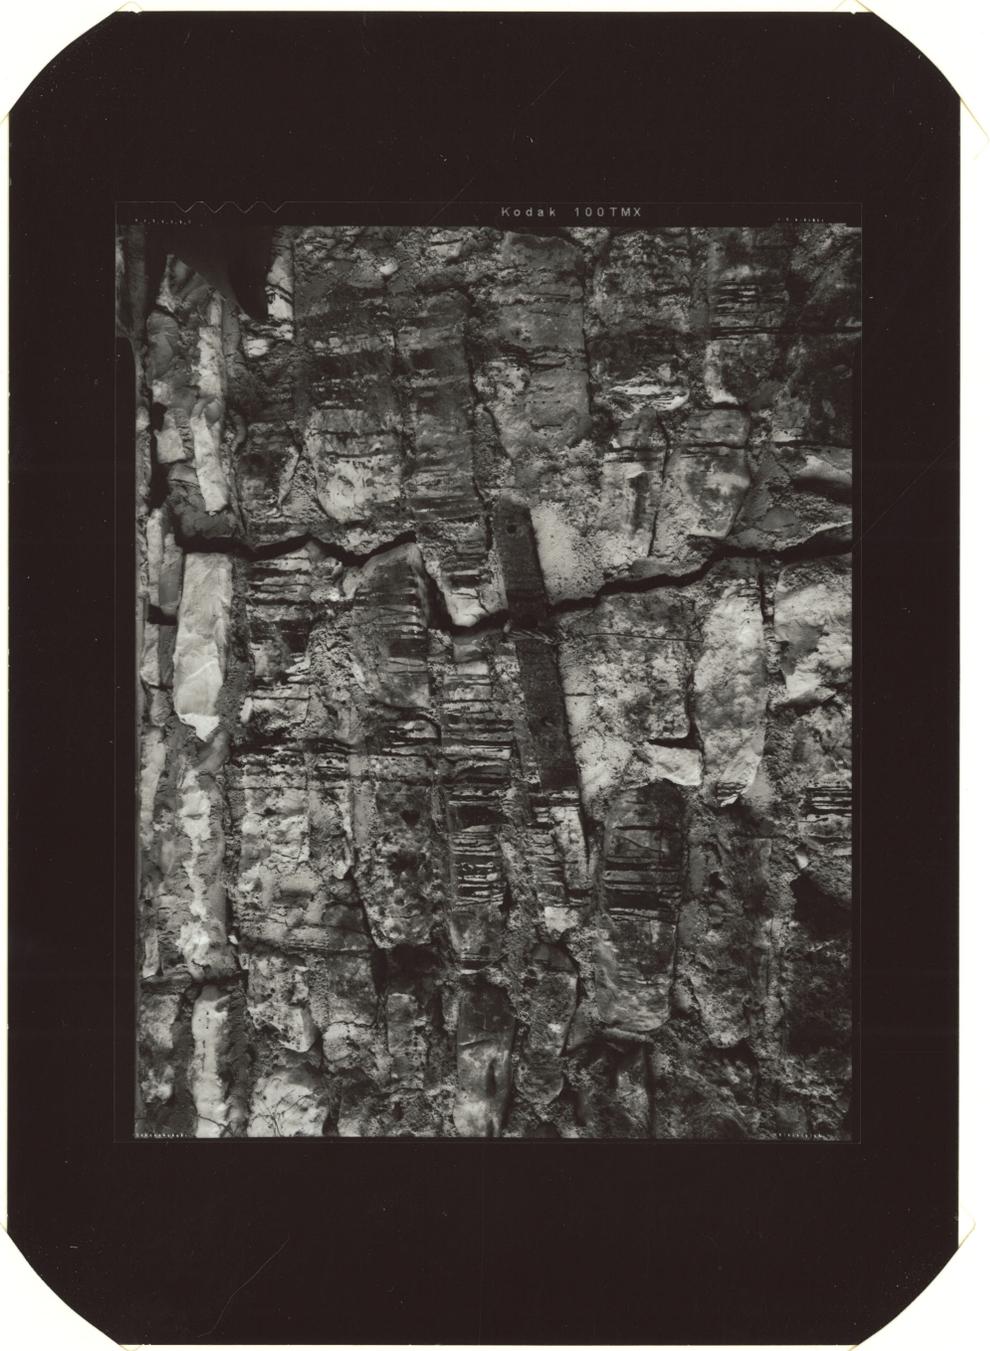
HAER No. TX-118-7

TX-118 -1	OVERALL VIEW LOOKING SOUTHWEST
TX-118 -2	OVERALL VIEW LOOKING SOUTHEAST
TX-118 -3	VIEW OF NORTH END LOOKING SOUTH
TX-118 -4	VIEW OF SOUTH END LOOKING NORTH-NORTHEAST
TX-118 -5	VIEW OF SOUTHWEST WING WALL LOOKING NORTHWEST
TX-118 -6	DETAIL VIEW OF SOUTHWEST WING WALL AND CONCRETE DECK
TX-118 -7	DETAIL VIEW OF WALL TIE, STONEMWORK, AND CRACK ON EAST WALL OF STRUCTURE

2. **Condition of Fabric:** The Evans Road Cattle Pass Rock Structure retains its character and integrity. The structure shows evidence of normal deterioration due to exposure to the elements. Noted deterioration includes two vertical cracks on the east stone wall and missing and loose stones from the northwest wing wall stone cap. Asphalt drips on the stone walls and metal flashing at the top of the walls indicate attempts to prevent moisture from the roadway above from penetrating the tops of the supporting walls.
