Cultural Resources Survey of the 76-Acre Craemer Tract Along Helotes Creek at Loop 1604 and Culebra Road in Bexar County, Texas

SWCA Cultural Resources Report No. 2009-313

September 2009

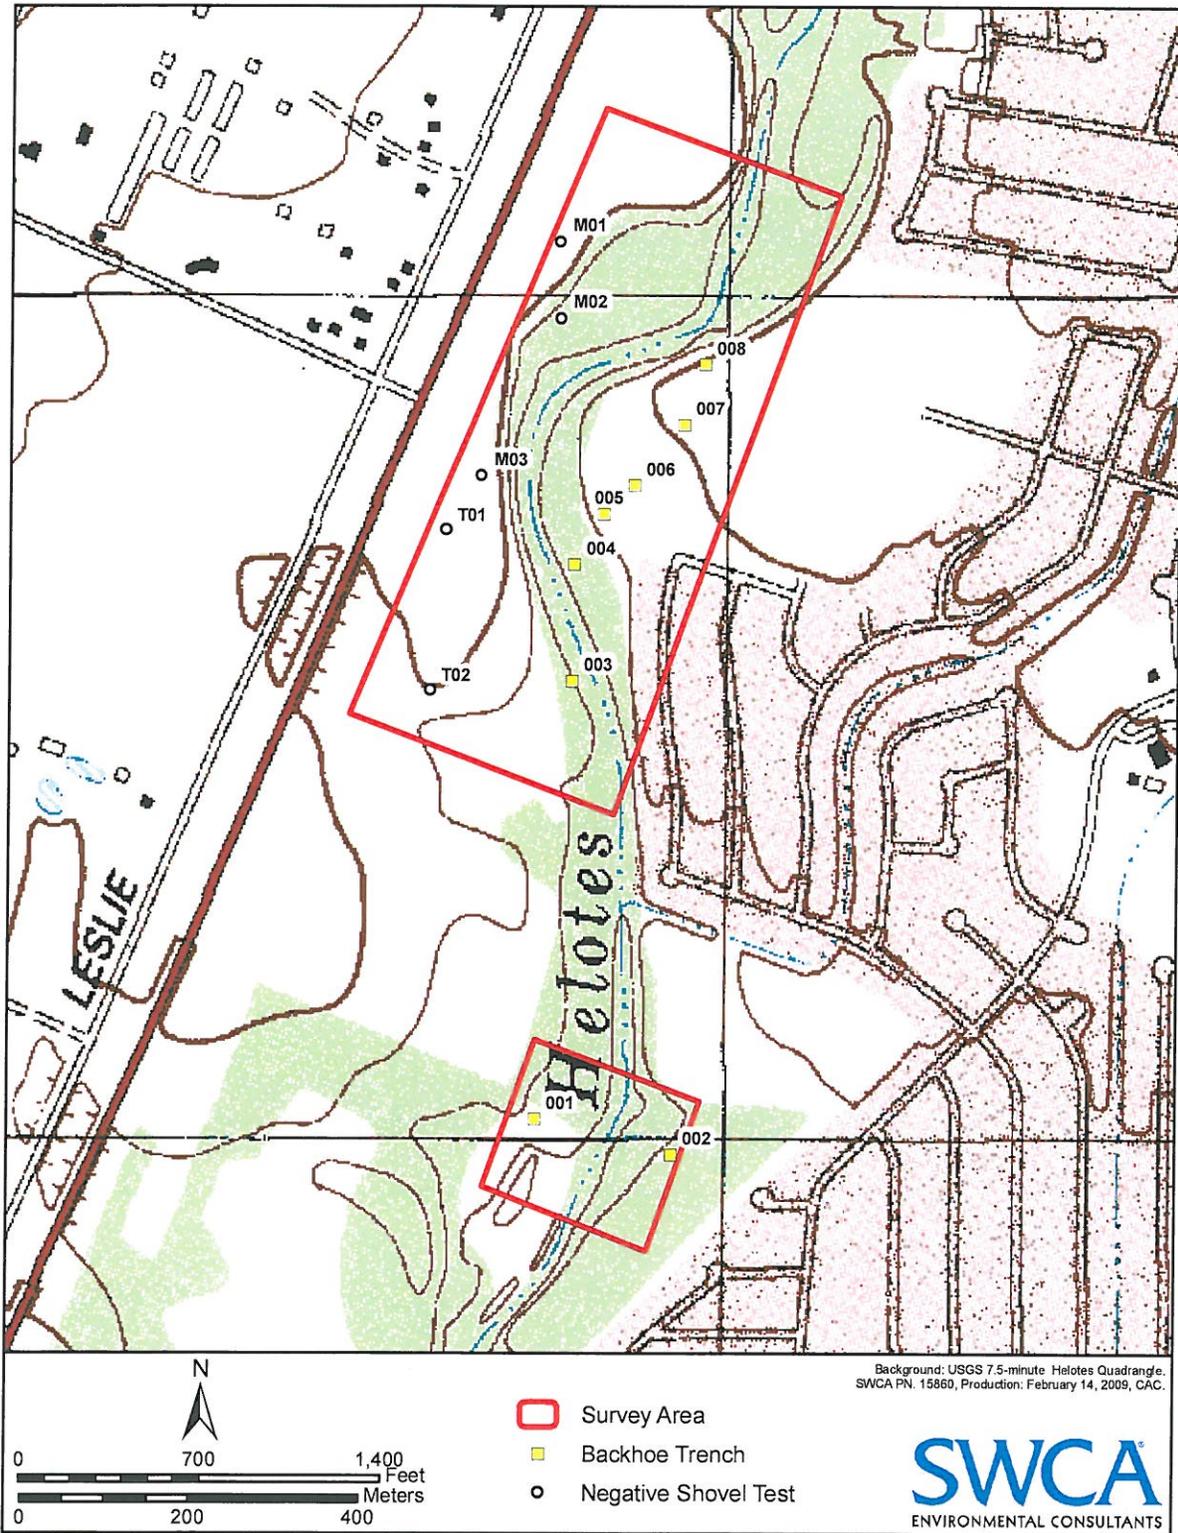
Figure 2. Survey results map.

On September 3 and 9, 2009 SWCA archaeologists conducted an intensive pedestrian survey of the APE utilizing subsurface investigations (see Figure 2). The first field investigations utilized eight backhoe trench excavation to target the lowland portions of the project area. The second field visit used five shovel test excavations to investigate the upland deposits. A majority of the Craemer Tract project area, about 80 percent (60 acres), is situated in a lowland setting while about 20 percent (16 acres) is in an upland setting. As such, the project area lowlands were the focus of the archaeological survey.

The shovel test excavations of the project examined the upland T-3 terrace on the right bank (west side) of Helotes Creek (see Figure 2). The five excavated shovel tests (M01 through M03, T01, and T02) ranged from 40–45 cmbs and encountered a very compact silty clay loam with CaCO₃ filaments (Table 2). This stratigraphy is consistent to the upper two strata observed in backhoe trenches BHT-07 and 08.

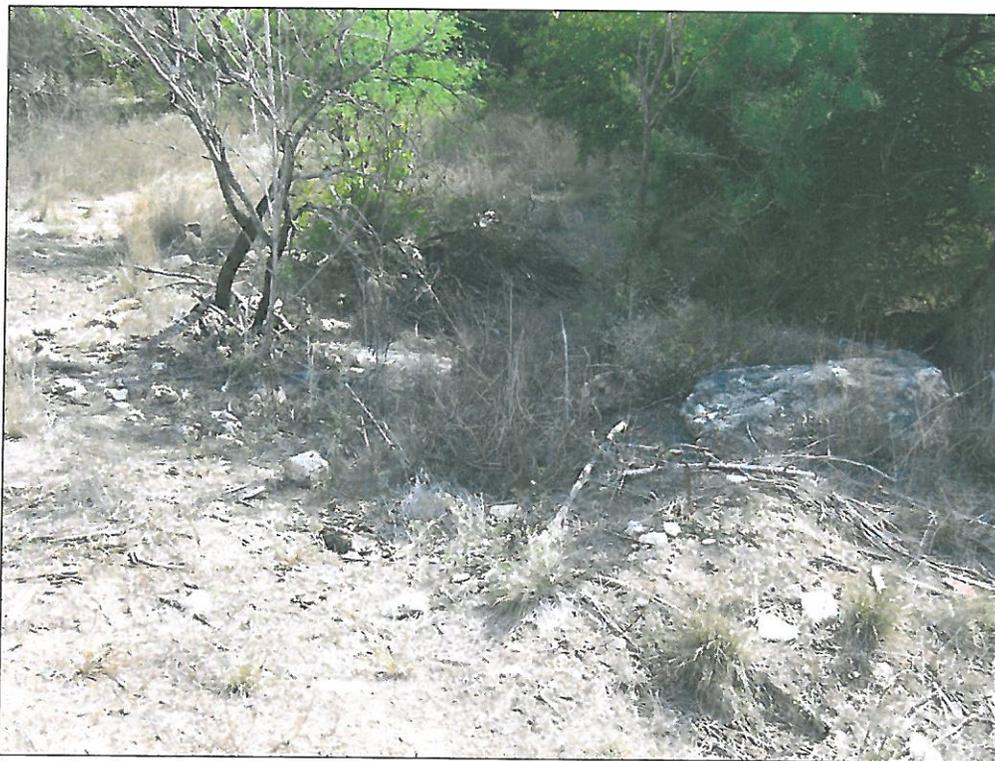
The project area exhibits some disturbance and has variable integrity throughout. Some impacts include a large gravel pile, erosion from high intensity hydrological activity, two-

track roads, cattle, fence lines, modern dumping, and push piles from vegetation clearing (Figures 3 and 4). Of these disturbances, erosion and recent dumping have been the most detrimental to the Craemer Tract.

Figure 3. Overview of Craemer Tract disturbances and setting; note infilled borrow pit.

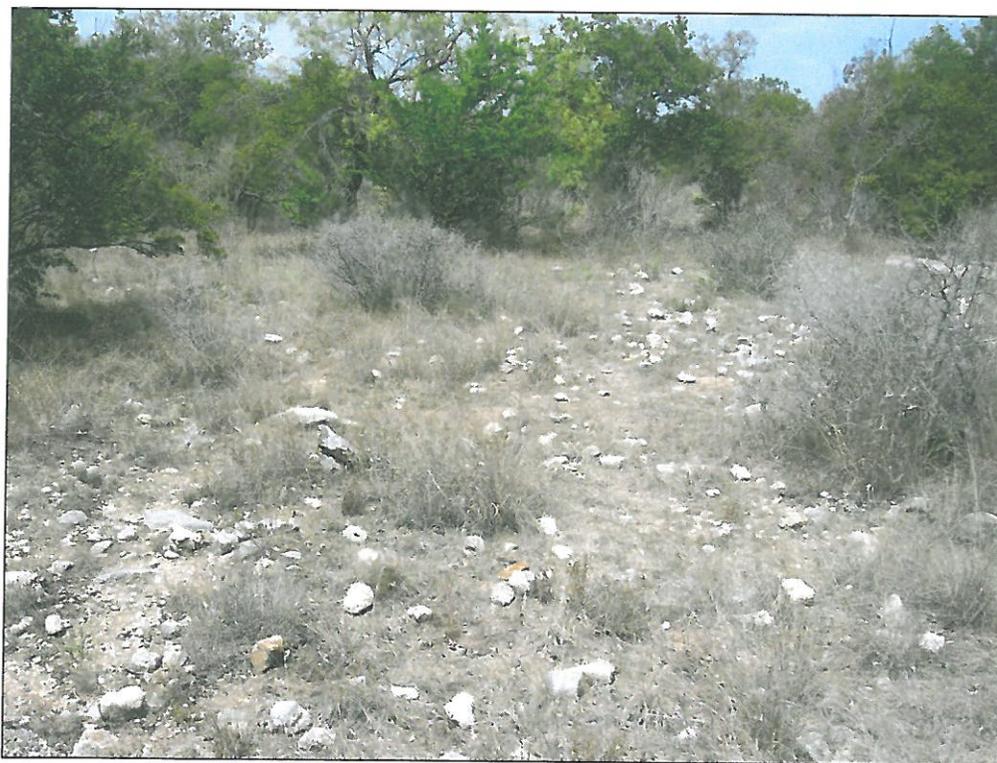
Figure 4. Overview setting of Craemer Tract; note rocky surface.

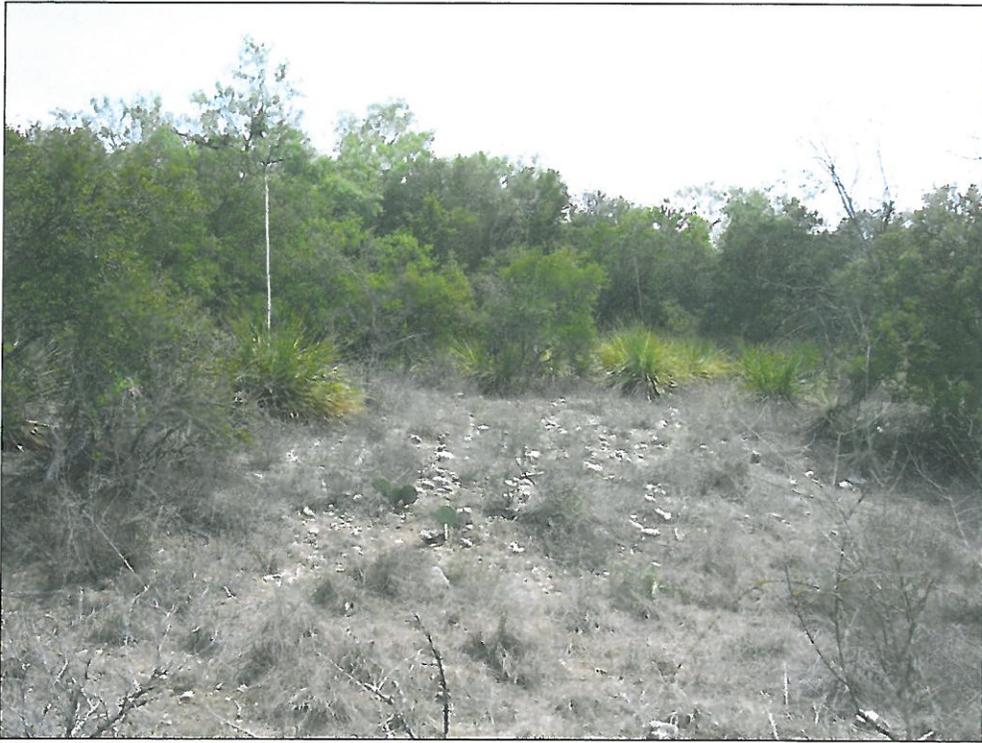
The vegetation of the lowlands is composed of moderately dense woods with a mixed hardwood (e.g., oaks and elms) overstory and an understory containing assorted shrubs and short grasses (Figure 5). In contrast, the upland is more open with scattered mesquite and occasional oak trees with an understory of cacti, shrubs, and short grasses. Both the upland and lowland areas of the project have broad exposures of rocky surface containing assorted cobbles and gravels. These conditions culminate in a surface visibility ranging from 40–90 percent with a typically excellent

Figure 5. Overview of typical vegetation of Craemer Tract; T-2 terrace background.

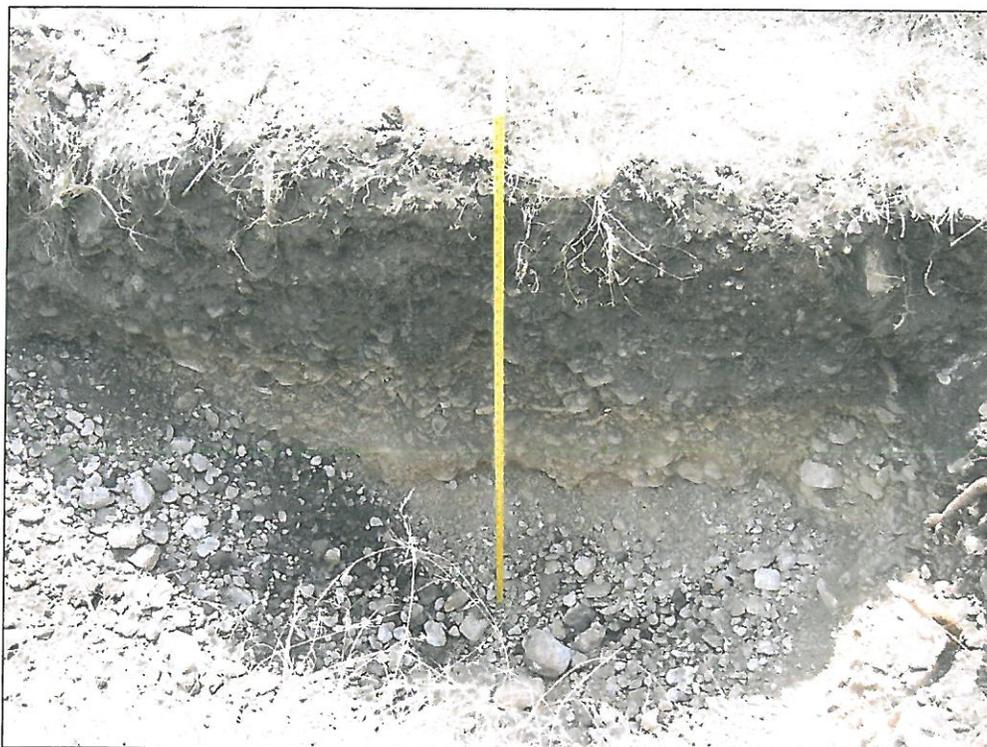
Figure 6. Profile of BHT-6 on T-2 terrace; note imbricated rocky strata.

| Trench | Location | Depth (cmbs) | Munsell (moist) | Soil Color | Soil Texture Description | Inclusions | Lower Boundary | Comments |
|---|---|---|---|---|---|--|---|---|
| BHT 6 | East side Helotes Creek | 0-50 | 10YR3/1 | Very Dark Gray | Friable silty clay loam | Roots, rootlets, rounded limestone pebbles, gravels and cobbles | Clear/Level | Matrix supported stratum; rock inclusions look to be loosely size sorted, 30%. No cultural materials. |
| | | 50-120+ | 10YR5/4 | Yellowish Brown | Loose silty loam | Abundant limestone pebbles, gravels and rounded cobbles | Unobserved | Clast supported; poorly sorted, rock inclusions ~80-90%. No cultural materials. |
