**CULTURAL RESOURCE SURVEY OF HIGH-PROBABILITY AREAS AT ALAMO
RANCH, BEXAR COUNTY, TEXAS**

SWCA Project Number 9496-004-AUS
SWCA Cultural Resources Report No. 2005-162

April 21, 2005

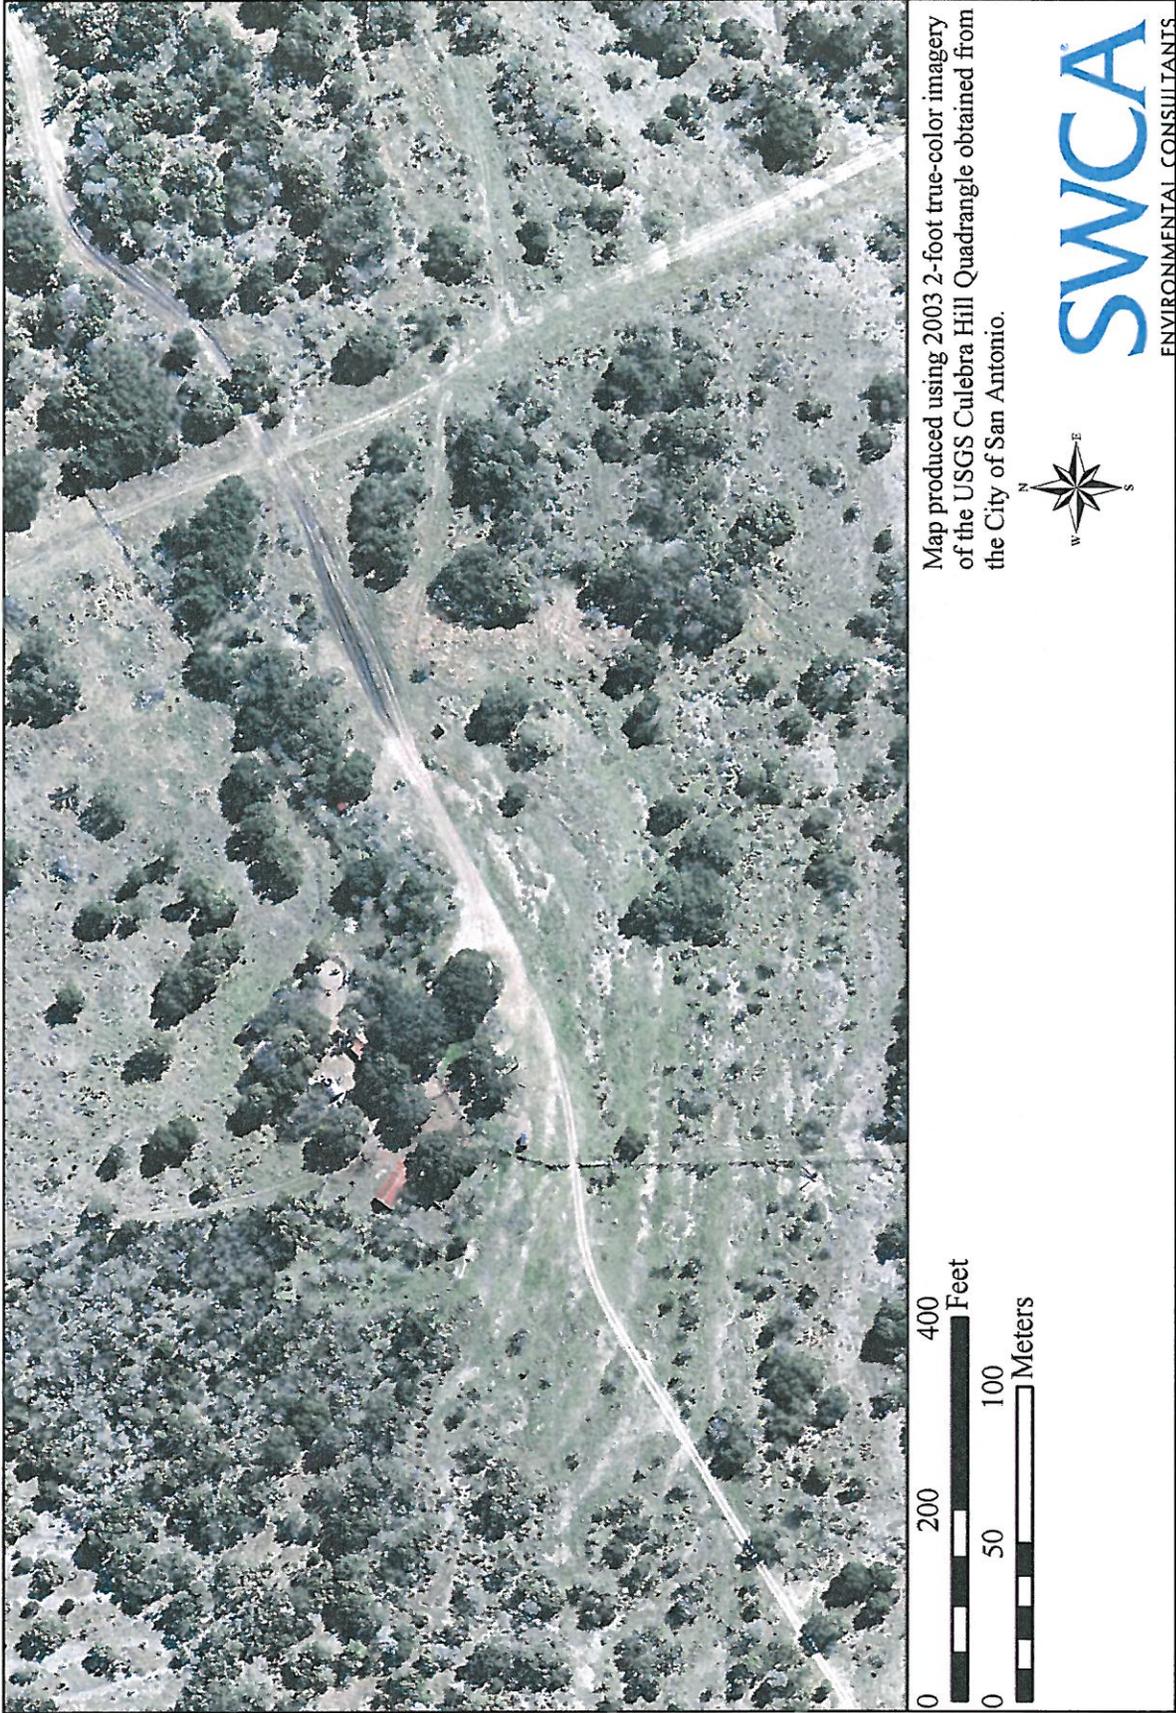
Figure 2. Aerial photograph of structures in the southwestern corner of the project area.

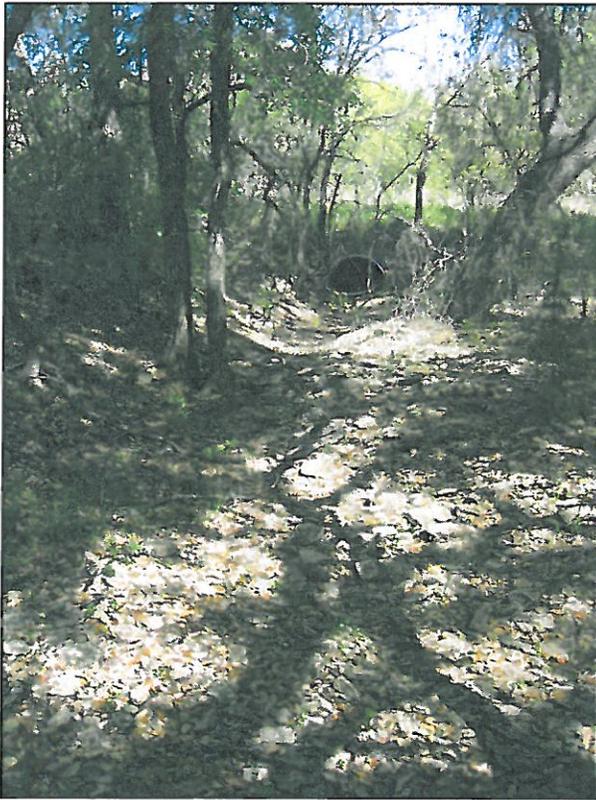
Figure 4. Bedrock exposure at the bottom of the drainage. Culvert is beneath dirt road.

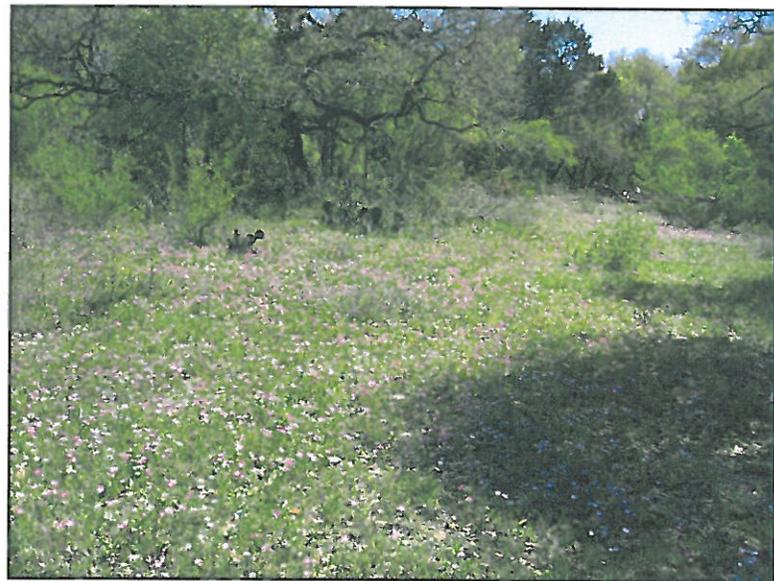
The majority of the 80-acre area surrounding the two drainages consisted of slightly rolling hills that formed a wedge where the bottom of the drainage was located. The drainage varied in shape from a wide shallow channel to a deeply incised channel, forming a “V” (Figure 4). Foliage around the drainage was similar to that within the remainder of property, consisting of live oak, juniper, and short grasses (Figure 5). The drainage became shallower as one

Figure 5. Example of terrain on either side of the two drainages.

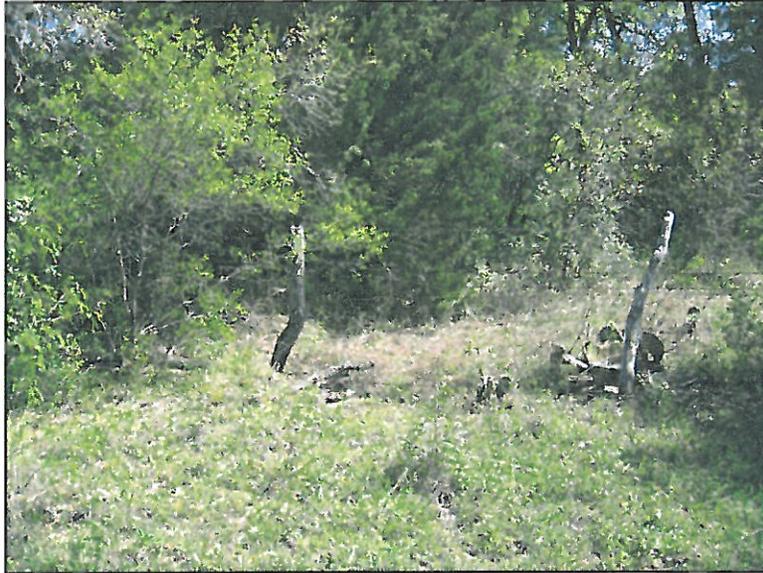
progressed upslope, to a point where the drainage could not be easily discerned from the surrounding terrain (Figure 6). On average, about 30–50 percent of the ground surface was visible, and the most prevalent obstructions were leaf litter and short grasses. Surface level bedrock was seen in several places. Additionally, at one point along the easternmost drainage, the area had been significantly altered and channelized near the existing residential development.

Figure 6. Drainage area towards the top of the slope.

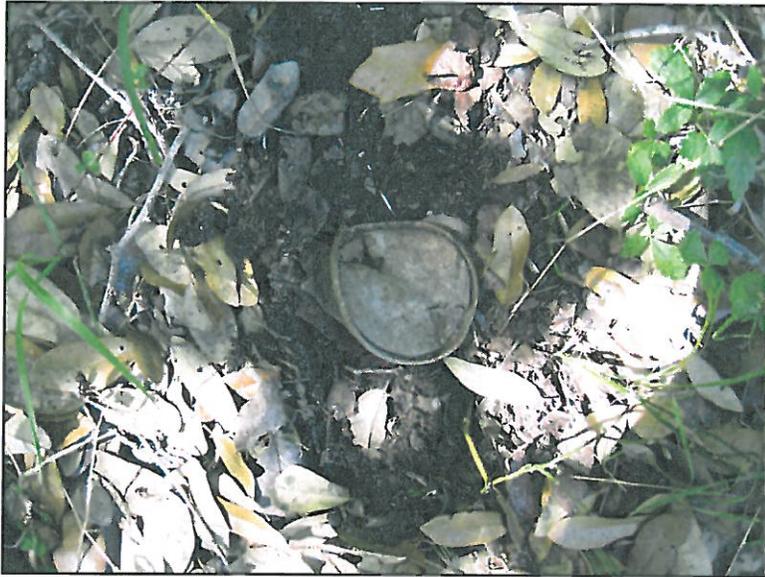
Figure 8. Beer can with aluminum top and opened with a church key.

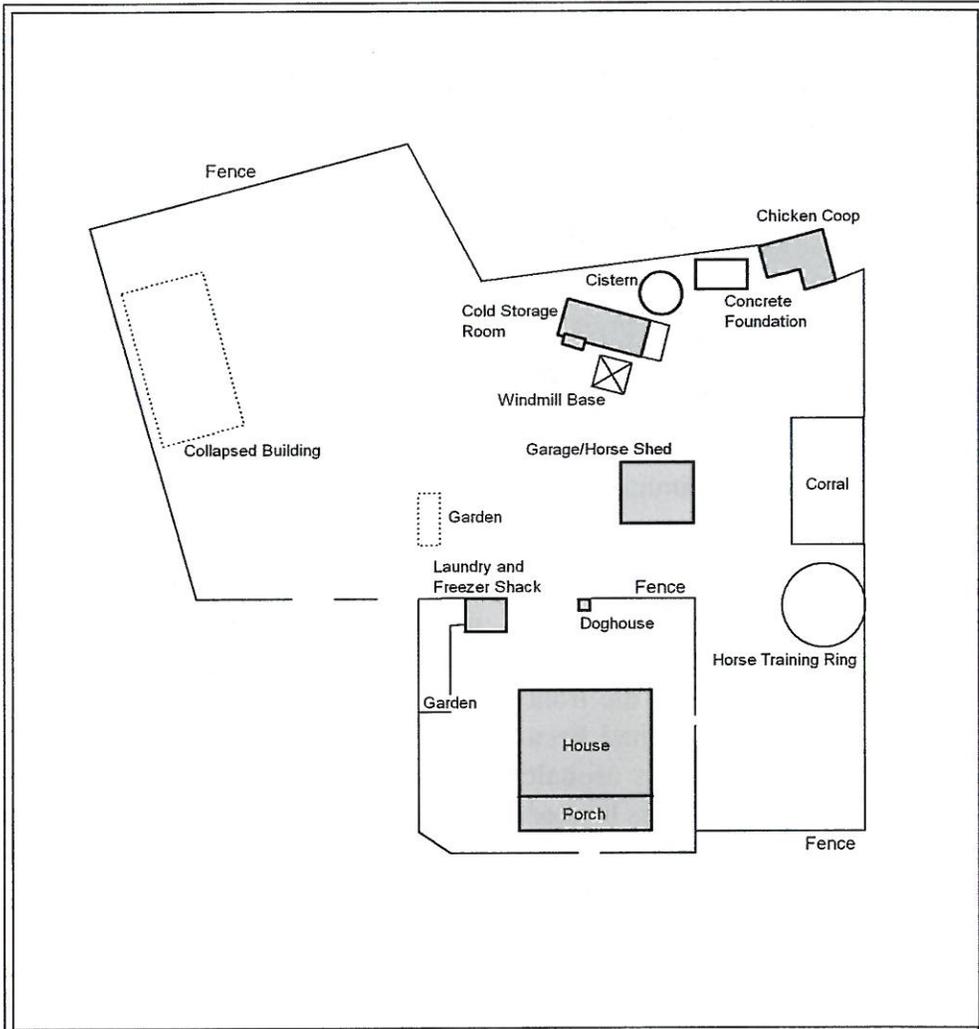
Figure 9:	
Sketch Plan of Horse Ranch	
Project:	
Cultural Resource Survey of High Probability Areas at Alamo Ranch, Bexar County, Texas	
Project No.	Report No.
9496-004	2005-162
Date:	Rev. Date:
April 15, 2005

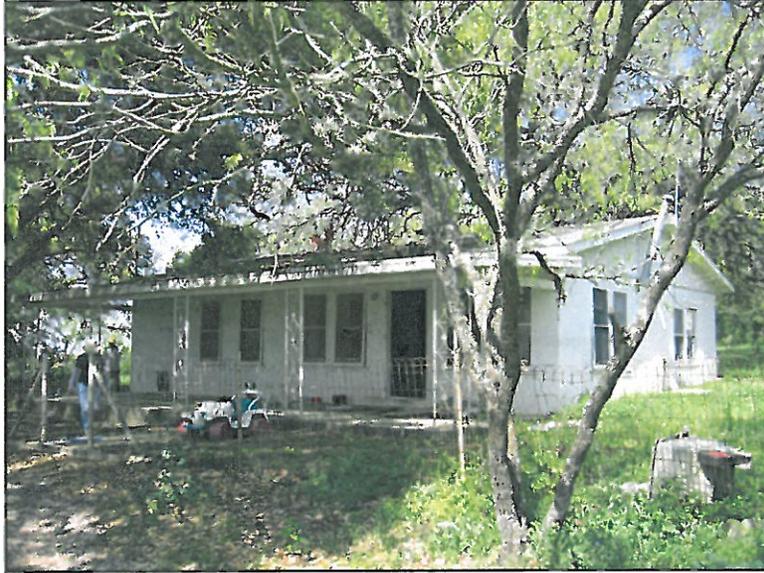
The residence consists of a wood frame structure over a concrete pad foundation, a side gable roof, and covered front porch. The house has wooden

single pane double hung windows, but all of the interior and exterior doors have been removed. Painted wrought iron posts supports the front porch. The original wooden siding had been covered with stucco, and the roof is asphalt shingles. A crumbling brick chimney is located in the kitchen area and extends beyond the roof, but had been turned into a cupboard at the base. The house interior is a basic halved plan with the living, bedroom, and bath on one side, and two bedrooms and a kitchen on the other (see Figure 10). All of the kitchen appliances and cabinets had been removed, the toilet was found smashed, and the furnace removed. Drywall covered the walls, trimmed by plain painted pine boards, and carpet or linoleum covered the floors. Residential trash was scattered about, and magazine address labels had “Stephen Seale” listed as the resident, but other labels had “Tyson Fitzpatrick” and “Tyler Leann Fitzpatrick” on them. The name Kyle H. Seale, Trustee et al. is listed as the property owner in the Bexar County Appraisal District records, and Stephen Seale is likely a relative (Bexar County 2005).

Figure 11. Three bedroom, two bath residence.

requirements. The residence may have been built prior to 1959, but the concrete pad foundation, one-over-one windows, and wrought iron porch posts all point to a very late 1950s construction, and the house was most likely built between 1955 and 1960. Thus, the house is not considered to be of historic age. In addition, the house does not show significant integrity or could be seen as a good example of this type of construction, and does not appear to be associated with a significant event in history or with any historic persons. It does not meet NRHP-eligibility requirements.

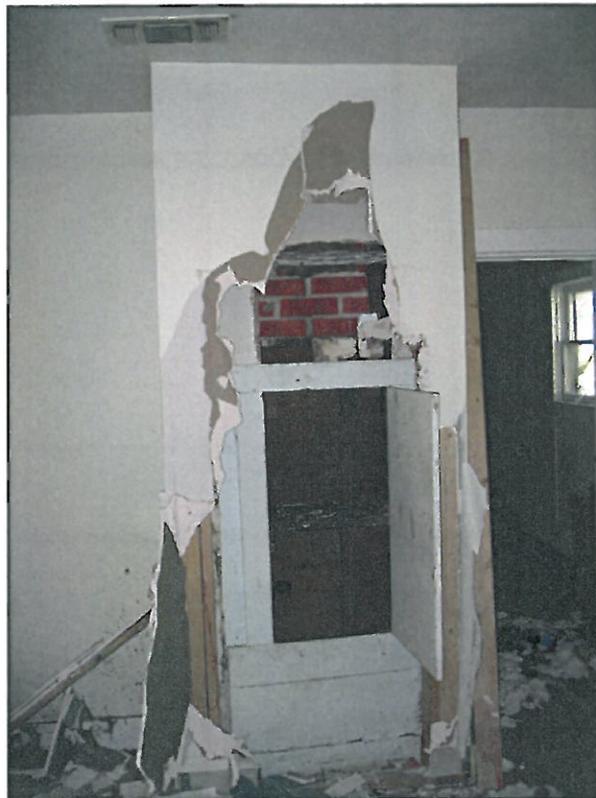
Figure 12. Old chimney covered into cupboard.

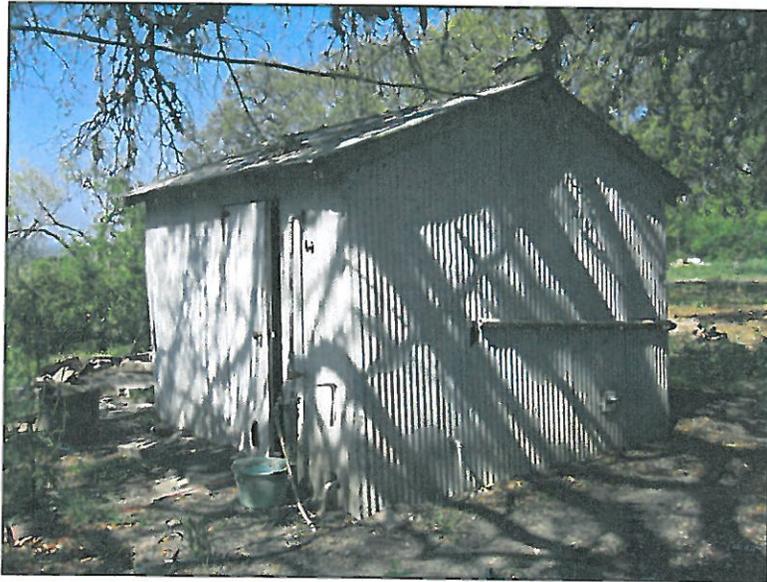
The laundry shack is a side gable wood frame structure with corrugated tin walls and flat tin roof. The garage and horse shed consists of a front gable roof and shed addition, two large swing out doors, and two additional small doors. “V” groove tin covers both the walls and roof. The interior space is divided into stalls for horses and a space for a car. A hitching post is located adjacent to the stable side.

Figure 13. Laundry and freezer shack.

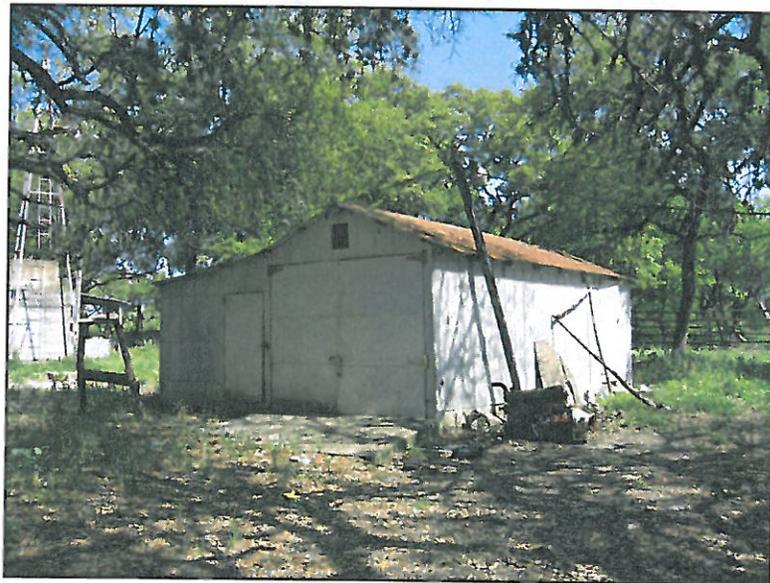
Figure 14. Garage and horse shed.

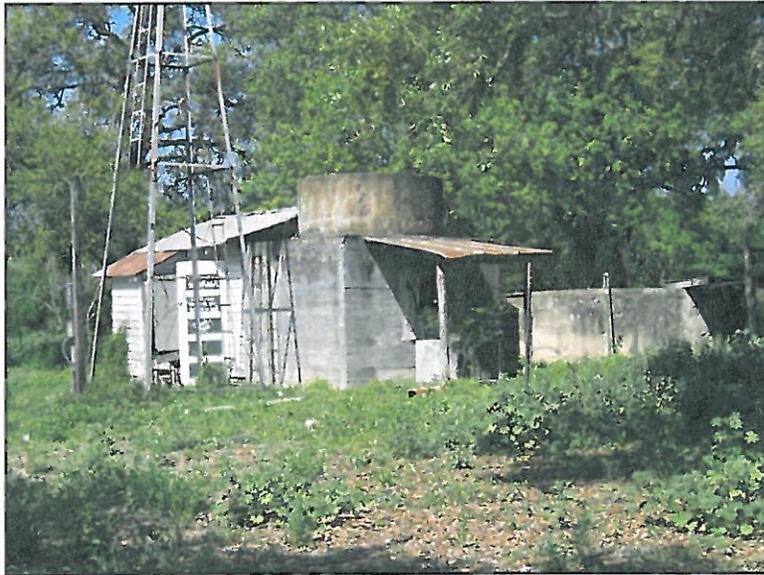
The most interesting structure is the cold storage room, likely designed to store game animals or other large meats. The freezer portion of the building is made of a square poured concrete box, with a rounded concrete roof structure, and contains beams and hooks inside. The preparation portion of the building is a wood frame structure with a gable roof and shed roof addition, both covered with recycled wood siding and covered with corrugated and flat tin roofing material. Another shed roof covers an open area containing the air conditioner.

In front of the cold storage room is a metal windmill base, and on the opposite side of the room is the cistern, which is open topped and made of poured concrete.

Figure 15. Cold storage room. Note windmill on left and cistern on right.

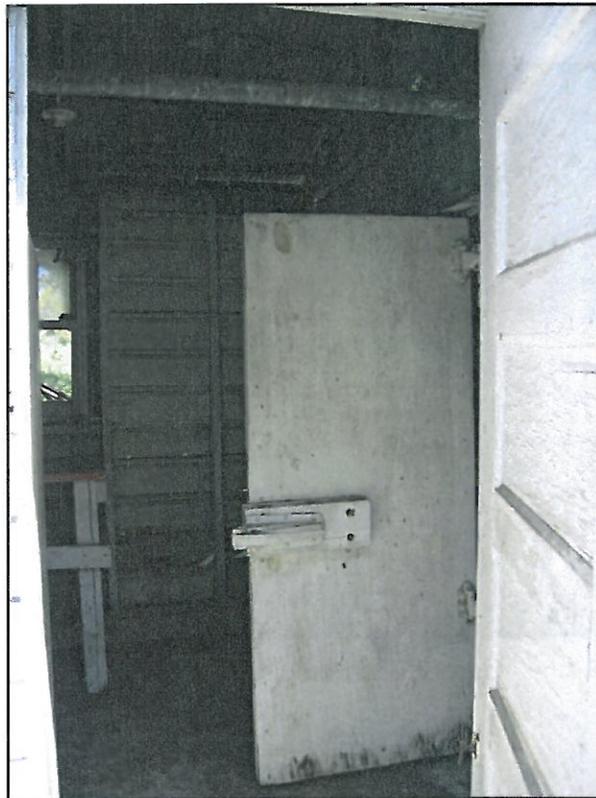
Figure 16. Freezer door in cold storage room.

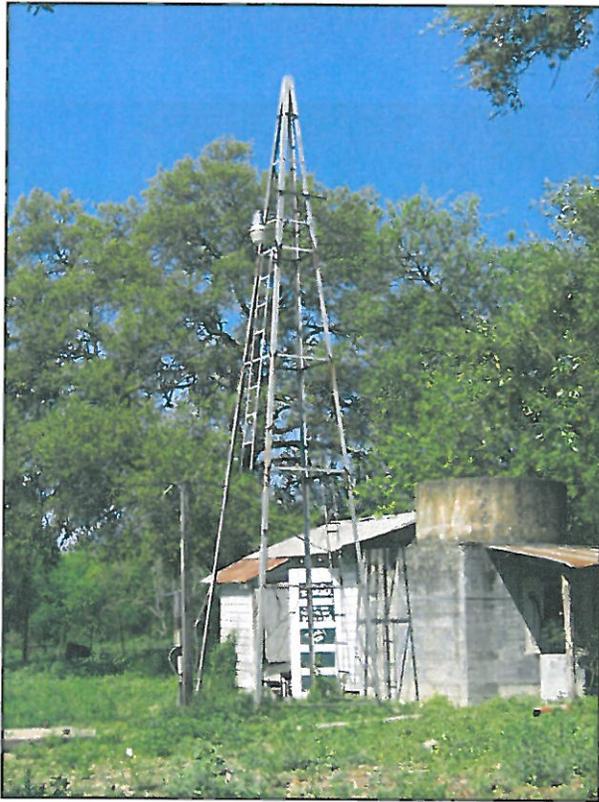
Figure 17. Metal windmill.

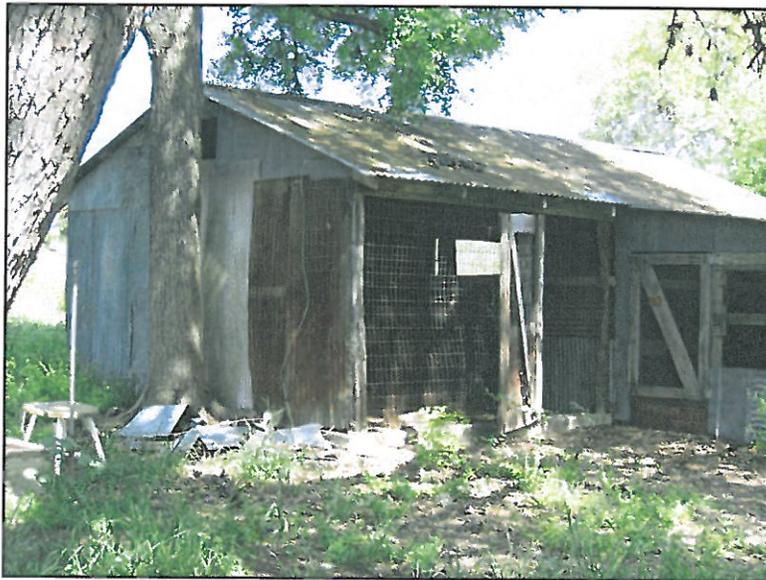
The chicken coop consisted of an “L” shaped structure with a main hip roof and shed addition, covered with both corrugated and flat tin sheets, with several openings covered with chicken wire. The structure was divided into one chicken roost and two animal pens, likely for a sheep- or goat-sized animal.

Figure 18. Chicken coop.

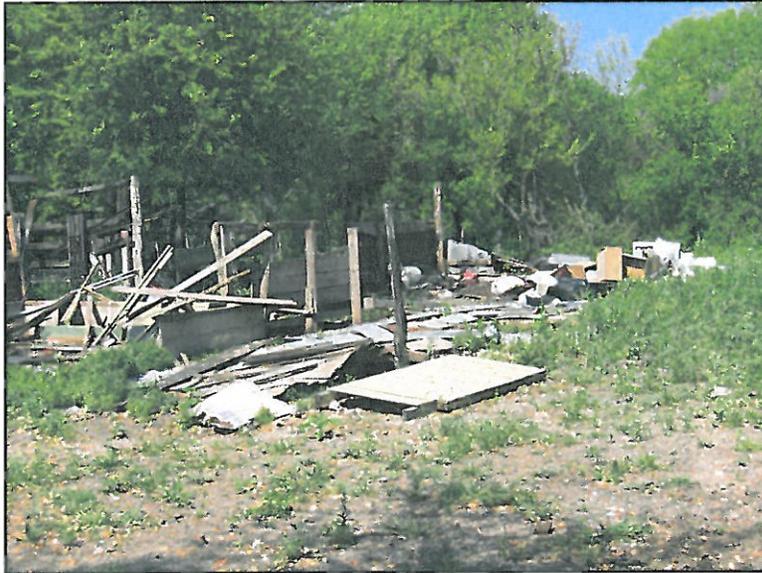
A concrete foundation with building debris was also located near the chicken coop, and another large collapsed building and trash dump was located away to the west. This building was

Figure 19. Collapsed building.

standing as late as 2003, as it appears intact in the recent aerial photograph. From the aerial, it looks to have been a rectangular structure with a tin covered gable roof. The remains are of a wood frame building with corrugated walls, with both a concrete wall and pier and beam foundation.

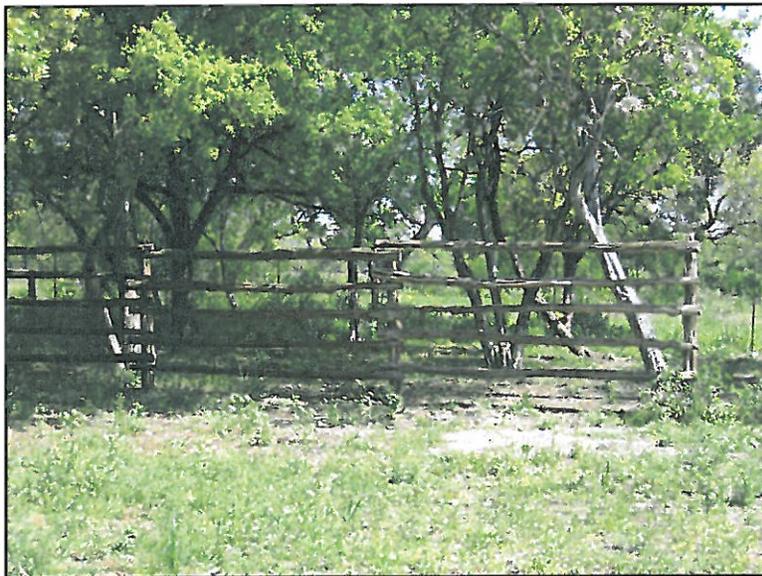
Figure 20. Corral.

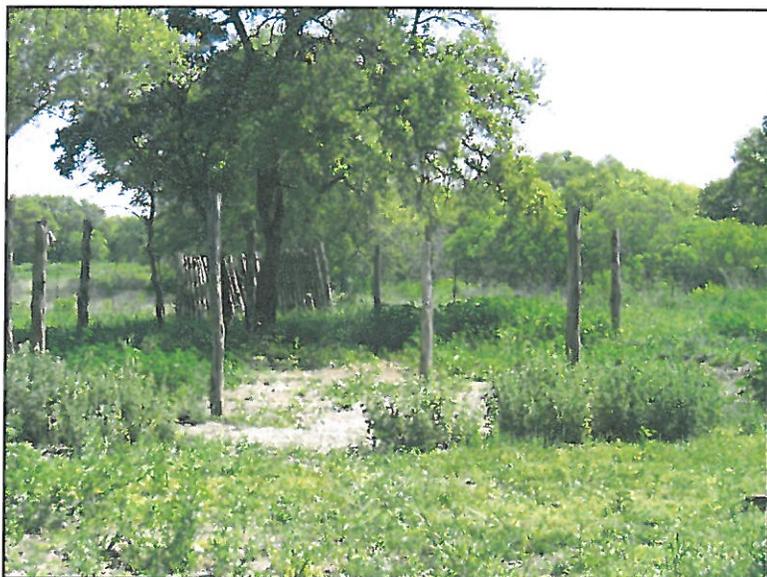
Figure 21. Horse training ring.

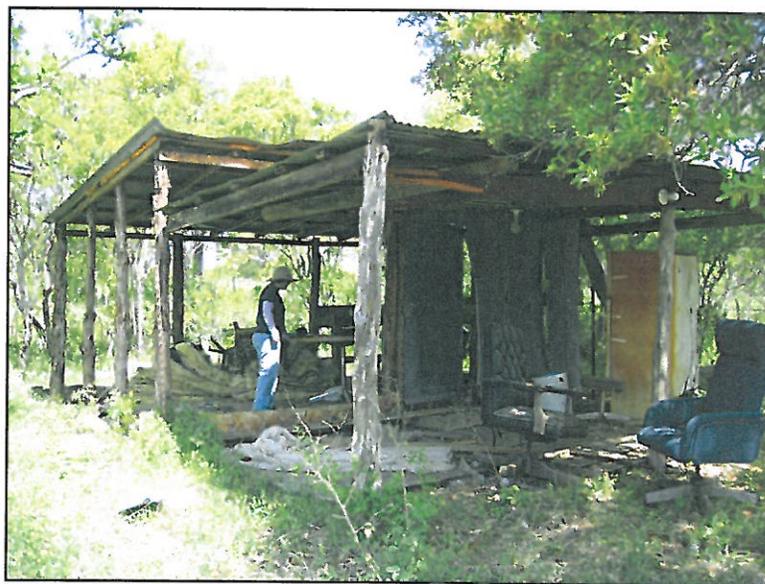
One building was located outside of the perimeter fence. An open walled shack was found along the roadway near the cluster of buildings, and consisted of two shed roofed

structures attached together and constructed with large cedar posts and corrugated tin roofs. Tin sheets were used as dividers of the interior space, and the floor was poured concrete. Large amounts of trash were found within the shack.

Figure 22. Open walled shack located outside the fenced area.
