**ARCHEOLOGICAL AND HISTORIC RESOURCES SURVEY ON EAST  
HOUSTON STREET FROM AT&T PARKWAY TO INTERSTATE HIGHWAY 10,  
CITY OF SAN ANTONIO, BEXAR COUNTY, TEXAS (CSJ 0915-12-481)**

LETTER REPORT NO. 821

July 2010

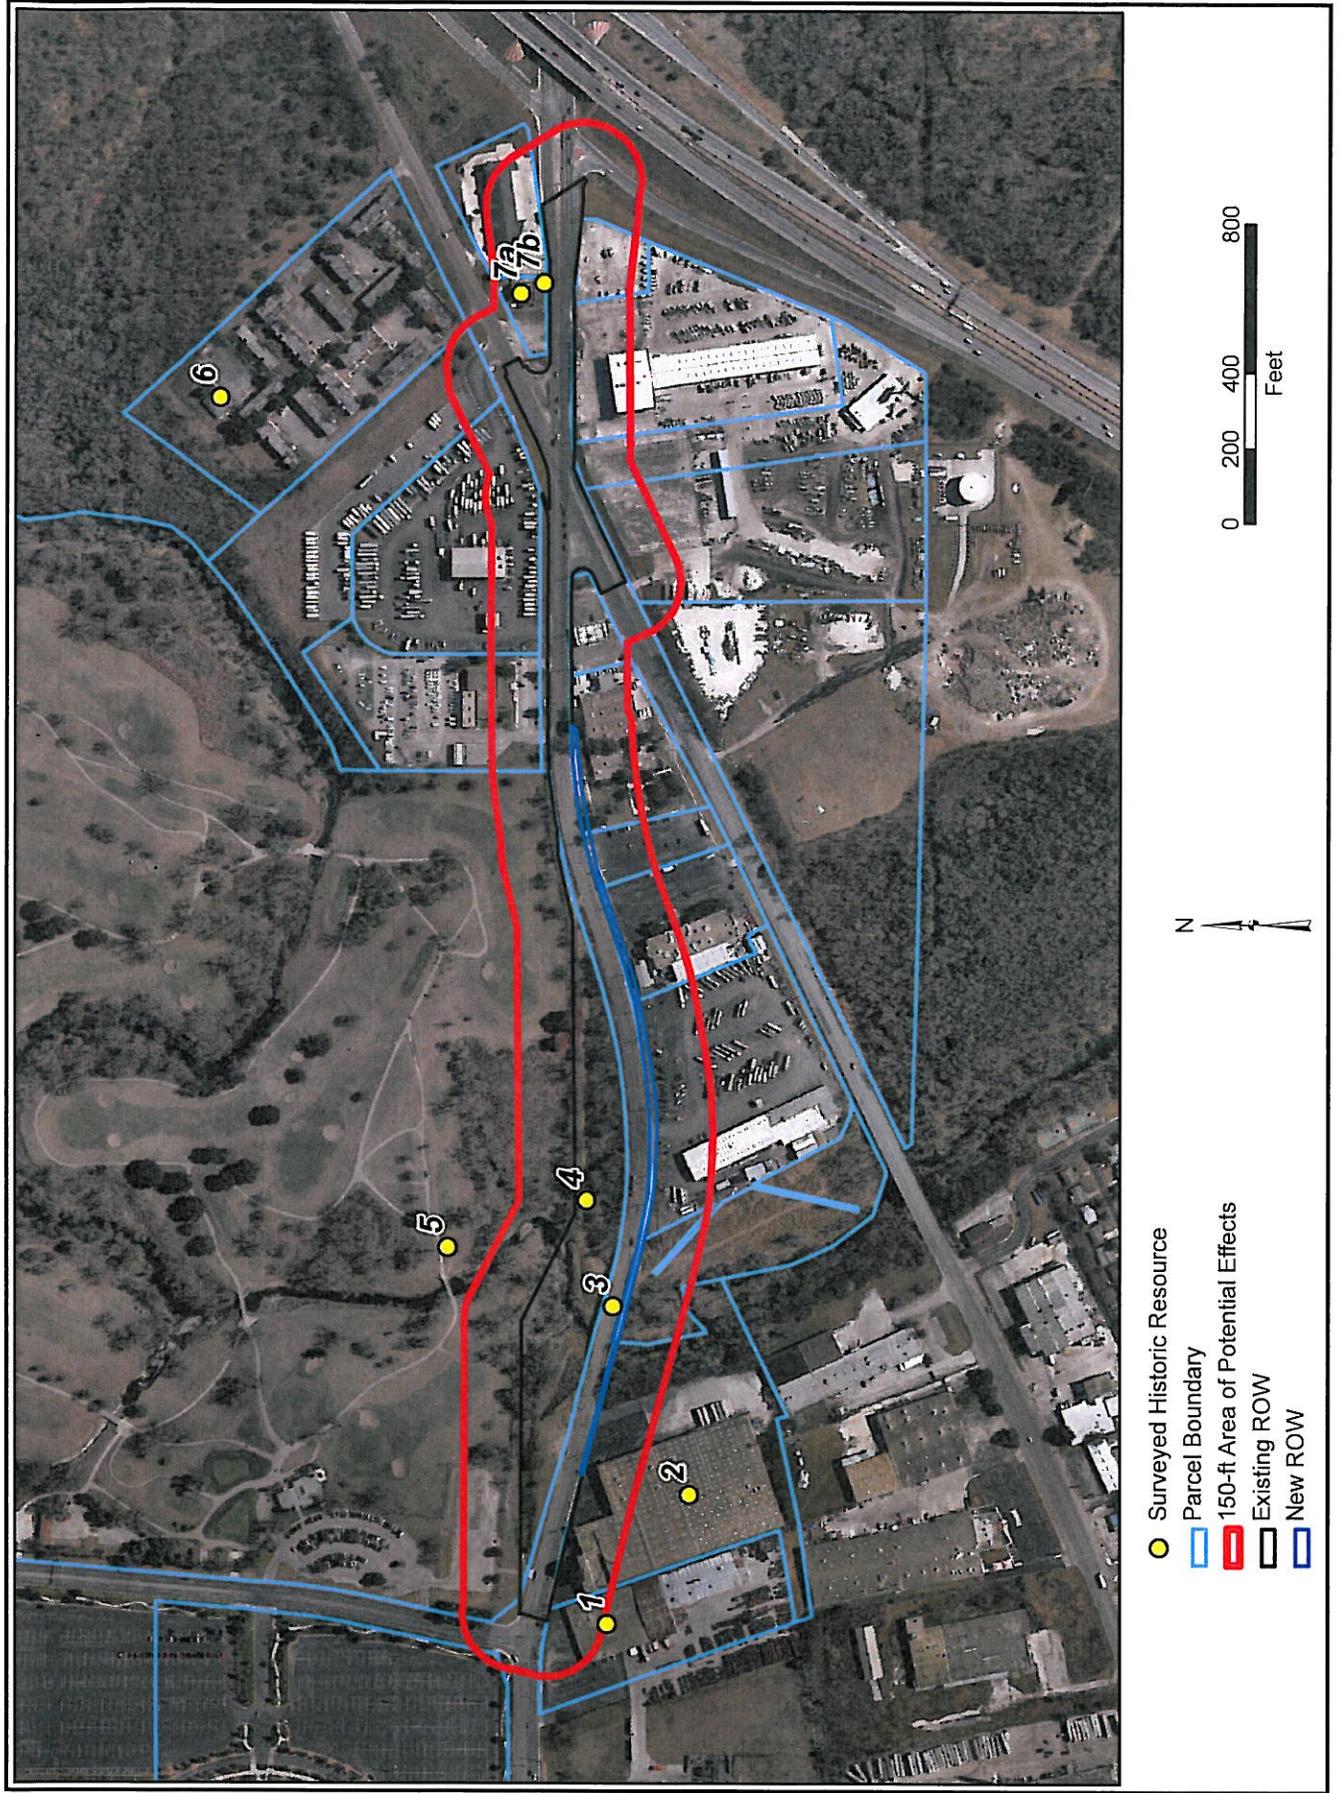
Figure 2

**Figure 2.** Modern aerial imagery showing Area of Potential Effects for historic resources survey, historic resources identified, and land parcels in the study area.
