ARCHAEOLOGICAL MONITORING AND MINOR
TESTING AT THE SITE OF MARTI'S,
310 WEST COMMERCE, SAN ANTONIO, TEXAS

Report No. 74
Abasolo Archaeological Consultants
San Antonio, Texas
2007

Archaeological monitoring and limited testing was carried out at 310 West Commerce, the future location of Marti's and the former location of Apache Café in downtown San Antonio. The location, being next to the Governor's Palace, was sensitive archaeologically in several ways. It lies near the heart of the early commercial and military activities in San Antonio. Second, a stone wall of historic significance framed the Marti's property on the east which also bordered the Governors Palace property. This stone wall was to be preserved at the request of the Historic Preservation office. Third, previous excavations on the Governors Palace property by UTSA showed a dense deposit of 18th and early 19th century trash. Shovel testing was conducted along the stone wall that defined the original south wall base and to examine the north wall base. Monitoring was carried out during the removal of at least two feet of fill in preparation for foundation construction of the new building and during core drilling activiti

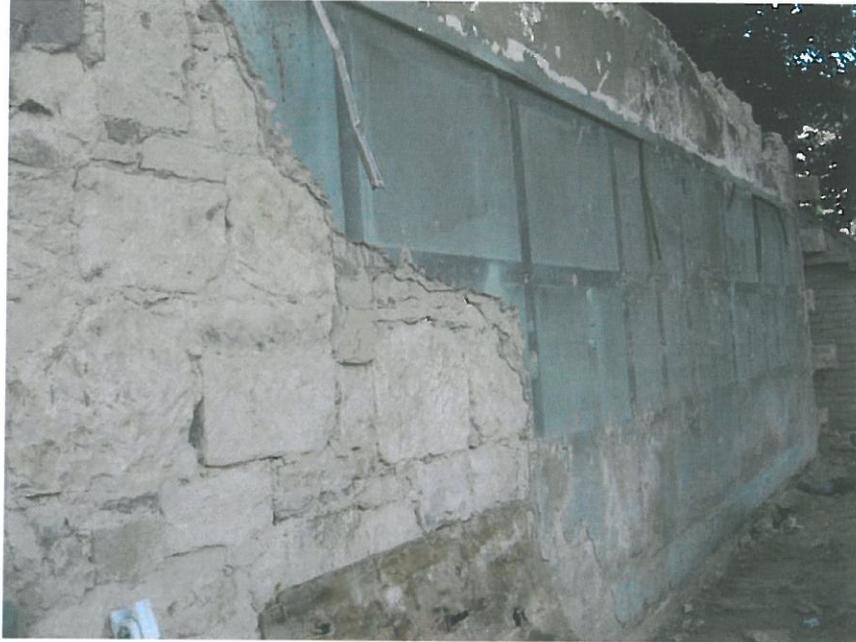
The cut stone wall (Fig. 2) had the appearance of considerable antiquity but it was unknown if it was associated with the Spanish Governor's Palace. The association was doubtful, however, because it was not shown on any early 19th century maps, but possibly on later 19th century maps and therefore it was regarded as historic by the COSA Historic Preservation Officer. In order to obtain more information about the wall we felt it necessary to conduct some subsurface investigations to better examine the wall and its base.

Figure 2. Historic stone wall that was to be preserved and incorporated into the new Marti's building.

The east wall will be saved and incorporated into the new construction based on an agreement between the COSA Historical Preservation and Jack Suneson. The fresco block used in the south wall was also to be pulled and saved.

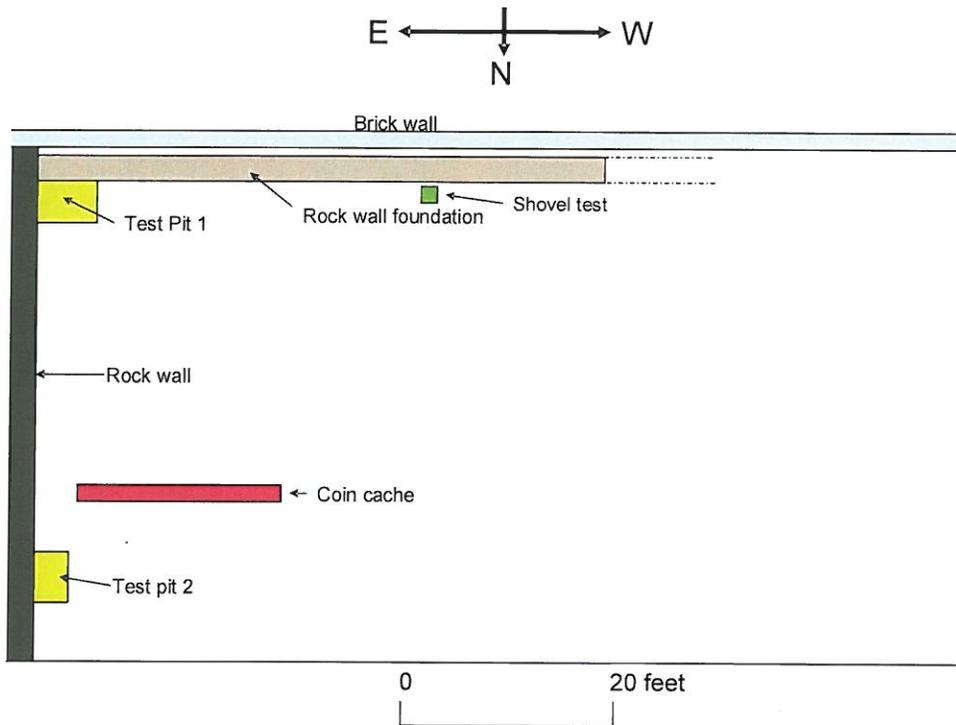
A shovel test was excavated about 30 feet west from the corner along the back wall to see if that wall remnant continued (Fig. 7); the test showed that it did as the top was encountered about 1.5 feet beneath the current fill.

Figure 7. Site plan showing the locations of the test pits, rock wall foundation, brick wall, and the cut stone rock wall (black).

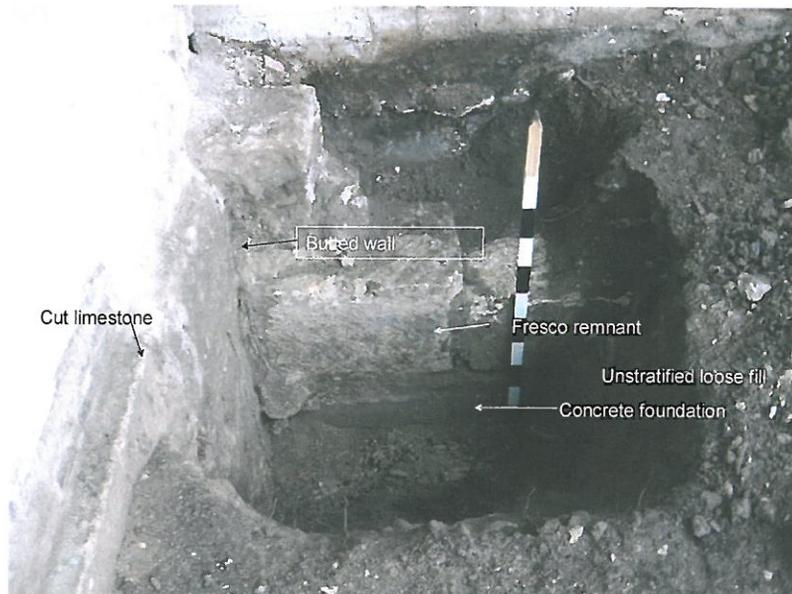
Objectives No. 1 and 2 were accomplished on July 18, 2007. Test Pit No. 1 was excavated at the southeast corner of the lot to a depth of 4.3 feet (Figs. 7 and 8). Exposure of the corner revealed that the south wall was built later than the east wall as shown by the manner in which it was abutted. Also, the base of the south wall is concrete and not cut limestone as is the case with the east wall (Figs. 9 and 10). Of interest was a block in the south wall with a noticeable fresco (Fig. 11). This and other fresco remnants seen in the east wall (Fig. 12) indicated that the east wall and the lower courses of the south wall were constructed of recycled stone. The source of the stone is unknown, but this was not unusual for that time period (Late 18th, early 19th centuries) to recycle stone from earlier stone Spanish Colonial and early Anglo stone structures.

Figure 9. Test Pit 1 showing the butted wall, cut limestone wall (left), fresco remnant, and concrete foundation (scale is one-meter).

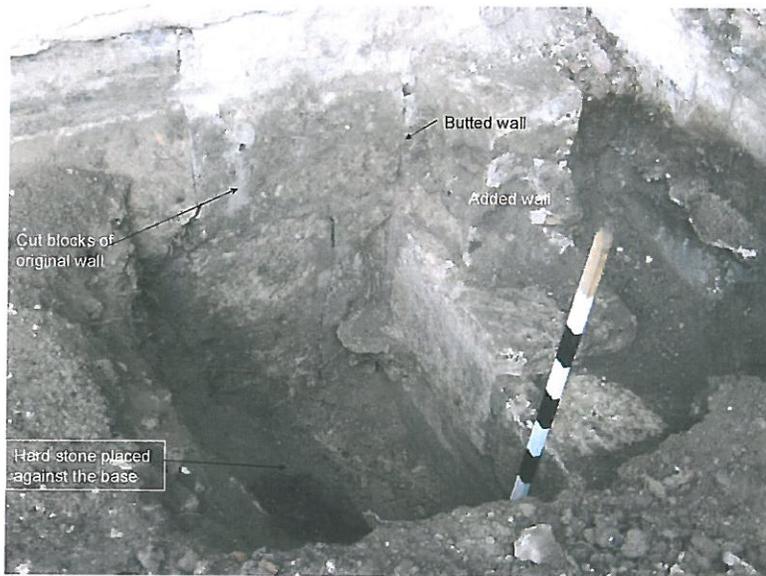
The sequence of wall construction is relevant to deciphering the sordid history of construction that took place at the location. The question is: when was the east wall constructed? The suggested sequence below is based on the observations made during the test excavations and monitoring. The earliest architectural feature is the cut stone wall base to the east wall. When this construction took place is unknown, but probably before 1885. Is this the wall of the structure shown in the 1885 Sanborn map or a wall associated with the earlier cantina? Or was it laid at the time the wall itself was built? That wall base was later used to construct the current wall composed of recycled cut stone blocks obtained from demolished buildings perhaps dating to the Spanish Colonial Period as some of the blocks contain remnants of frescos. When the standing east wall was constructed is unknown. The next construction series involved constructing a concrete foundation to the south wall which also was constructed of recycled blocks some contain fresco remnants. The concrete shows the striations from the frame, and I chipped a piece off with a pick to be absolutely sure it was concrete. In other words, the east wall and the south wall that was later demolished save for a couple of courses of cut stone were constructed at the same time although the south wall remnant does abut to the east wall. The last construction event was the brick wall that borders the Spanish Governor's courtyard behind the demolished south wall. This brick wall (since removed) was apparently constructed about 1919-1926. This brick wall enclosed part of the old cut stone foundation along the south wall.

Figure 10. Test Pit No. 1 showing the butted wall, south wall base (added wall), and cut stone blocks in the east wall foundation.

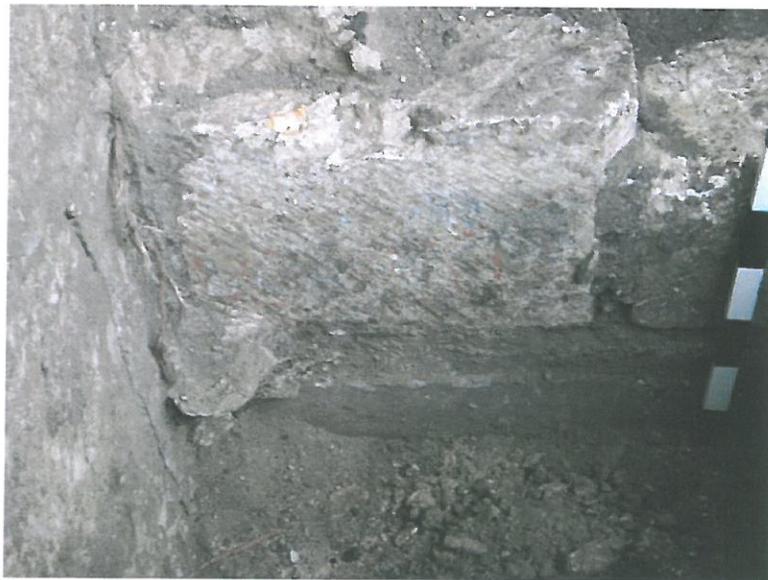
Figure 11. Fresco block in the south wall remnant that was saved.

Kay Hinds and Ann McClone provided some consultation regarding the possible history of the standing wall and what conservation measures to take. They wanted the block with the fresco that we exposed in the back wall taken out and preserved.

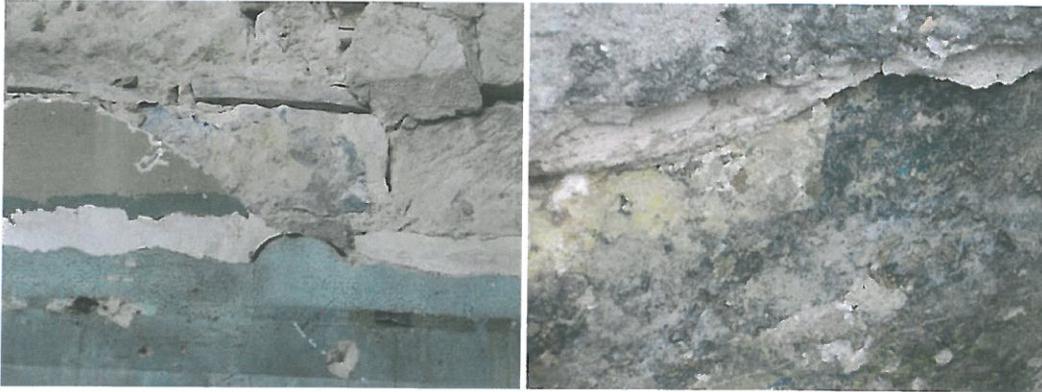
Figure 12. Early fresco blocks incorporated into the standing stone wall, covered with plaster and a later fresco.

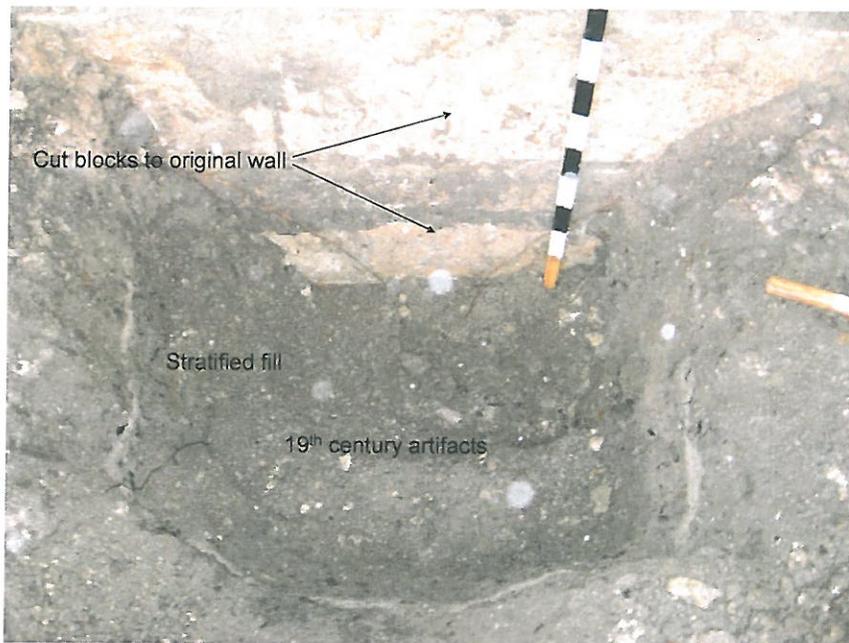
Objective No. 3 was partly accomplished; we were able to determine that the base of the east wall here (about midway along the wall) was the same as observed at the corner. Test pit No. 2 was placed along the east wall to see if the cut-limestone block foundation continued which it did (Figs. 7 and 13). Also, in excavating this test pit, numerous artifacts were seen and three soda water bottles, a beer bottle, and other bottles and fragments along with several pieces of stone ware were collected for dating.

Of particular interest here is the fact that the deposits were stratified. At about 1.3 feet an ash layer was noted across the pit; artifacts beneath this ash layer were prolific and dated to the late 19th century (Fig. 13); the spoon and bottles were collected from this deposit. The importance of this observation is that the fill against the east wall is essentially undisturbed while that against the south wall is disturbed and contains 20th century trash. That would further confirm that observation that the south wall was constructed later.

Figure 13. Test Pit No. 2 showing the base of the cut stone east wall and stratified fill.
