**ARCHEOLOGICAL AND HISTORIC RESOURCES SURVEY OF TWO
ALTERNATIVE PLAYGROUND LOCATIONS AT ROOSEVELT
PARK IN SAN ANTONIO
BEXAR COUNTY, TEXAS**

City of San Antonio, Texas

Steven W. Ahr and Sherry N. DeFreece Emery
URS Corporation
9400 Amberglen Blvd.
Austin TX 78729

November 2009

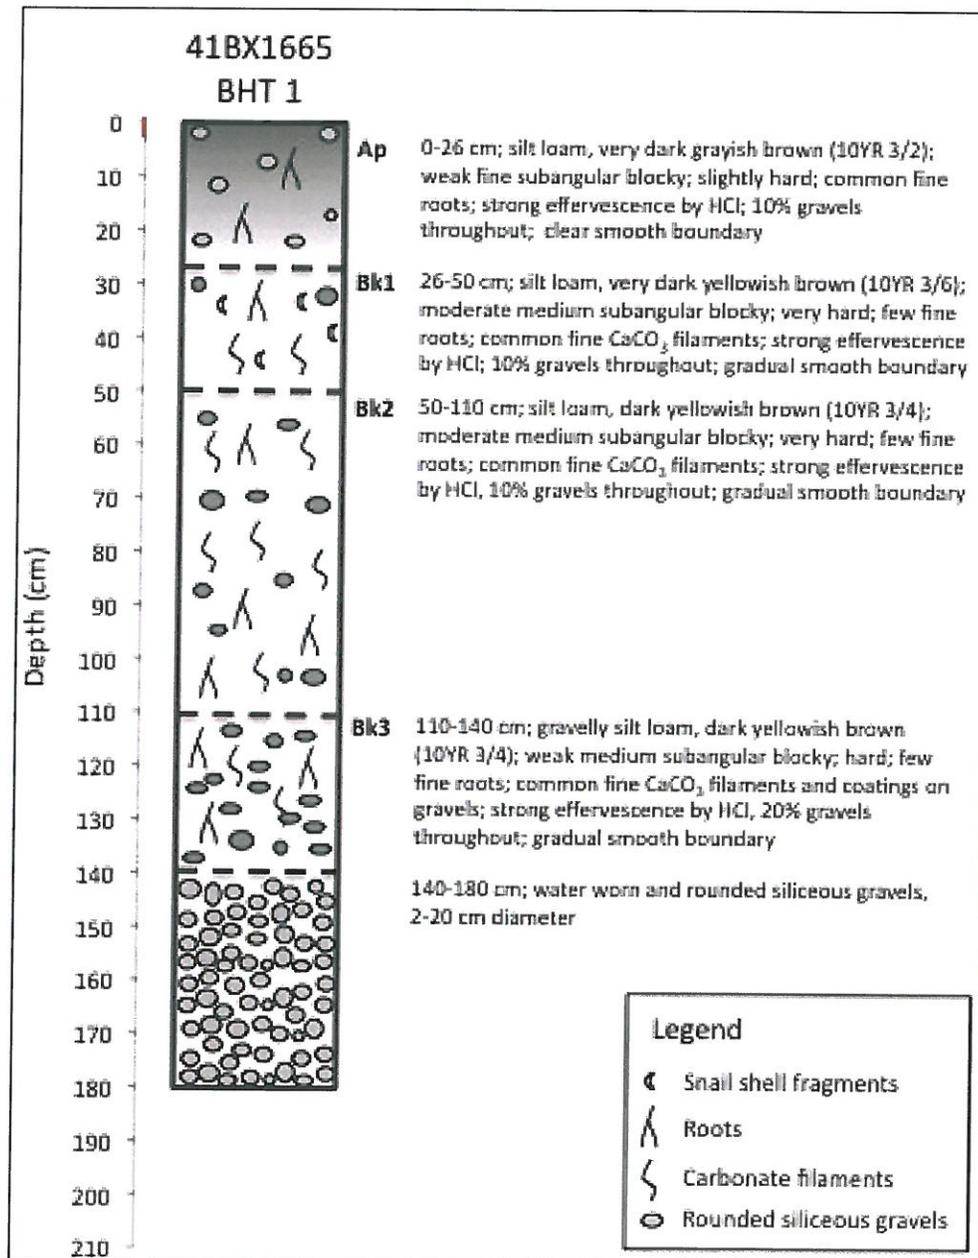
Survey Area 1 is located at the northeast corner of Roosevelt Park and was surveyed on April 20, 2009. The goals of the survey was to determine if site deposits from 41BX1665, which was recorded to the southwest, extended into the area and to determine if significant deposits would be impacted by construction of a playground. One backhoe trench (BHT 1) and four shovel tests were excavated within Survey Area 1 (Figure 3). All excavated units were positive for prehistoric cultural materials. Given the types of cultural materials recovered, the depth ranges, and the observed geomorphology, these artifacts are assumed to represent an extension of previously recorded site 41BX1665. The revised site boundaries for 41BX1665 are illustrated in Figure 3. Site details are discussed below.

Figure 3. Location of survey areas and 41BX1665 at Roosevelt Park.

Given that both the original 41BX1665 site boundaries and the newly surveyed playground area are situated upon the same soil-geomorphic setting as 41BX1665 and contain similar prehistoric artifacts, it is reasonable to conclude that these finds should be considered the same site. Thus, the redefined site boundary extends approximately 130 meters northeast-southwest, and 80 meters northwest-southeast (see Figure 3). Artifacts recovered from the current survey (including an end-scraper, core, lithic debitage, bone, and burned caliche) are consistent with those identified during the original recording of this site in 2006, and strongly suggests the possibility of a Late Prehistoric or Historic Indian campsite with artifact integrity (Shafer and Hester 2006). Given the geomorphic setting of this site, it is likely that stratified cultural components may be preserved in overbank alluvial deposits. As such, we concur with the original site investigators that this site warrants designation as a State Archeological Landmark. Given the SAL status, we further recommend that this site area be avoided by construction.

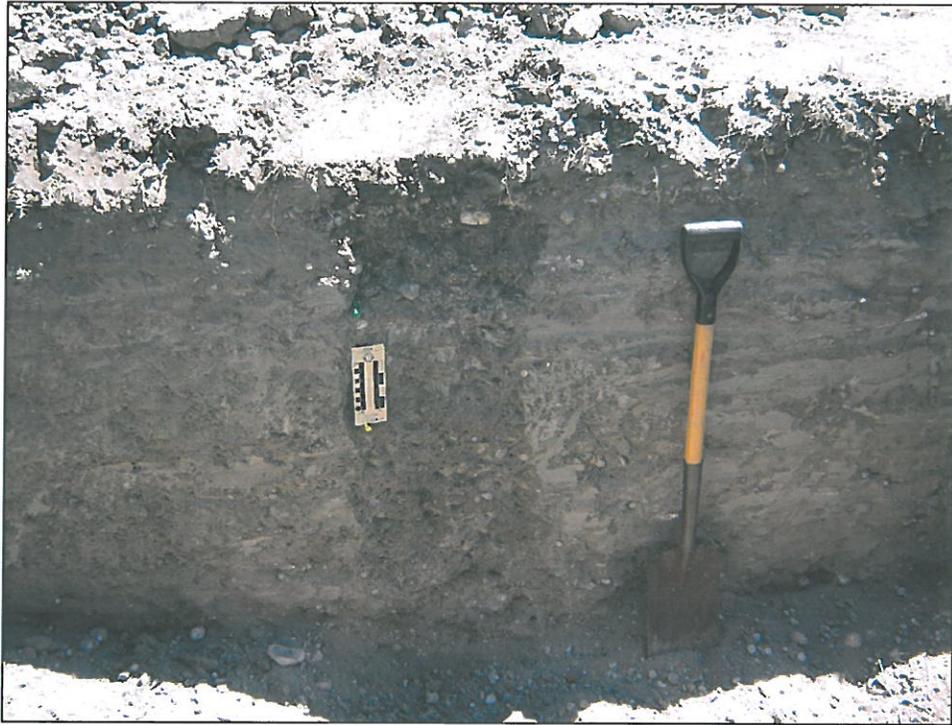
Figure 5. East wall profile of BHT 1.

The current survey (this report) was conducted approximately 30 meters northeast of the originally recorded 41BX1665 site boundary (Figure 3). The purpose was to identify whether site 41BX1665 extended into the proposed playground area, and if so, to assess whether any deposits would contribute to the SAL eligibility of site 41BX1665. The survey included a single backhoe trench (BHT-1) excavated to 180 cm, and four shovel tests ranging from 20 to 100 cm. Detailed BHT profile examination revealed a 140 cm-thick silt loam and gravelly (e.g., >15% gravel) and calcareous silt loam solum exhibiting an Ap-Bk1-Bk2-Bk3 horizon sequence (Figures 4 and 5). This soil horizon sequence is developed over a 40 cm-thick zone of water worn and rounded siliceous ancient terrace gravels ranging from 2 to 20 cm in diameter. Few fine roots and fine calcium carbonate filaments are present throughout the soil profile, which was strongly effervescent with HCl.

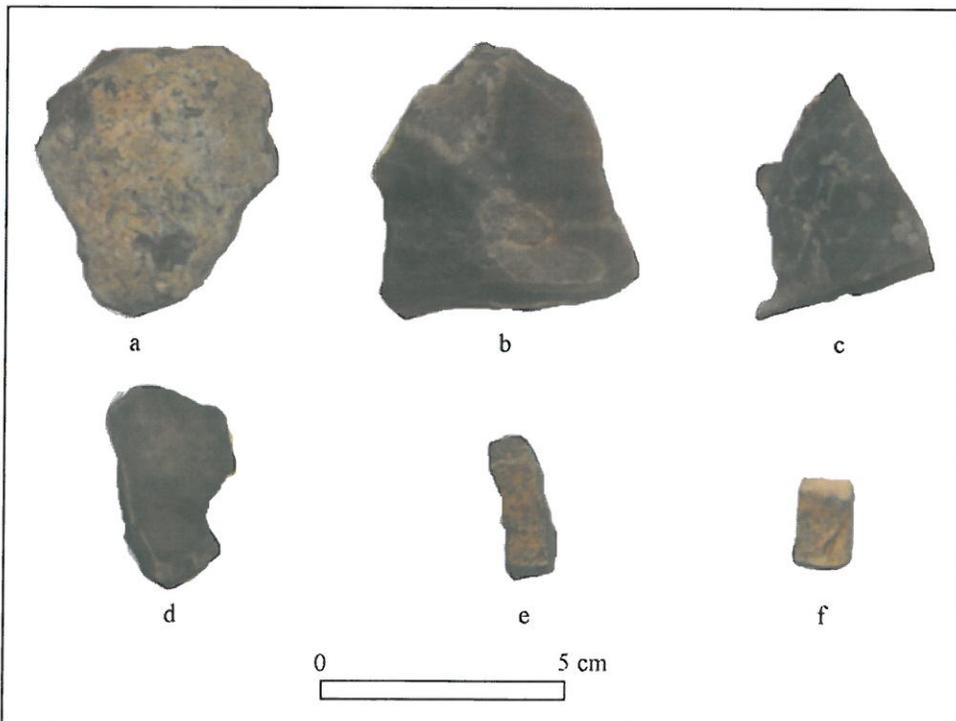
Figure 6. 41BX1665 artifacts : a) end-scraper; b) core; c-d) angular fragmented debitage; e-f) bone.

Prehistoric materials were found in backhoe trench backdirt recovered from depths of 20 to 50 cm below surface, which would include the Ap through Bk1 soil horizons. Artifacts recovered from backdirt include one small end-scraper, one core, one angular chert debitage fragment, and two small bone fragments (Table 1). Selected artifacts are illustrated in Figure 6. Trench walls were cleaned and closely inspected for additional cultural materials; however, none were found. Shovel Test 1 was dug into the east wall of the trench to a depth of 100 cm. Sediments taken in 20-cm intervals were screened; however, no artifacts were found. Three additional shovel tests were excavated to the east, west, and south of the backhoe trench. Shovel Test 2 was negative for cultural materials. However, a single unmodified flake was found in Shovel Test 3 from 0-20 cm (Figure 6c). Shovel Test 4 yielded four small bone fragments, a single piece of chert debitage, and one piece of burned caliche.

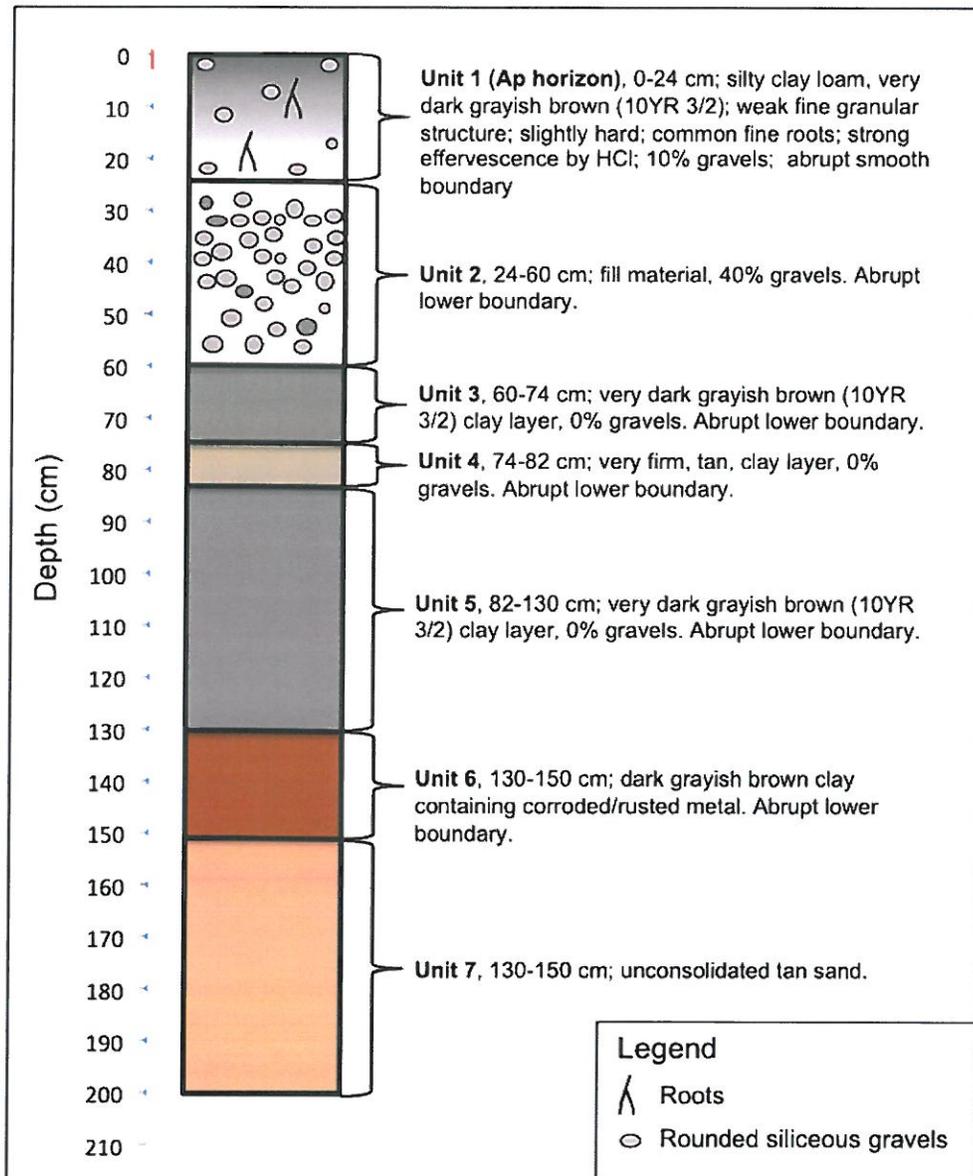
On April 20, 2009, BHT-2 was excavated immediately east of the existing playground and revealed numerous historic-age artifacts extending to a depth of at least 2 meters; no prehistoric materials were found in this trench. Because these historic deposits do not appear to be temporally or geologically related to the cultural deposits from site 41BX1665, the historic materials are not considered part of site 41BX1665. Detailed BHT profile examination revealed that instead of one or more alluvial-soil stratigraphic sequences, the entire depth of deposits consisted of artificially emplaced fill materials of varying thicknesses, textures, and consistencies. Since these layers are depositional rather than pedogenic soil horizons, the standard methods for soil description were abandoned, and each distinct layer was assigned a depositional unit number, from top to bottom. Seven distinct units were recognized in the field (Units 1-7) and are illustrated and described in Figures 7 and 8. Historic materials were observed throughout the entire profile sequence to 200 cm below surface (Table 2; Figure 9). Ages assigned to various artifacts observed in the field are largely inclusive of late 19th through early 20th century (see Table 2). Artifacts were most heavily concentrated from 100 to 200 cm below surface; fewer artifacts were observed in fill deposits ranging in depth from 20 to 100 cm, likely because this range is composed largely of gravelly fill over a dense, dark gray clay. Given the disturbed nature of this site, the compactness of the sediment, and the clearly non-natural layering of artificial fill deposits, no shovel tests were deemed necessary.

Figure 7. BHT-2 profile.

Backhoe trenching in Survey Area 2, east of the existing playground, revealed numerous late nineteenth to early twentieth century artifacts to a depth of at least 2 meters. All artifacts were contained within intentionally layered fill deposits, and arguably pre-date 1915. No prehistoric materials were found. Since none of the artifacts directly relate to military training operations of the First United States Volunteer Cavalry (e.g., Teddy Roosevelt's Rough Riders), nor indicate any association to the former alignment of Concepcion Road, it is likely that the trash items were incorporated into the soil-fill used to fill in the gravel pits that in use at this site until 1916. Given the secondary context of these remains, these artifacts do not appear to exhibit research value, and no further work is recommended at this location.

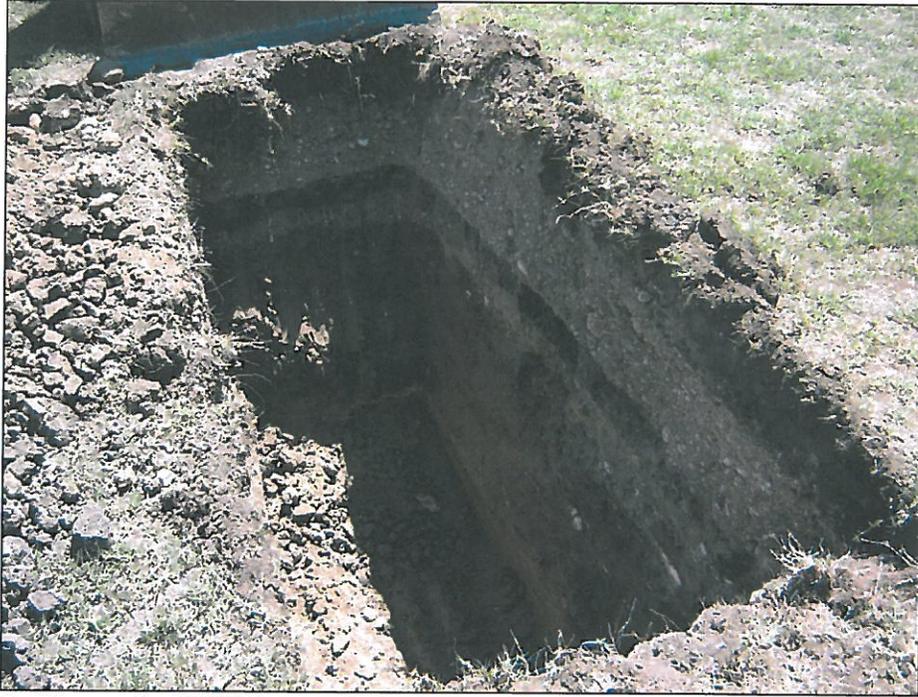
Figure 8. West wall of BHT-2 at southern playground alternative, showing layered fill deposits.

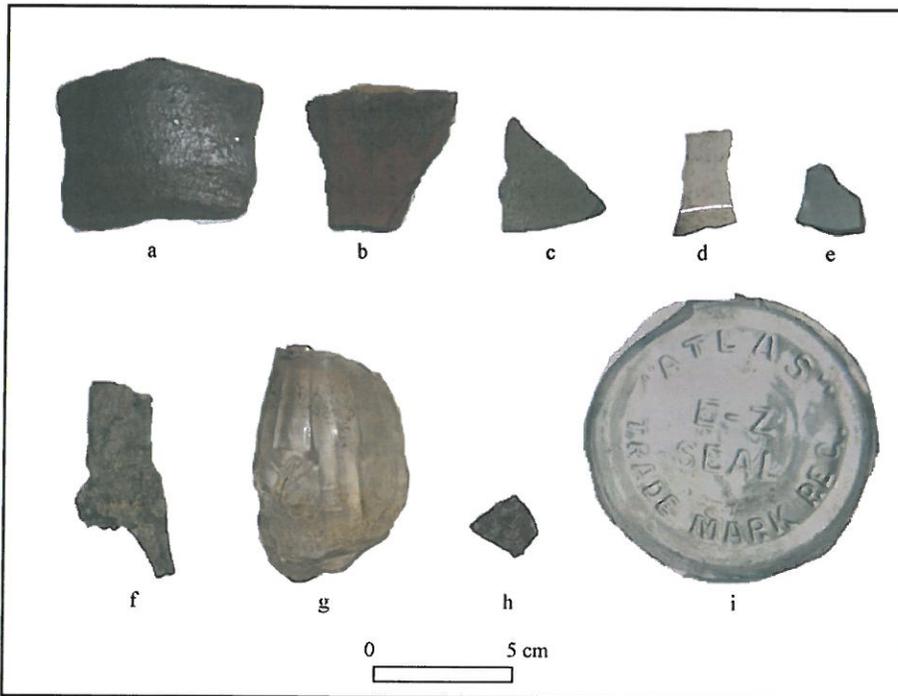
Figure 9. Selected artifacts identified in backfill deposits at southern alternative playground: a) salt-glazed stoneware fragment, 100-110 cm; b) ceramic utility pipe sherd, 100-110 cm; c) salt-glazed ceramic sherd, 100-110 cm; d) whiteware rim sherd, 100-110 cm; e) whiteware sherd, 80-90 cm; f) bone fragment, 100-110 cm; g) Coca-Cola bottle (partial), 150-170 cm; h) amber bottle glass fragment, 100-110 cm; i) "E-Z SEAL" bottle base, 150-170 cm.

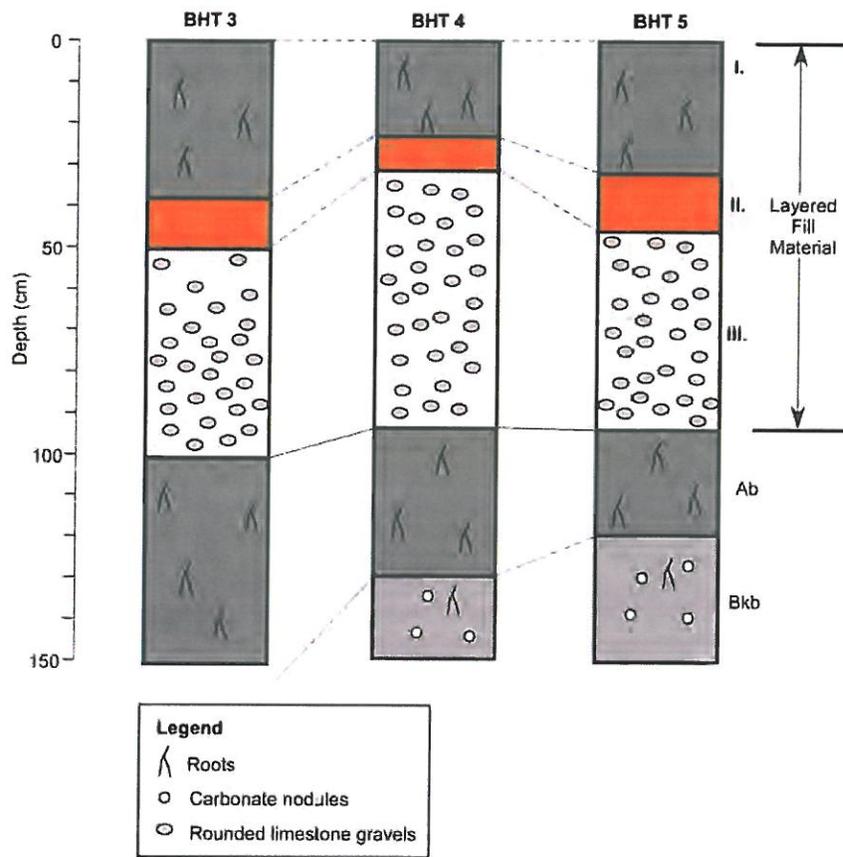
Abruptly beneath the layers of fill, the upper part of an intact buried Ab-Bkb (b = buried) soil horizon sequence was observed, beginning at about 1 meter depth. This intact buried soil is similar to the surface soil recorded in BHT 1 at Survey Area 1 in the northeastern corner of the park. The Ab horizon consists of very dark gray (10YR 3/1) clay, and moderate medium to strong coarse angular blocky and subangular blocky structure. The clay was extremely firm, with common (20%) fine roots. Less than 1% gravels were observed in this horizon. The Ab horizon gradually grades into a Bkb horizon beginning about 120 to 130 cm from below the surface. The Bkb horizon consists of dark brown (10YR 3/3) clay loam and exhibits strong, medium subangular blocky structure, and is very firm in consistence. This horizon contains approximately 2% finely disseminated hard carbonate masses less than 5 mm in diameter. Despite careful troweling, close examination of trench walls, and examination of backdirt deposits, no artifacts or features were found within the buried soil exposed in BHTs 3-5.

Figure 10. Backhoe trench profiles for BHTs 3-5.

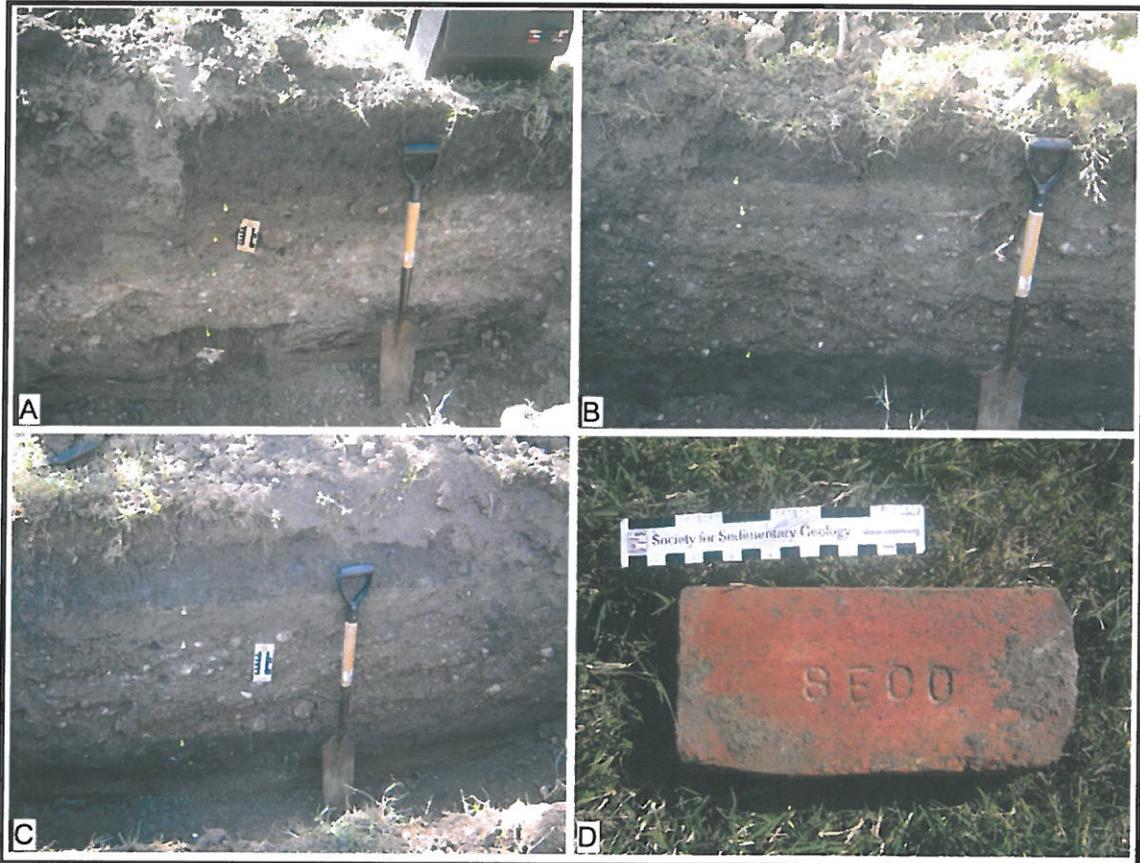
Subsequent to the survey of the proposed playground location east of the existing playground, the city developed plans to construct the playground immediately south of the existing playground. This plan also included re-routing the existing underground CPS Energy electric line that runs under the proposed site. On November 6, 2009 BHT 3 was excavated to test for buried deposits in the proposed playground immediately south of the existing playground. BHTs 4 and 5 were situated along the proposed CPS Energy utility re-route (see Figure 3). Each trench exhibited the same generalized soil-stratigraphic sequence (Figures 10-11) wherein the uppermost meter of deposits consisted of 3 distinct fill layers (e.g., zones). Zone I consists of modern topsoil and is a relatively loose very dark gray (10YR 3/2) clay loam with common fine roots throughout. Abruptly beneath Zone I, Zone II consists of a yellowish brown (10YR 5/4) silty clay loam to a depth from 30 to 50 cm. The bottom fill layer, Zone III, lies abruptly beneath Zone II and consists of gravelly silty clay, with approximately 20 to 40% gravel content. One Seco pressed brick (ca. post 1910) was found at the top of Zone III in BHT 3, at approximately 50 cm depth (Figure 11d). No other artifacts were found in any of these trenches.

Figure 11. Field photographs from BHTs 3-5: a) BHT 3 profile; b) BHT 4 profile; c) BHT 5 profile; d) Seco pressed brick found in fill deposits in BHT 3.

The presence of intentionally stratified fill material such as gravel, sand, and compacted clay layers, as well as trash deposits dating to as late as 1915 is consistent with backfilling of former gravel pits after the area was donated to the city in 1916. No evidence was found to suggest that the artifact deposits relate to military training operations of the First United States Volunteer Cavalry (e.g., Teddy Roosevelt's Rough Riders), who were encamped near here in 1898 prior to their deployment to Cuba during the Spanish American War (see historic resources section of current report). Furthermore, no evidence was found to indicate that the deposits are related to the former alignment of Concepcion Road. Given the secondary depositional context of late 19th to early 20th century

artifacts within the layered backfill deposits, these artifacts do not appear to exhibit research value, and no further work is recommended at this location. Since the preferred playground location at Survey Area 2 has been relocated to the immediate south of the existing playground (where no deposits were found), no further impacts to the trash deposits would occur.

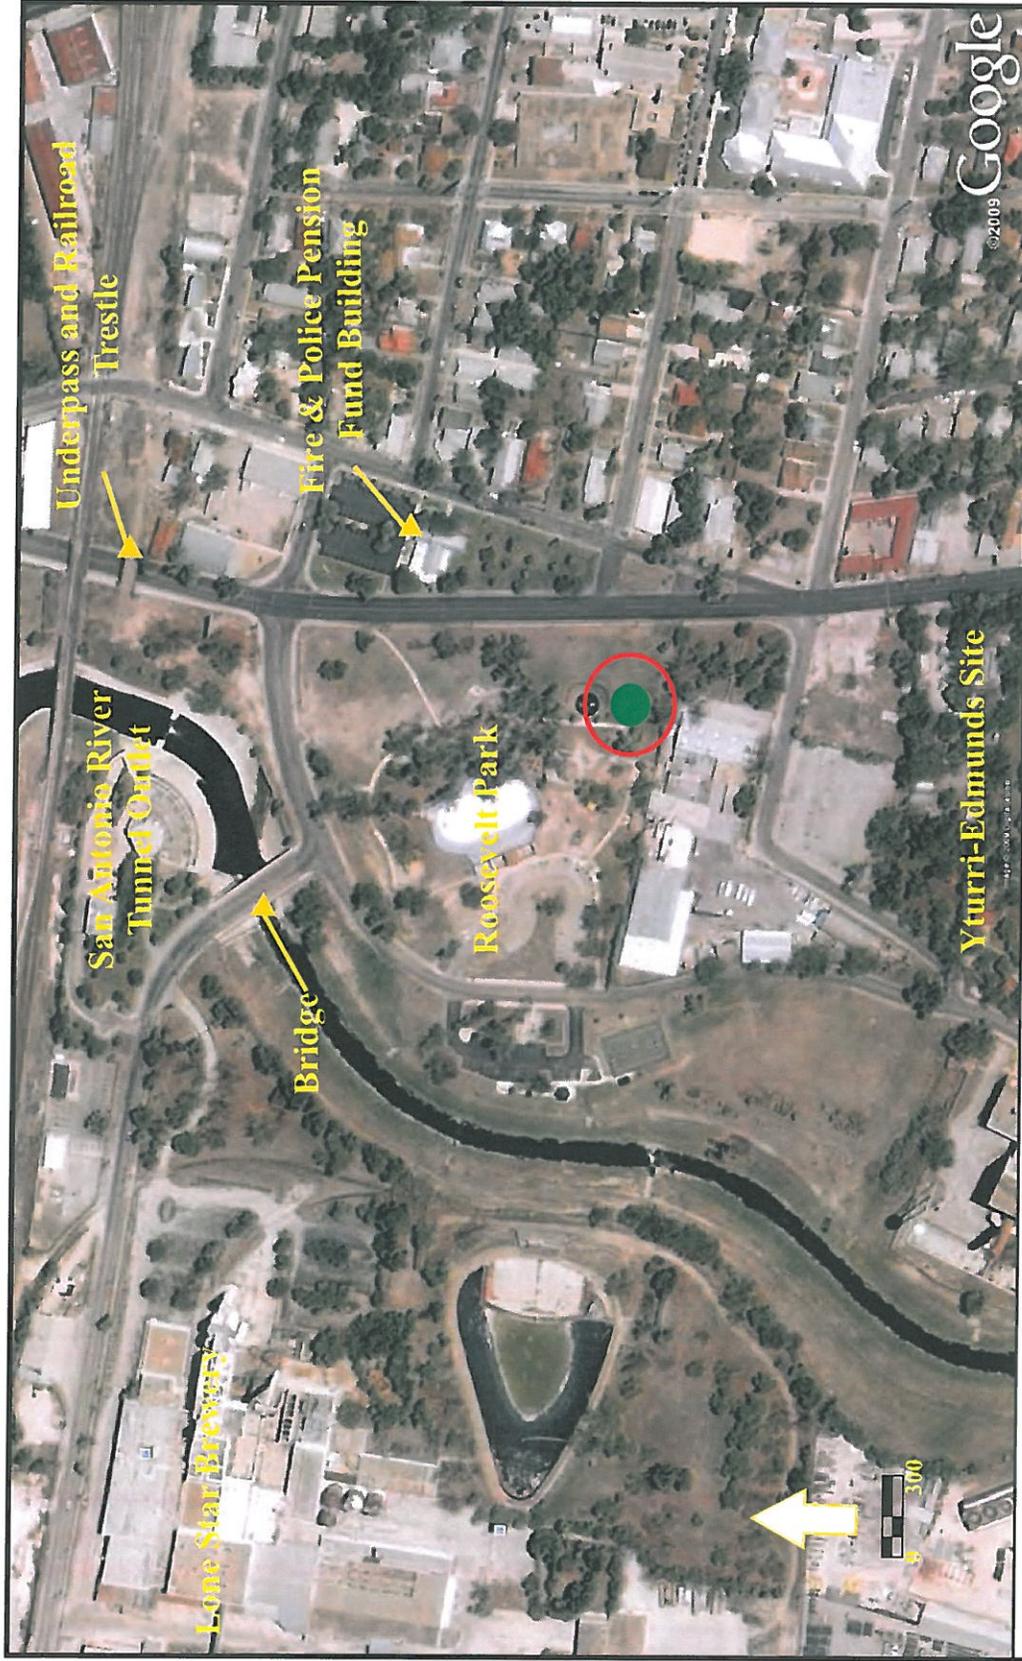
Figure 1. The Roosevelt Park project area with proposed playground location shown in green and the APE shown in red.

Roosevelt Park consists of 12.9 developed acres along the San Antonio River in San Antonio, Bexar County, Texas. The park was donated to the city of San Antonio Park and Recreation Department in 1916 (SAPAR 2009a). The park is officially located at 331 Roosevelt Avenue, and the site of the proposed playground is at the southeast corner of the park along Roosevelt (Figure 1).

In order to provide a photographic record of the current park site and its immediate surroundings, photographs were taken of the viewsheds from the proposed playground location, buildings and structures that surround the park on all sides, and of the proposed playground location. Photographs are presented in Appendix A, and correspond to the locations shown in Figure 1.

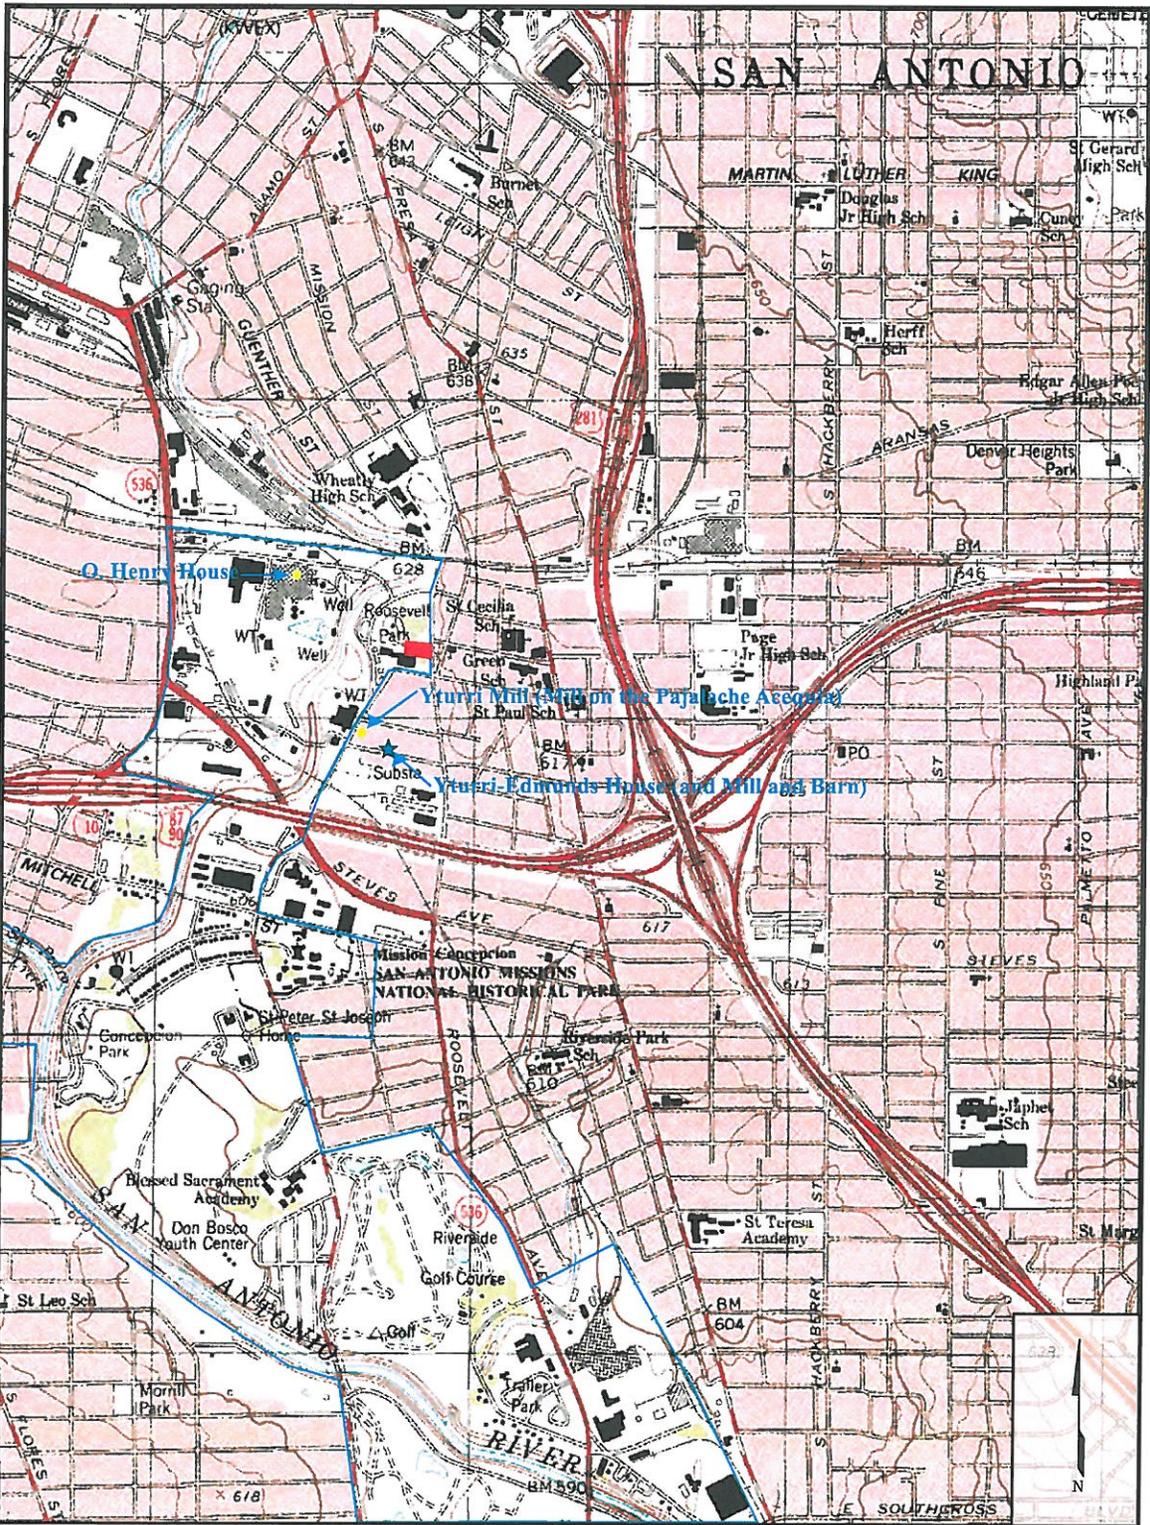
Figure 2. Topographic map showing previously documented historic-age resources in the Roosevelt Park project area, shown in red. The NRHP district is outlined in blue, the NRHP property is noted with a blue star, and historic markers are noted with yellow circles.

Upon further research and during the site visit, it was found that the 1936 Centennial Marker commemorating the Old Mill on the Pajalache Acequia is not located where indicated on the TSHA Sites Atlas map. It is instead located within the grounds of the Yturri-Edmunds property, which is owned and operated by the San Antonio Conservation Society. The Yturri-Edmunds property, located south of Roosevelt Park (Figure 1) contains a house, mill, and barn and is recognized in several ways: the Yturri-Edmunds House is listed on the National Register of Historic Places (NRHP); the Yturri Mill is listed as a Registered Texas Historical Landmark (RTHL); and the property contains two 1936 Centennial markers (the Yturri Mill and Old Mill on the Pajalache Acequia). The mill, house, and barn have also been the subject of a neighborhood survey. In addition to the Yturri-Edmunds property, the THSA showed the O. Henry House as located nearby within the property of the Lone Star Brewery. Upon further research and during the site visit, it was found that the O. Henry House was relocated to the intersection of Laredo and Dolorosa streets in 1998 (San Antonio Conservation Society 2009). No other historic resources were identified by the THSA as being near Roosevelt Park, except for the Mission Parkway National Register Historic District, which includes the park boundaries. Additional research was undertaken regarding whether the park itself was a contributing element to the historic district in September 2009. URS staff searched the files on the Mission Parkway National Register Historic District located at the Texas Historical Commission. The file search revealed no mention of Roosevelt Park, and did not indicate that the park or structures within the park was considered a contributing element to the historic district. All known historic resources are shown on Figure 2.

Roosevelt Park at 331 Roosevelt Avenue is within the boundaries of the Mission Parkway National Register Historic District (Figure 2). The NRHP listing does not specifically mention Roosevelt Park as a contributing element of the historic district, but does briefly discuss the earlier historical association of the land on which the park sits; prior to the construction of the park, this land was associated with the training of the First US Cavalry. The listing states the following:

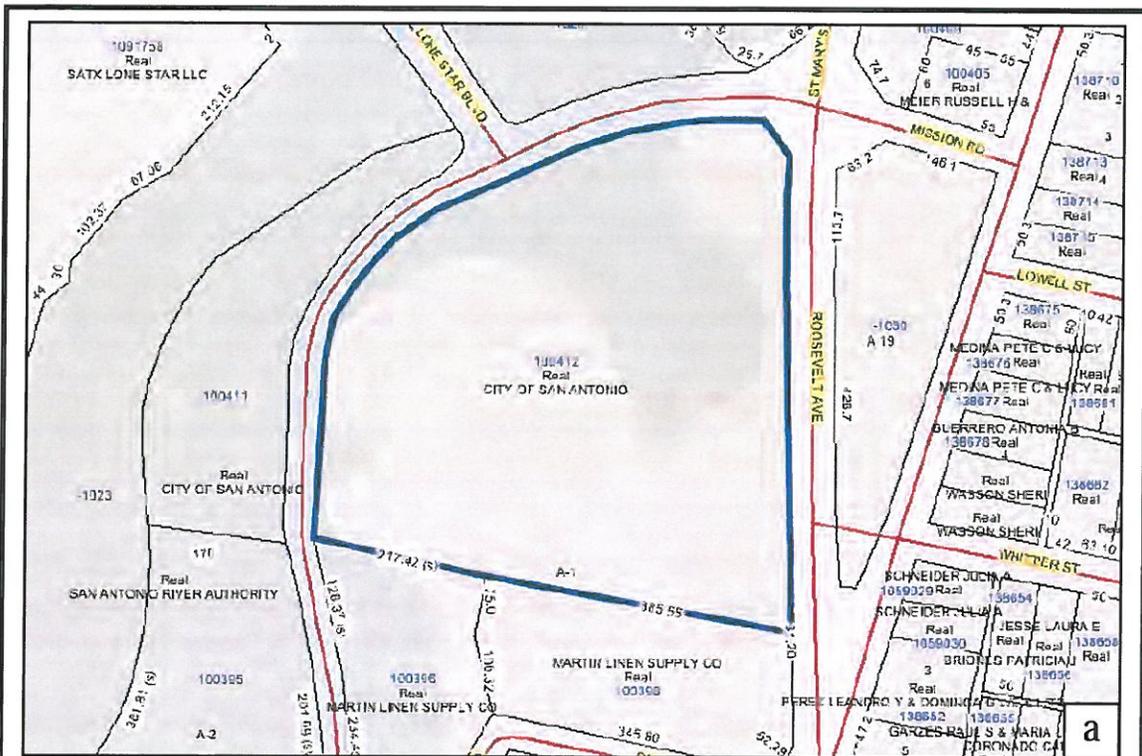
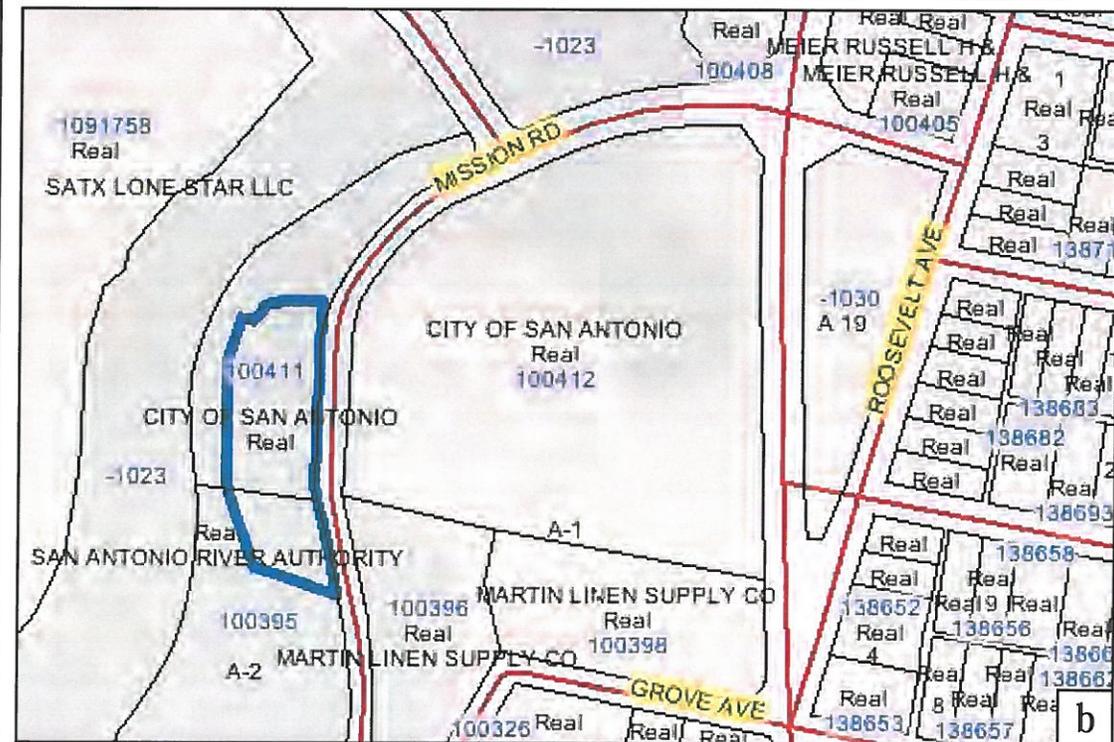
Suggested boundaries of the Roosevelt Park Historic District are shown in Figure 6, and include the eastern parcel bounded by Mission Road on the north, west, south, and Roosevelt Avenue, and the western parcel bounded by the San Antonio River on the west, property owned by the San Antonio River Authority of the north and south, and Mission Road on the east. Contributing elements to the park consist of the bathhouse (Resource Number 1a), the pool (Resource Number 1b), the men's and women's restrooms (Resource numbers 1d and 1e), the low stone wall (Resource Number 1g), the landscape area and water fountain (Resource 1h), and the picnic area (Resource 1j). These contributing elements were constructed within the period of significance of the park, and retain their historic integrity. They are all representative of early twentieth century rustic park architecture and therefore contribute to the park's eligibility under NRHP Criterion C. Non-contributing elements consist of the recreation building (Resource Number 1c), the pavilion/gazebo (Resource Number 1f), playground (Resource 1i), and the basketball court and associated parking (Resource 1k). These elements of the park were constructed outside of the period of significance. Detailed descriptions of each of the contributing and non-contributing elements within Roosevelt Park and assessments of their individual integrity are presented in Appendix B.

Figure 6. Roosevelt Park property boundaries, including the area east (a) and west (b) of Mission Road.

As it is currently planned, the construction of the proposed playground will not adversely affect the historic character of Roosevelt Park, its contributing historic-age resources, nor nearby historic-age resources.

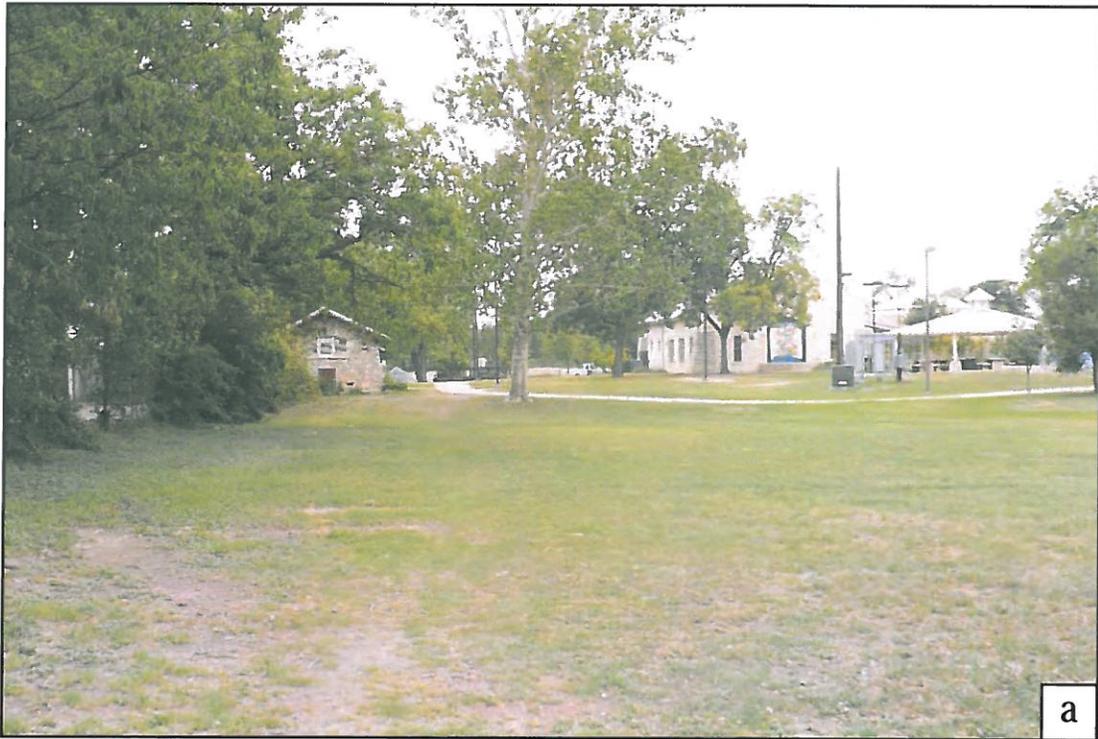
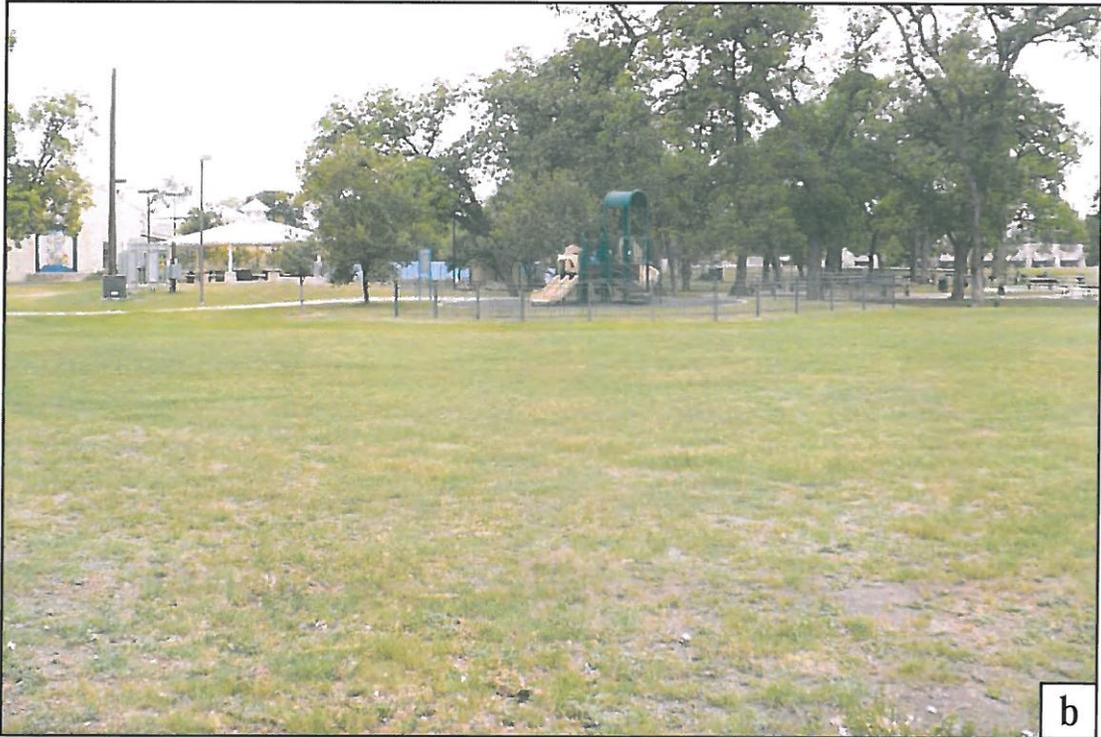
Exhibit A-14. The proposed playground site looking east (a) and northeast (b).

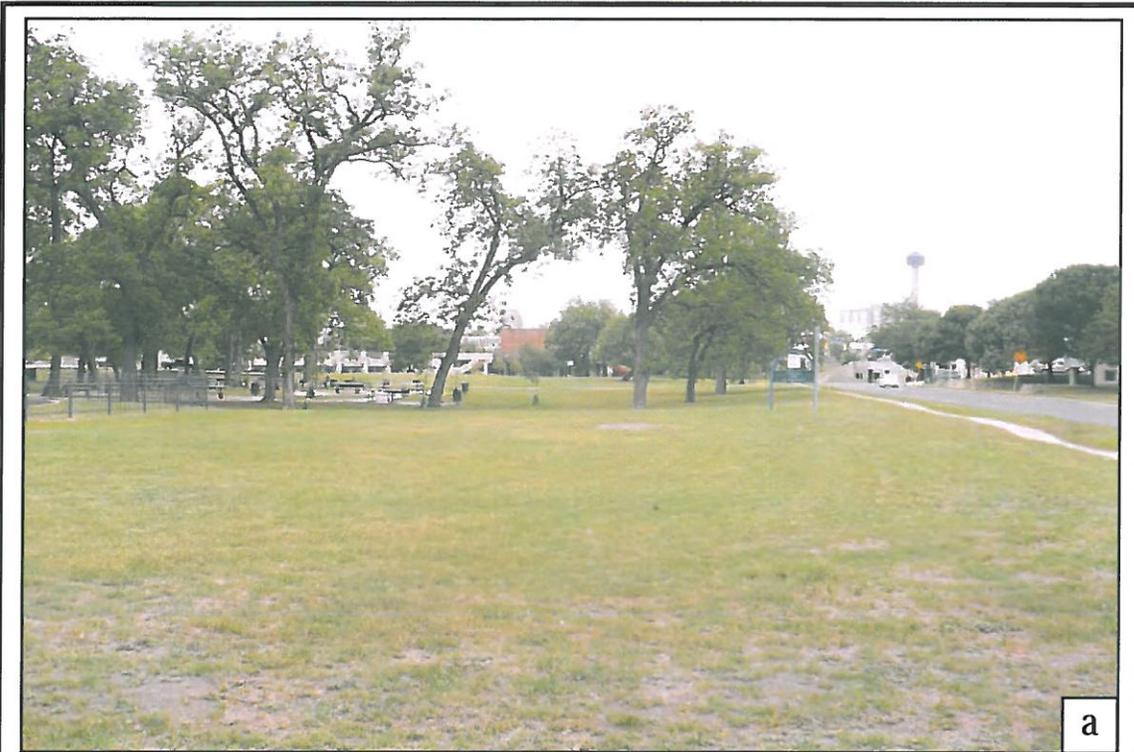
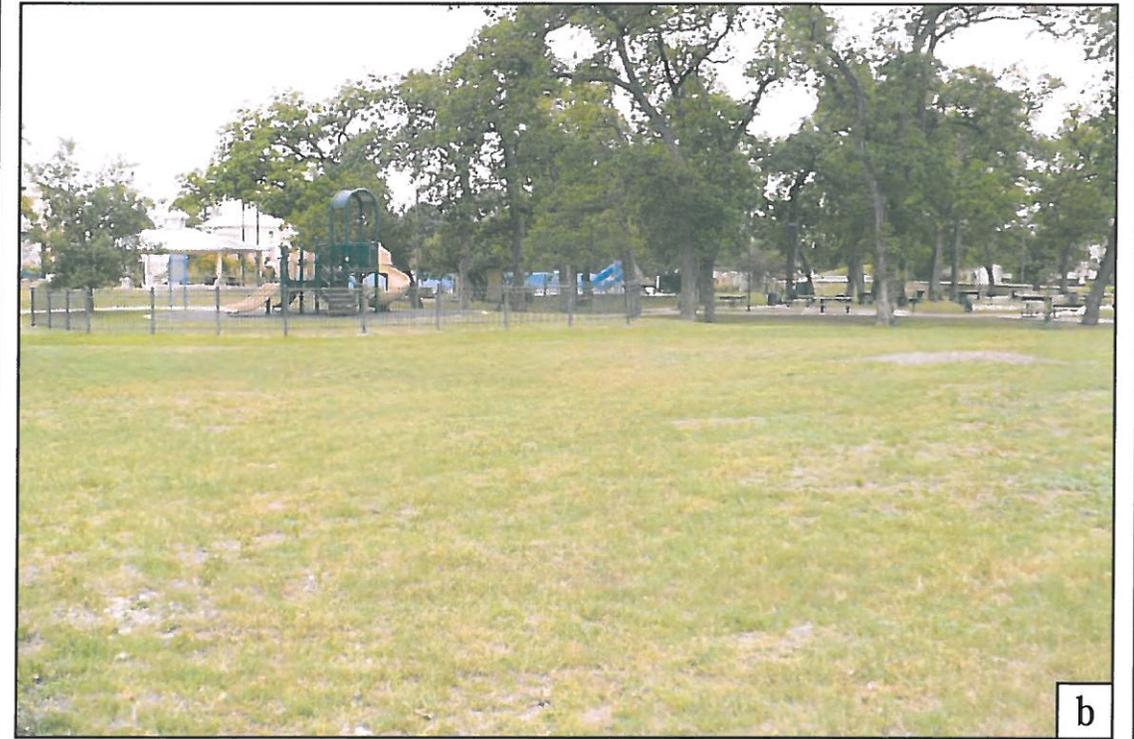
Exhibit A-15. View from the proposed playground site looking west (a) and northwest (b).

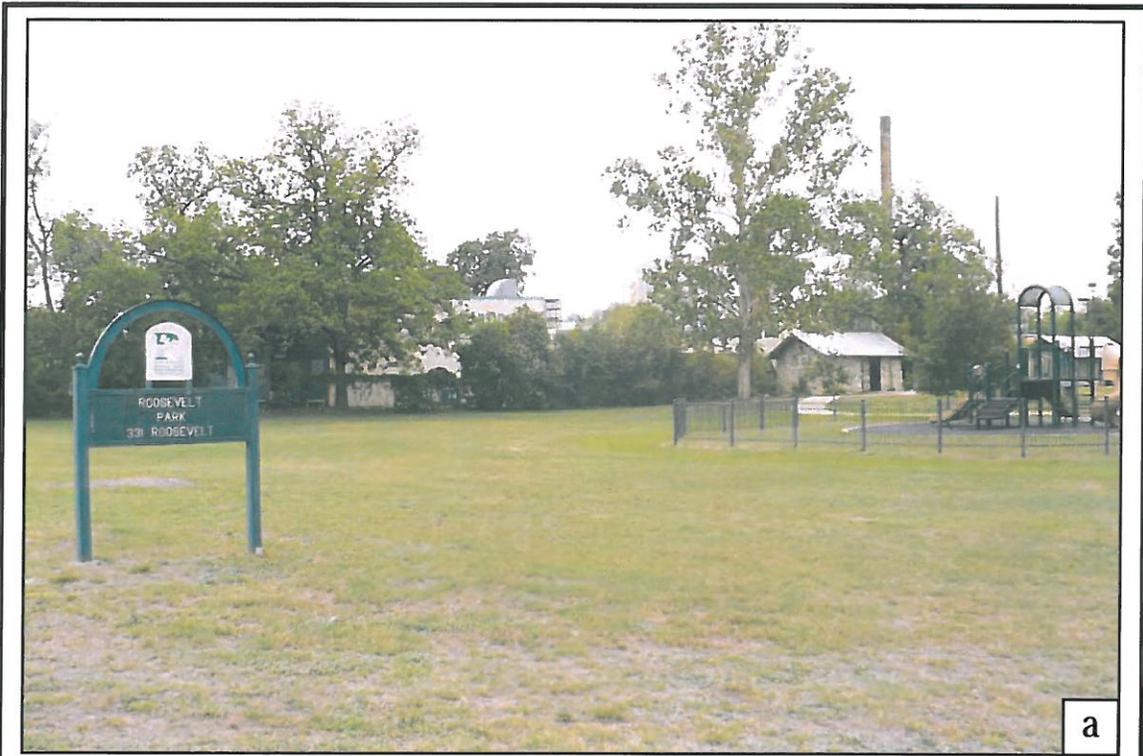
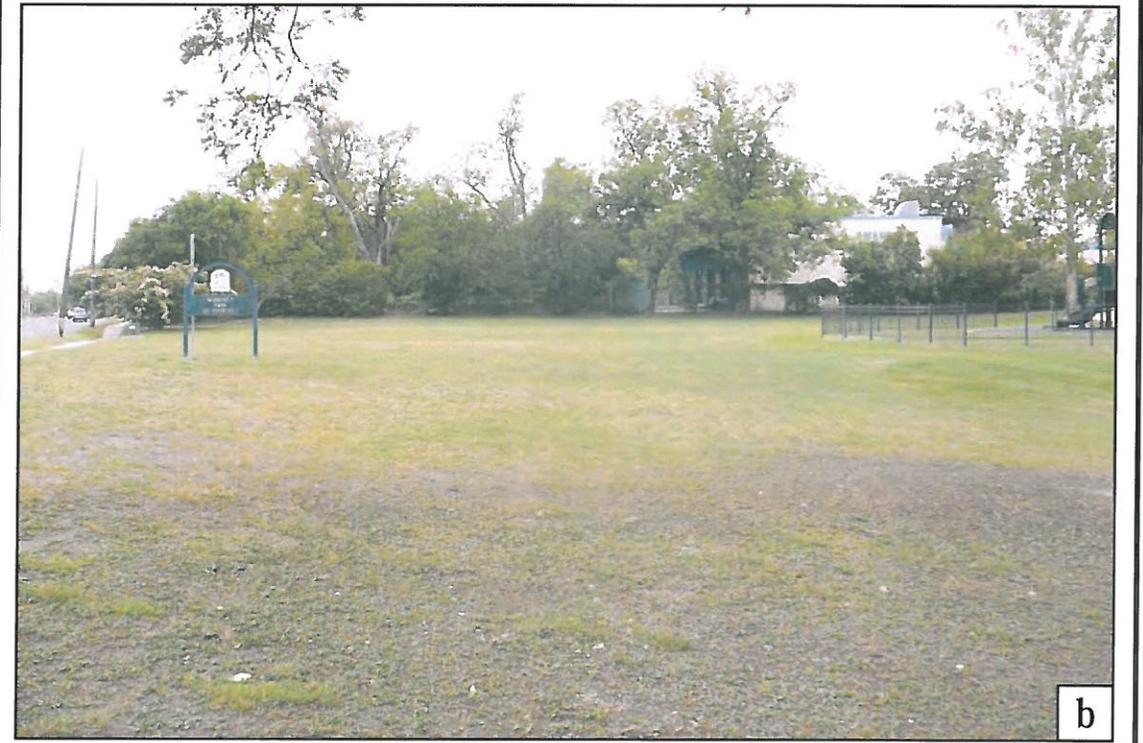
Exhibit A-16. View from the proposed playground site to the north (a), and northwest toward the site from Roosevelt Avenue (b).
