**ARCHEOLOGICAL AND HISTORIC RESOURCES SURVEY OF TWO
ALTERNATIVE PLAYGROUND LOCATIONS AT ROOSEVELT
PARK IN SAN ANTONIO
BEXAR COUNTY, TEXAS**

City of San Antonio, Texas

Steven W. Ahr and Sherry N. DeFreece Emery
URS Corporation
9400 Amberglen Blvd.
Austin TX 78729

November 2009

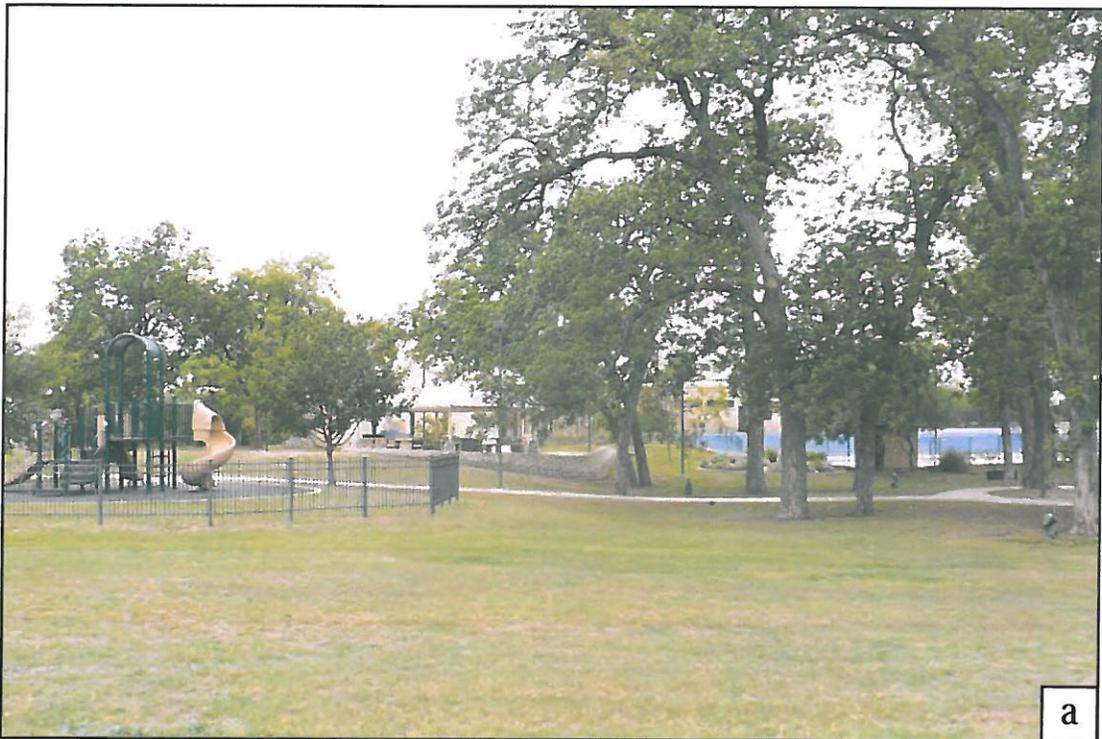
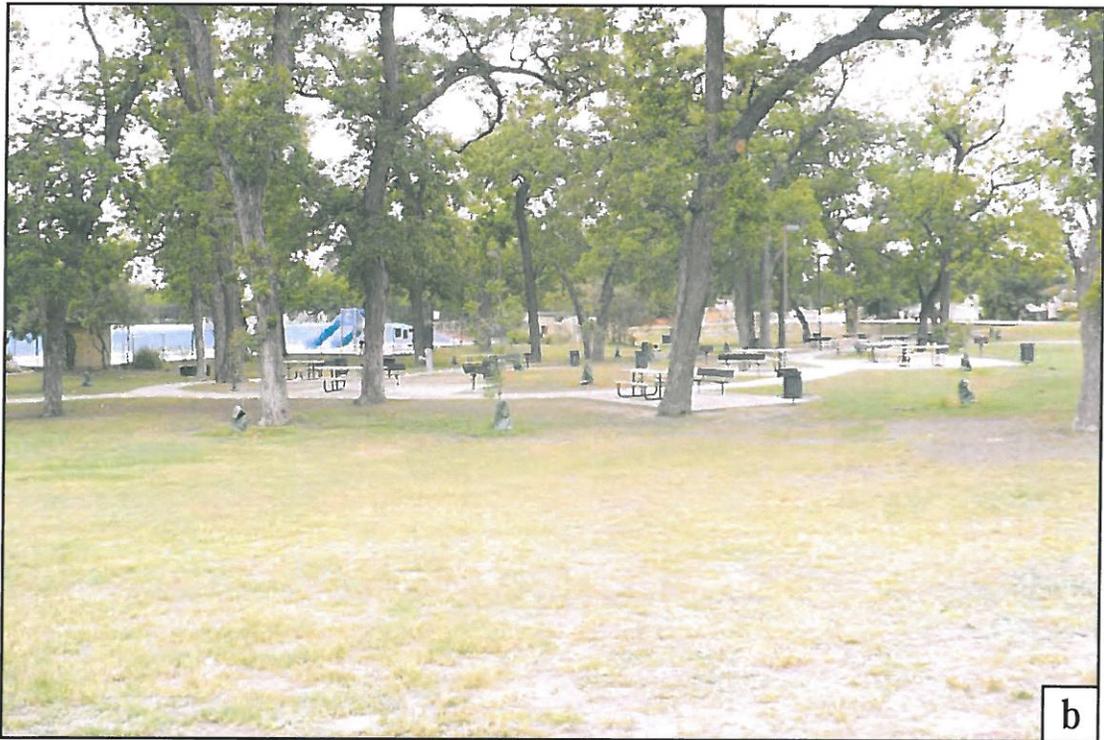
Exhibit A-17. View southwest (a) and south-southwest (b) toward the proposed playground site from Roosevelt Avenue.

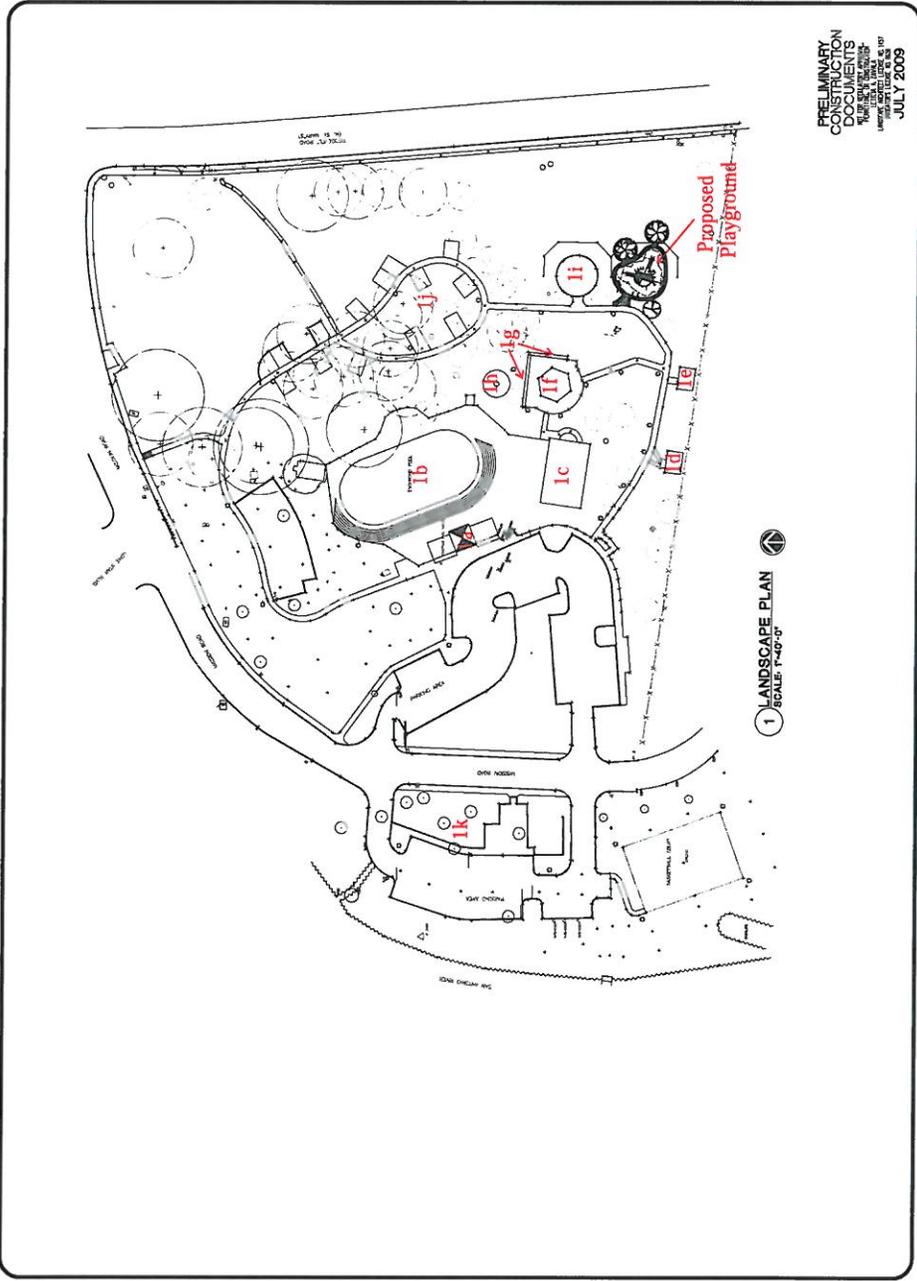
RL30
 SHEET NO. 1 OF 1

Exhibit B-1. Landscape Plan of Roosevelt Park showing resources recorded during reconnaissance survey.

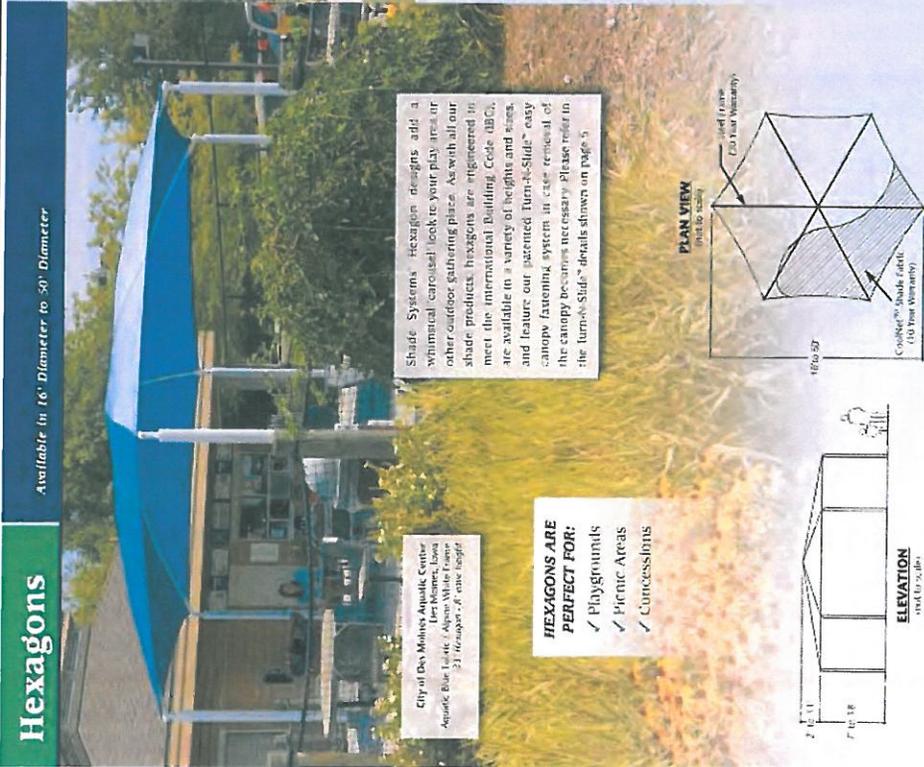
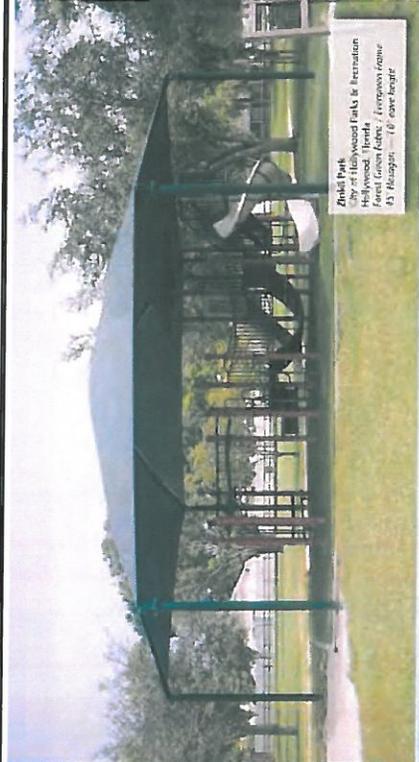
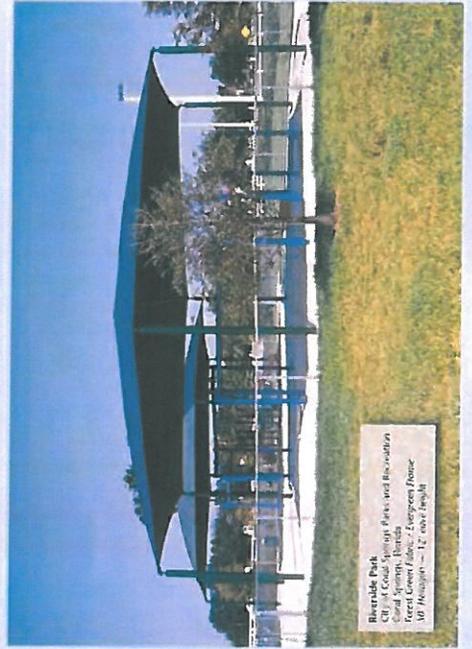
Exhibit B-3. Proposed shade structure types.

Shade Systems' hexagon designs add a whimsical, carousel-like look to your play area or other outdoor gathering place. As with all our shade products, hexagons are engineered to meet the International Building Code (IBC), are available in a variety of heights and sizes, and feature our patented Turn-a-Slide™ easy canopy fastening system in case removal of the canopy becomes necessary. Please refer to the Turn-a-Slide™ details shown on page 5.

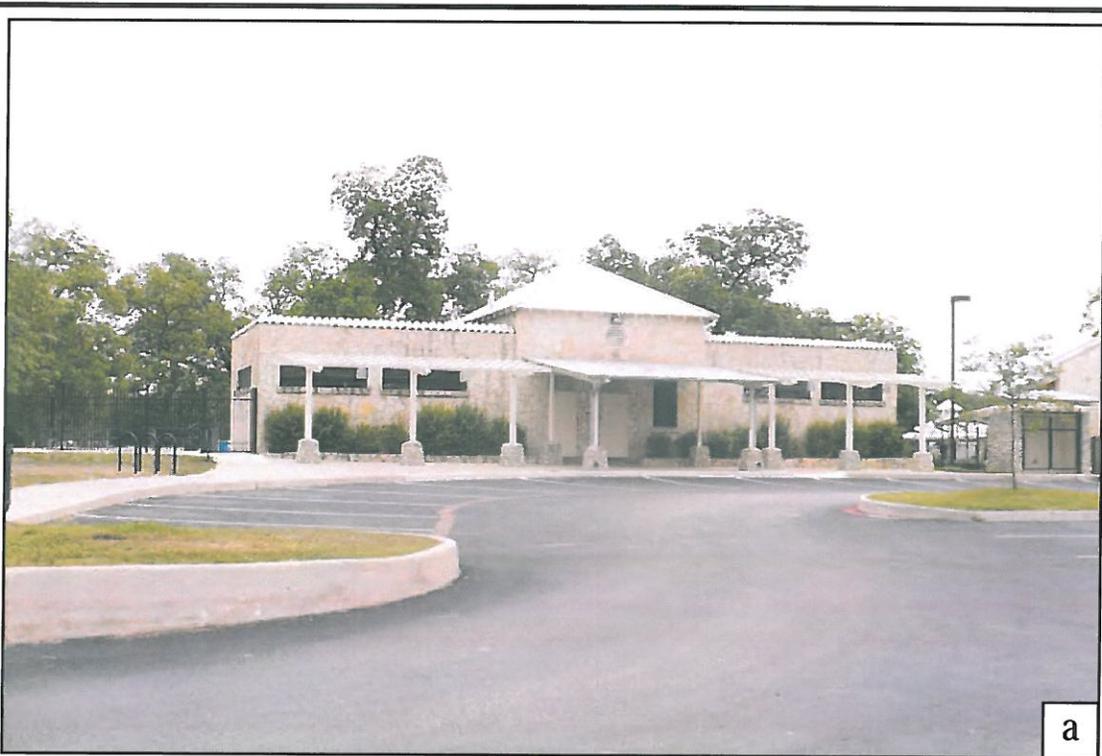
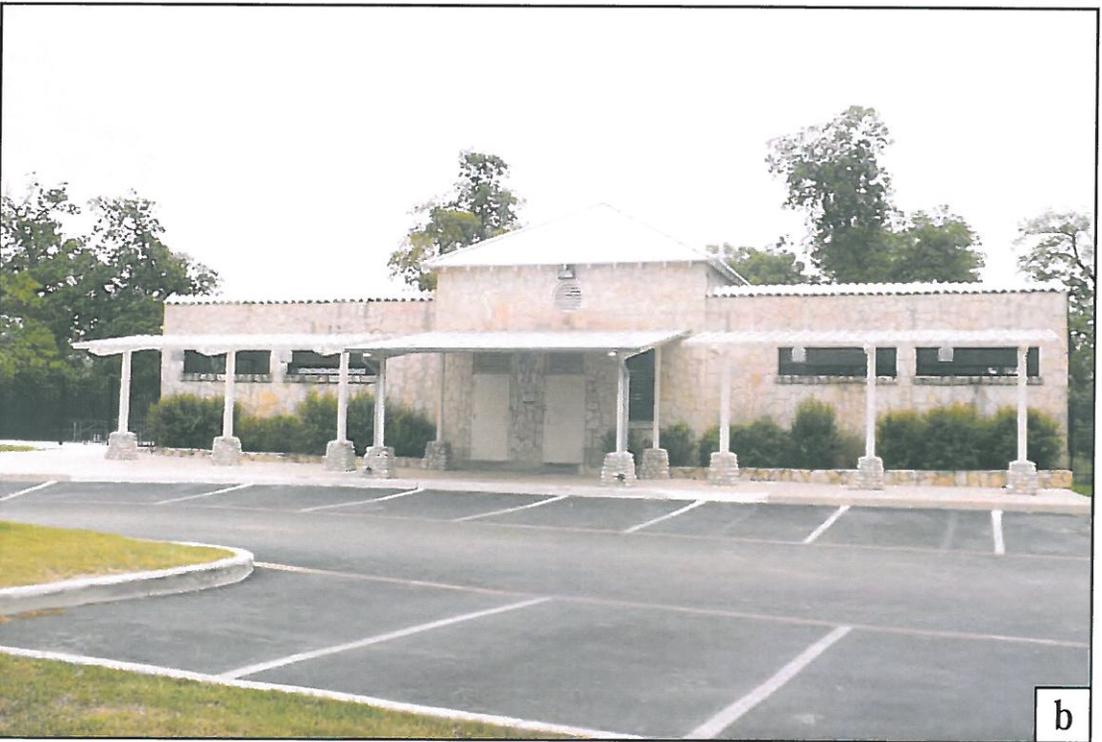
<p>Additional Description:</p> <p>Resource Number 1a is a one story, three bay bathhouse at Roosevelt Park. The building is modern in form, but the stone cladding the building presents a more rustic feel to the building. It is roughly linear, with a square central bay and two rectangular flanking bays. The center bay has a hipped roof clad in standing seam metal, and the flanking bays have flat roofs. The building is clad in stone, and both the primary (west) and secondary (east, poolside) facades contain three entry doors into the central bay, and a pair of ribbon windows with stone sills in each of the two flanking bays.</p> <p>The west façade of Resource Number 1a has a shed-roofed canopy addition with stone bases, metal columns, and a standing seam metal roof. While not original to the structure, it is not insensitive.</p> <p>The bathhouse is in good condition, retains its historic integrity, and is recommended as a contributing element to Roosevelt Park.</p>

Roosevelt Park Bathhouse (Resource 1a) looking southeast (a) and northeast (b).

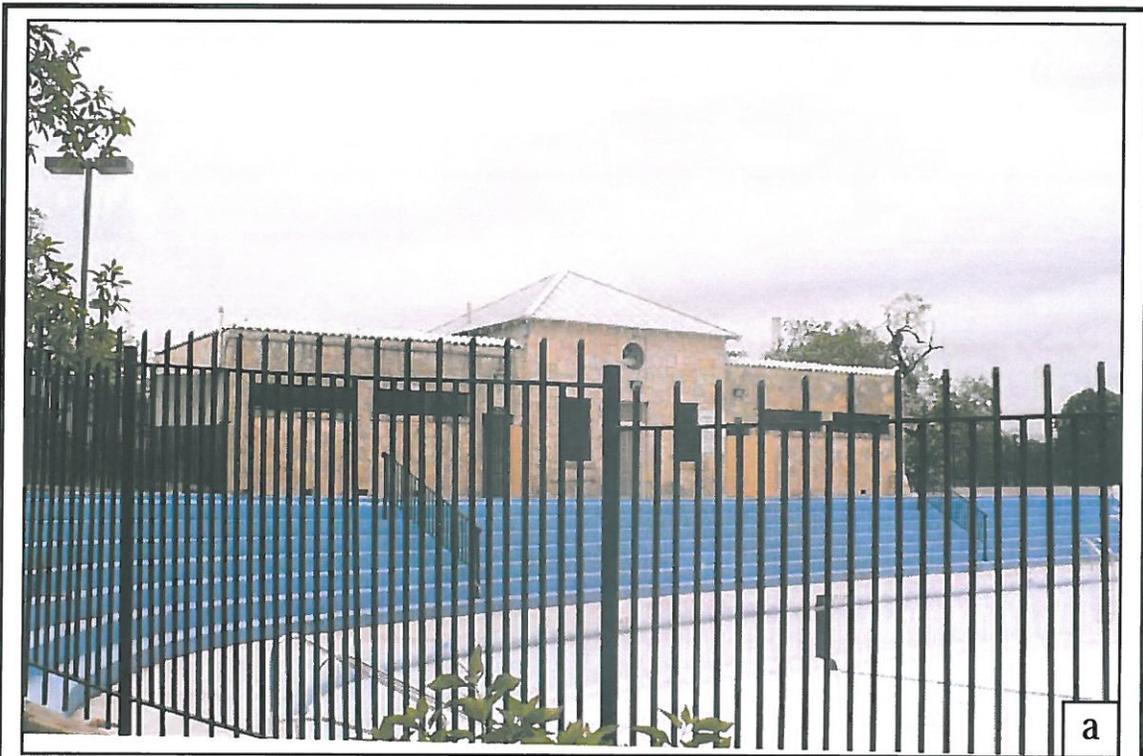
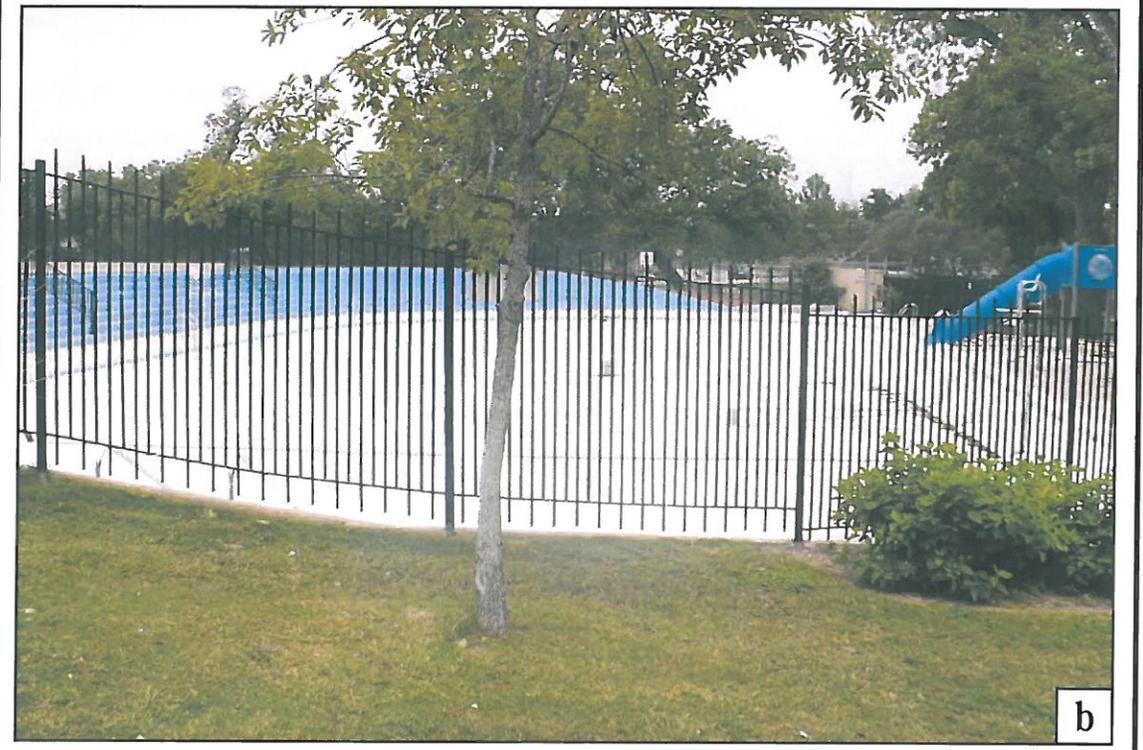
<p>Additional Description:</p> <p>Resource Number 1b is a kidney-shaped concrete swimming pool. The west side of the pool has steps leading to the deepest portion on the east side. New slides have replaced the diving board at the east end of the pool. A metal fence surrounding the pool does not appear to be historic, but its date is not known.</p> <p>The pool is in good condition, retains its historic integrity, and is recommended as a contributing element to Roosevelt Park.</p>

Roosevelt Park Bathhouse (Resource 1a) and pool (Resource 1b) looking northwest (a), and pool (Resource 1b) looking west (b).

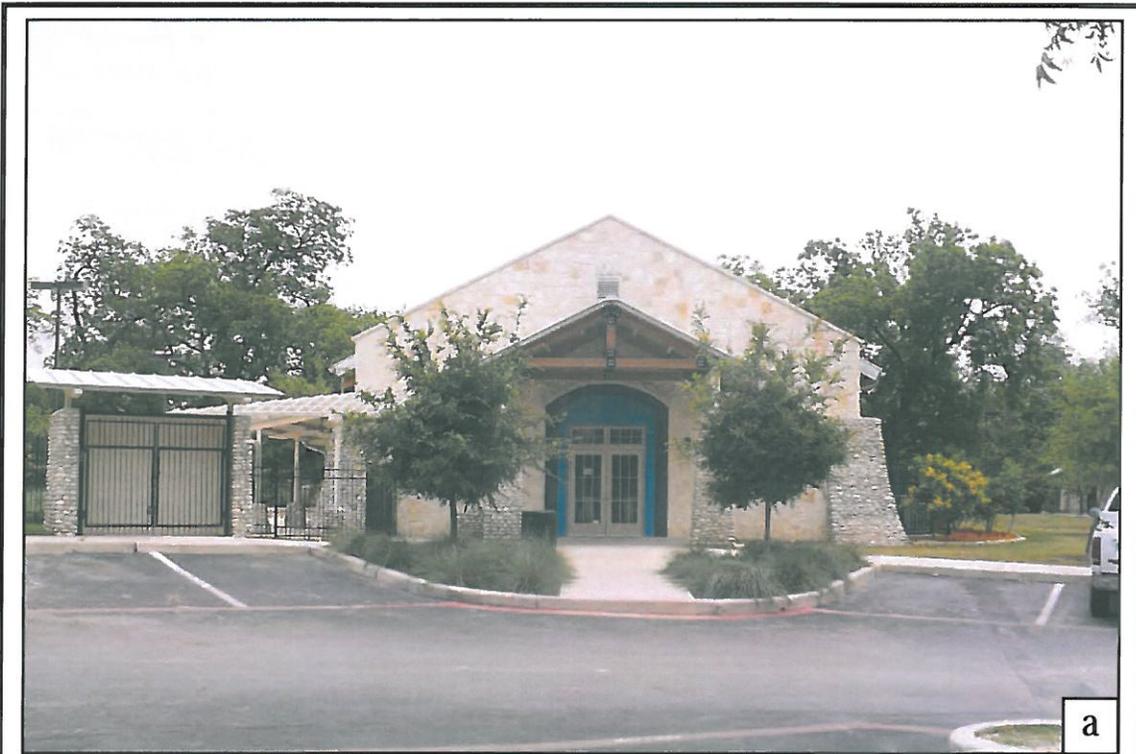
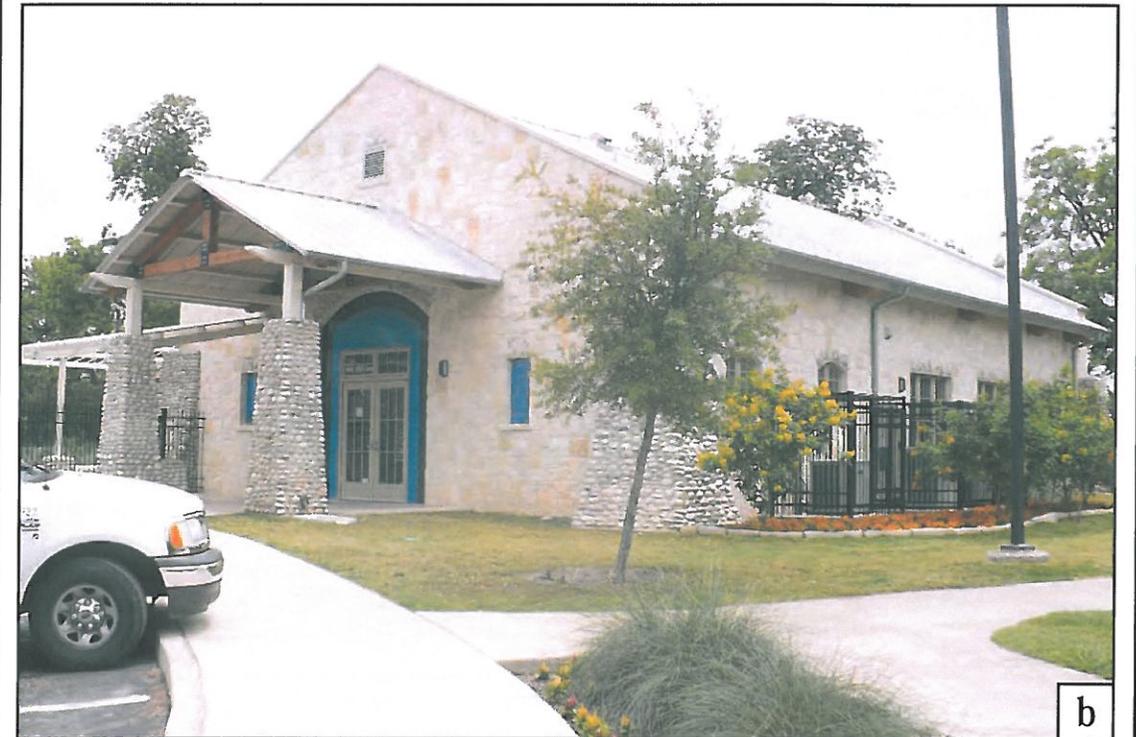
<p>Additional Description:</p> <p>Resource Number 1c was constructed recently. It is a one-story, front-gabled recreation building that is rectangular in plan. Clad in stone and featuring a standing seam metal roof with exposed rafters, the building features a prominent gabled porch with large, tapering, square stone columns and exposed trusses. The front door is inset into a tiled archway, which is echoed in a tiled mosaic on the rear (east) façade. The windows are wood.</p> <p>Resource Number 1c is not historic. It is recommended as a non-contributing element to Roosevelt Park.</p>

Roosevelt Park Recreation Building (Resource 1c) looking east (a) and northeast (b).

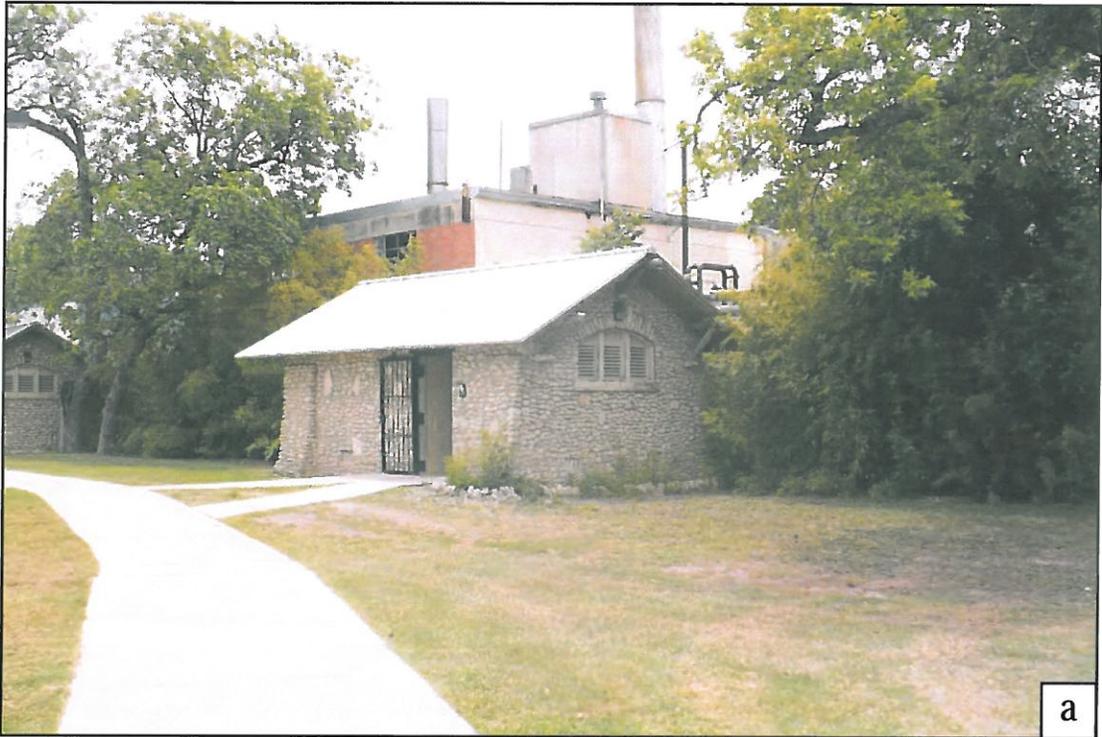
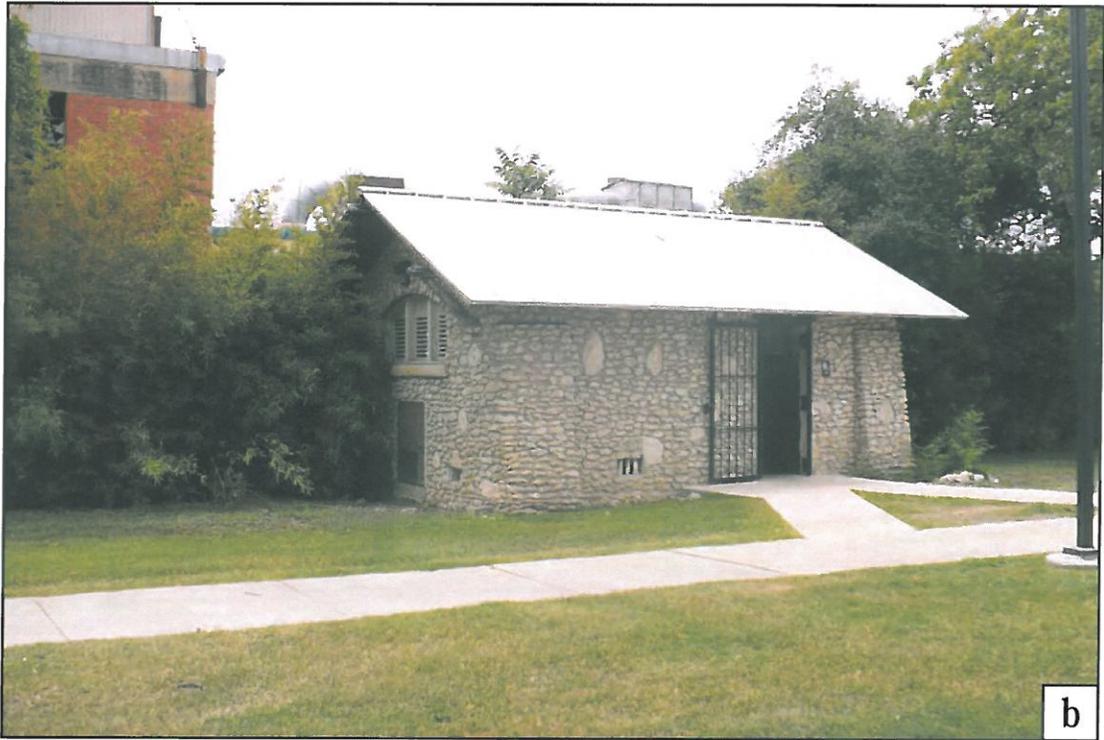
<p>Additional Description:</p> <p>Resource Number 1d is a one-story, side-gabled restroom building that is rectangular in plan. Clad in rounded fieldstone and featuring a standing seam metal roof with exposed rafters and brackets, the rustic, cottage-like building features arched openings with wood vents at either end, and stone buttresses on the front façade. The entry is inset, with an attached metal gate.</p> <p>The restroom building is in good condition, retains its historic integrity, and is recommended as a contributing element to Roosevelt Park.</p>

Roosevelt Park Men's Restroom (Resource 1d) looking southwest (a) and south (b).

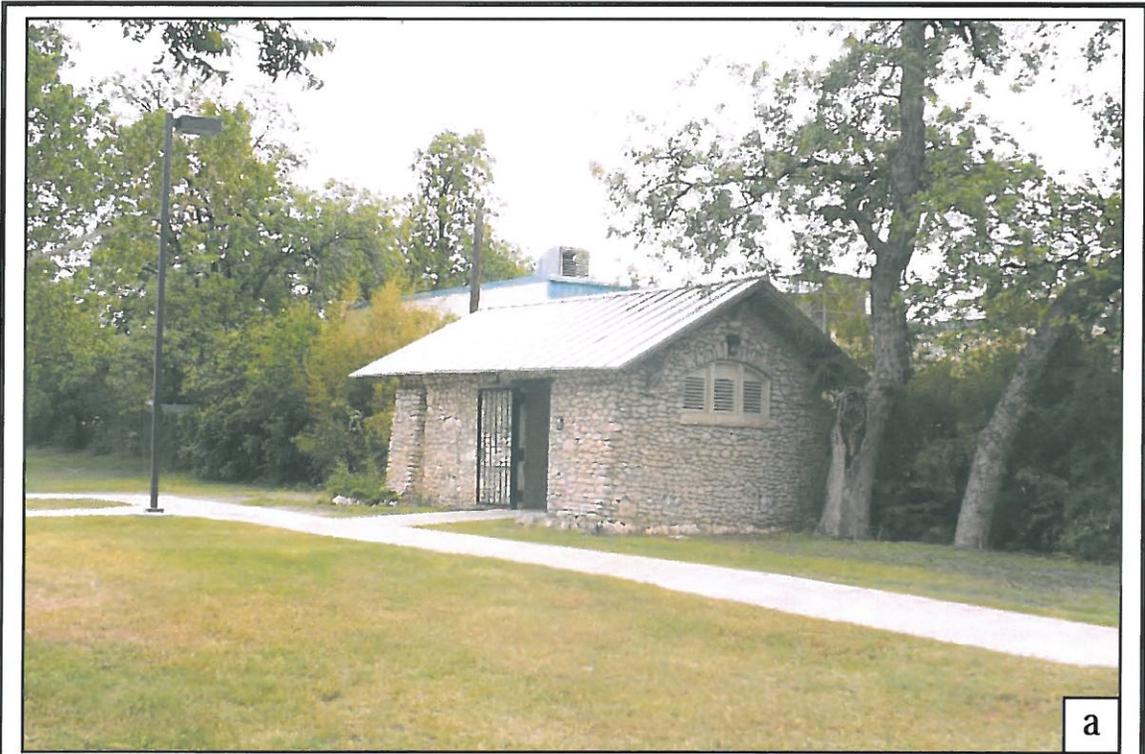
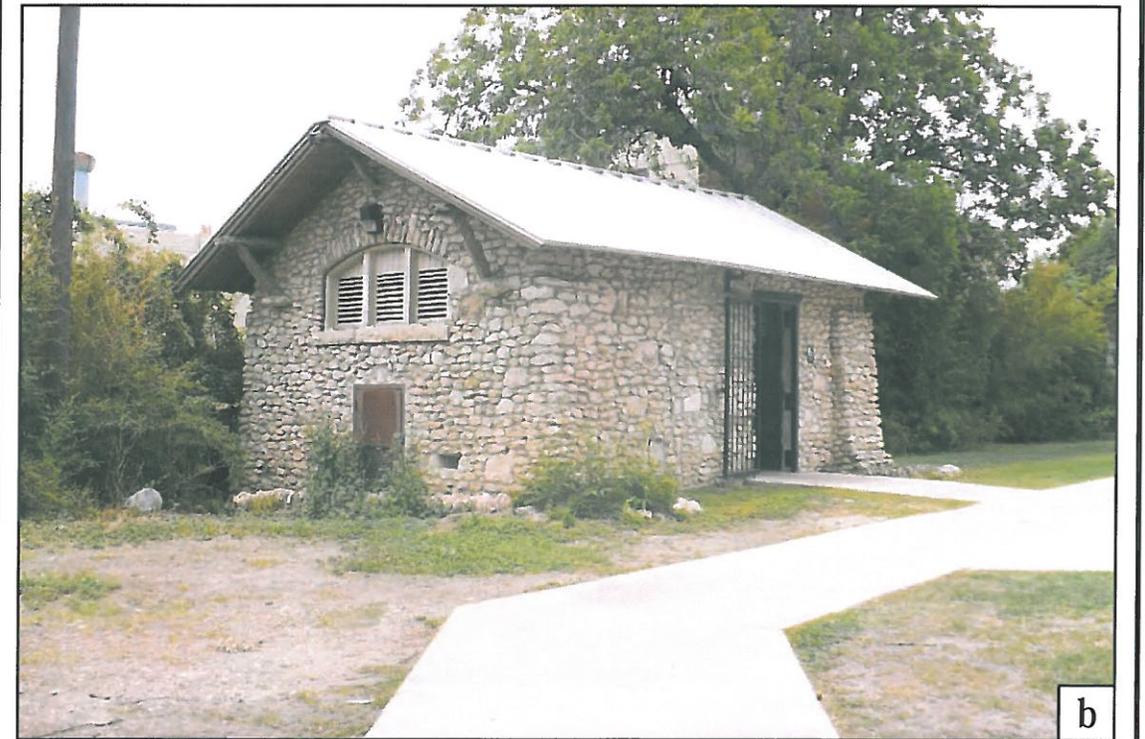
<p>Additional Description:</p> <p>Resource Number 1e is a one-story, side-gabled restroom building that is rectangular in plan. Clad in rounded fieldstone and featuring a standing seam metal roof with exposed rafters and brackets, the rustic, cottage-like building features arched openings with wood vents at either end, and stone buttresses on the front façade. The entry is inset, with an attached metal gate. The northern end contains a sunken area that may lead to a low mechanical room or crawlspace beneath the building. The sunken area is surrounded by a low stone curb.</p> <p>The restroom building is in good condition, retains its historic integrity, and is recommended as a contributing element to Roosevelt Park.</p>

Roosevelt Park Women's Restroom (Resource 1e) looking south (a) and northwest (b).

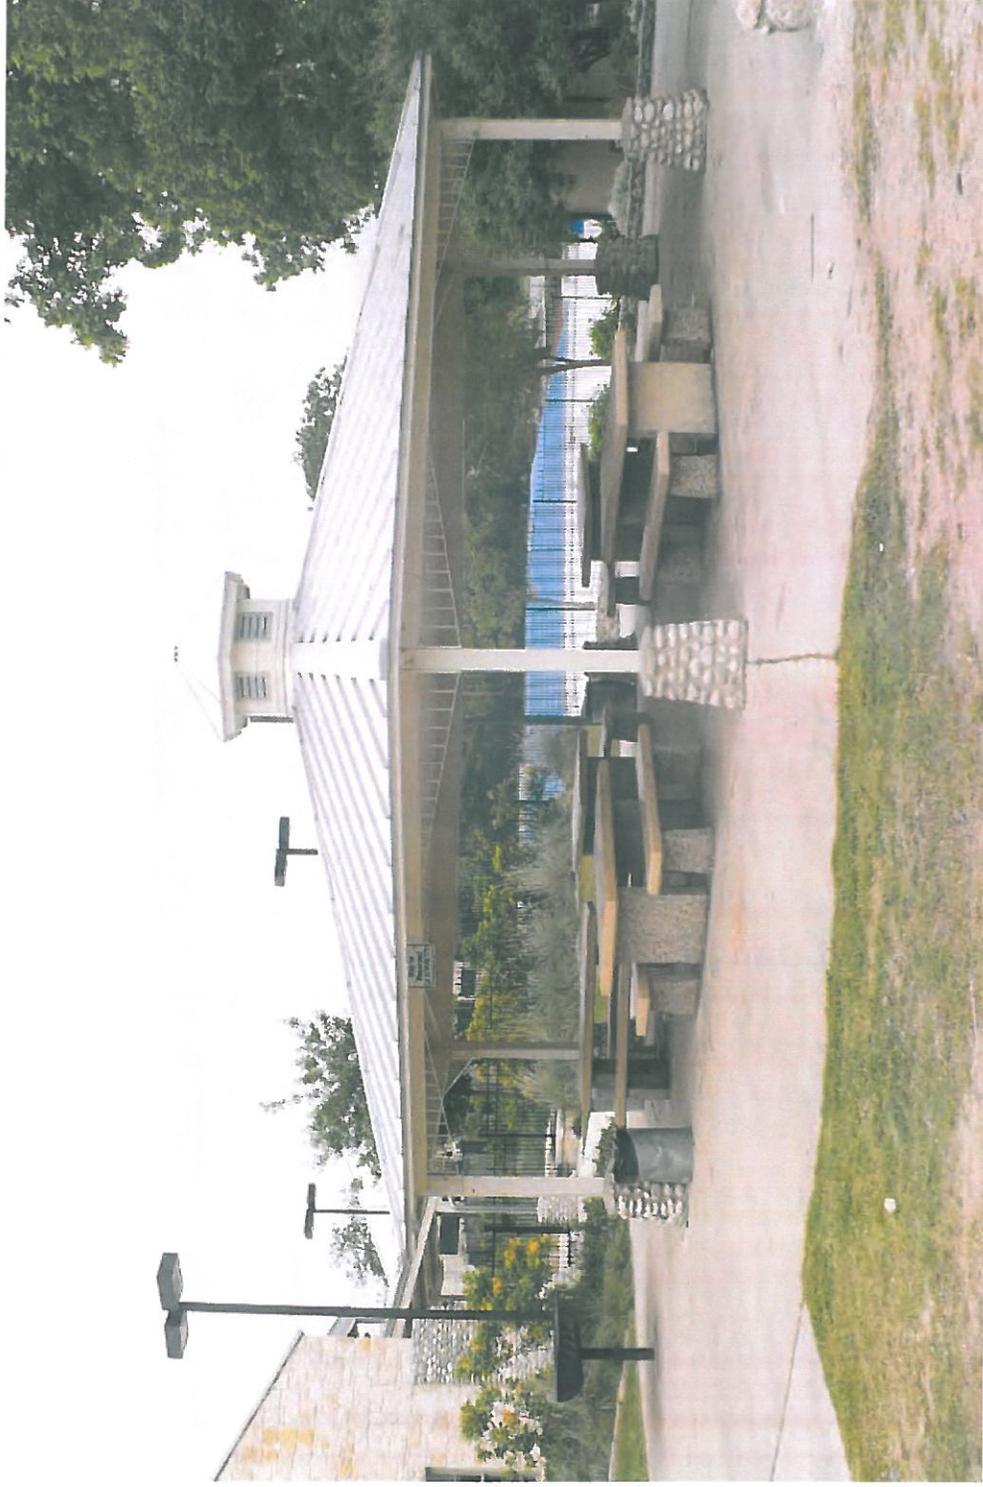
<p>Additional Description:</p> <p>Resource Number 1f is an open, hexagonal pavilion/gazebo. It features a standing seam metal roof supported by wood columns on tapered square stone bases. Inside the pavilion are new picnic tables and benches. The pavilion is surrounded by a low wall (Resource Number 1g), which appears to be historic, indicating that the pavilion may be located at the site of an older pavilion structure.</p> <p>The pavilion/gazebo is of recent construction. It is recommended as a non-contributing element to Roosevelt Park.</p>

• Roosevelt Park pavilion (Resource 1f).

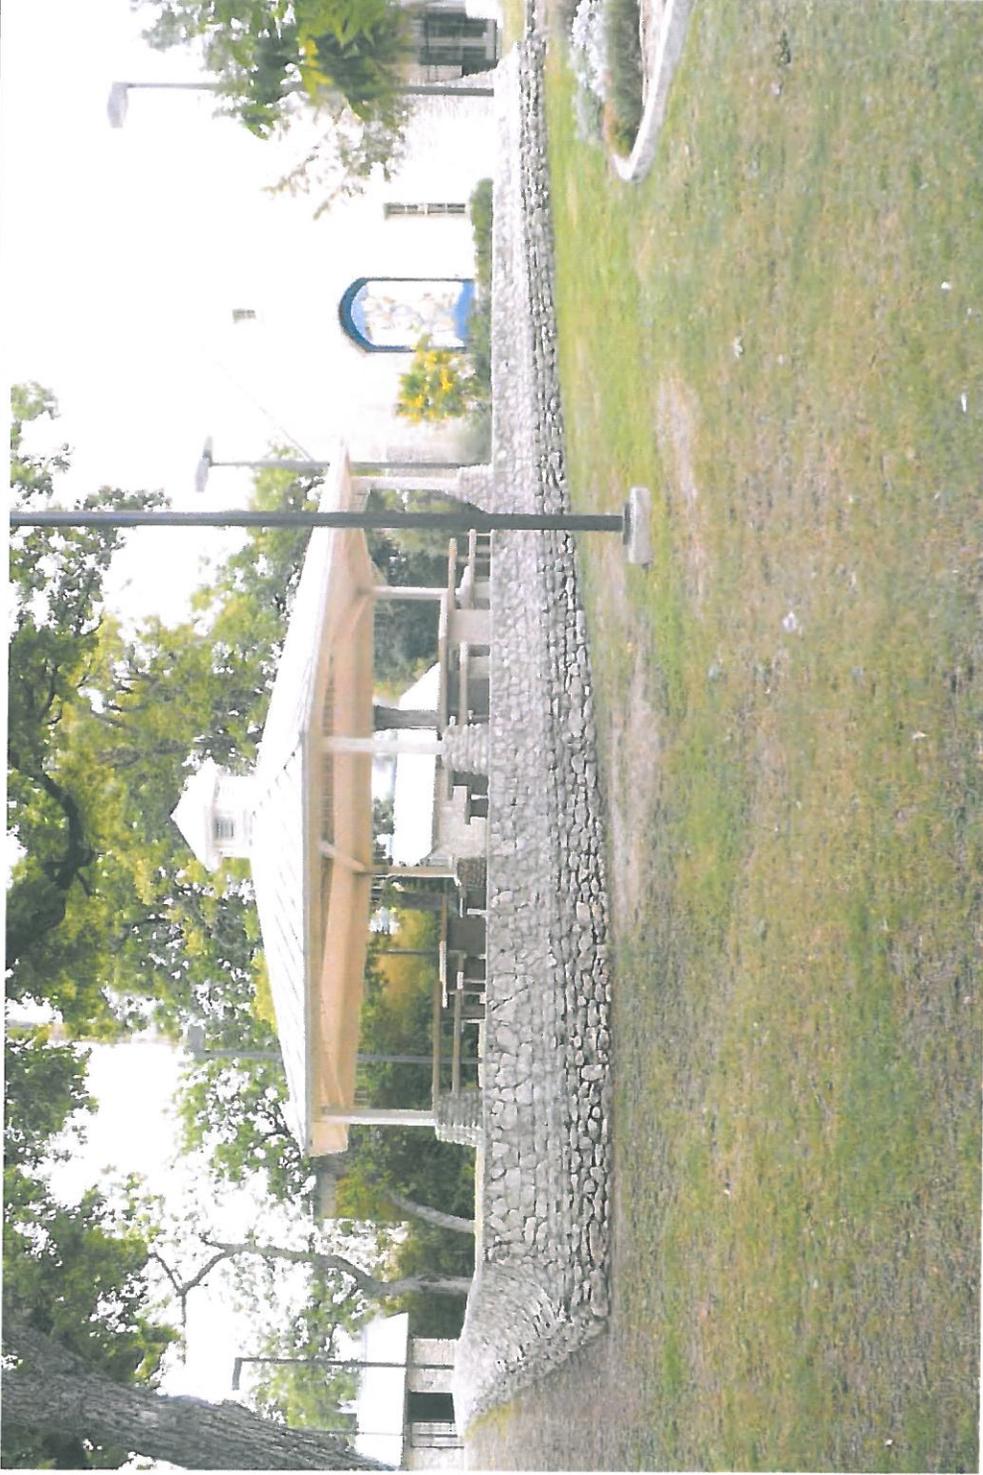
<p>Additional Description:</p> <p>Resource Number 1g is a low stone wall, approximately two and one-half feet in height. It is roughly square, and tapers from the base to the top. The wall surrounds the pavilion/gazebo (Resource Number 1f).</p> <p>The stone wall is in good condition, retains its historic integrity, and is recommended as a contributing element to Roosevelt Park.</p>

Rock wall surrounding the Roosevelt Park pavilion (Resource 1g), looking northwest.

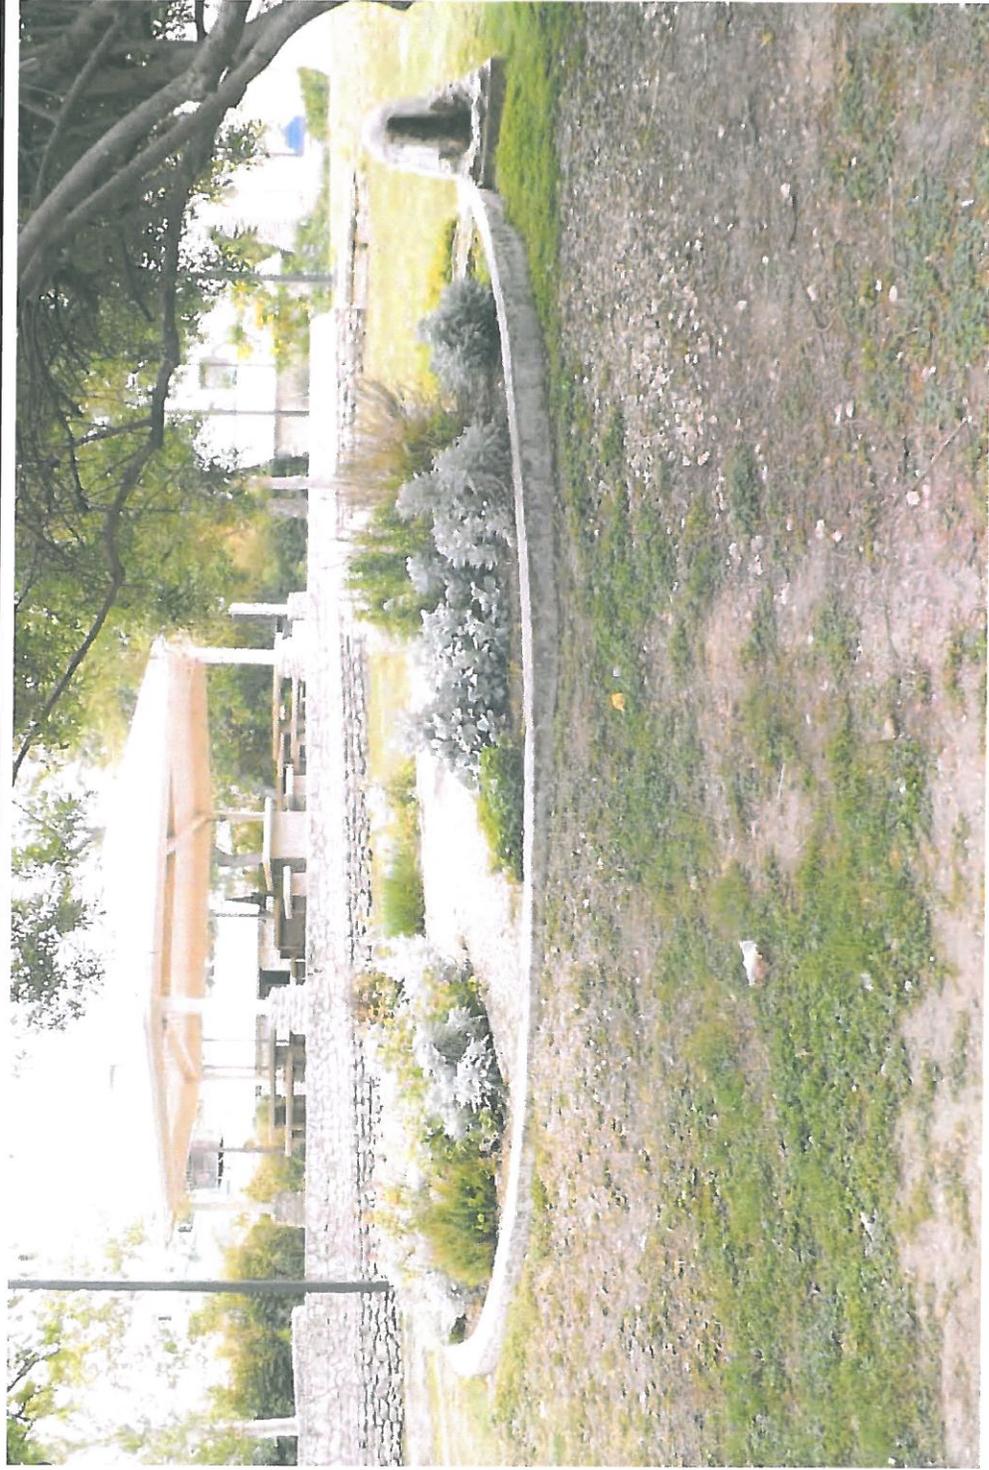
The stone curb and drinking fountain are in good condition, retains its historic integrity, and is recommended as a contributing element to Roosevelt Park.

Roosevelt Park landscape/drinking fountain (Resource 1h), looking west.

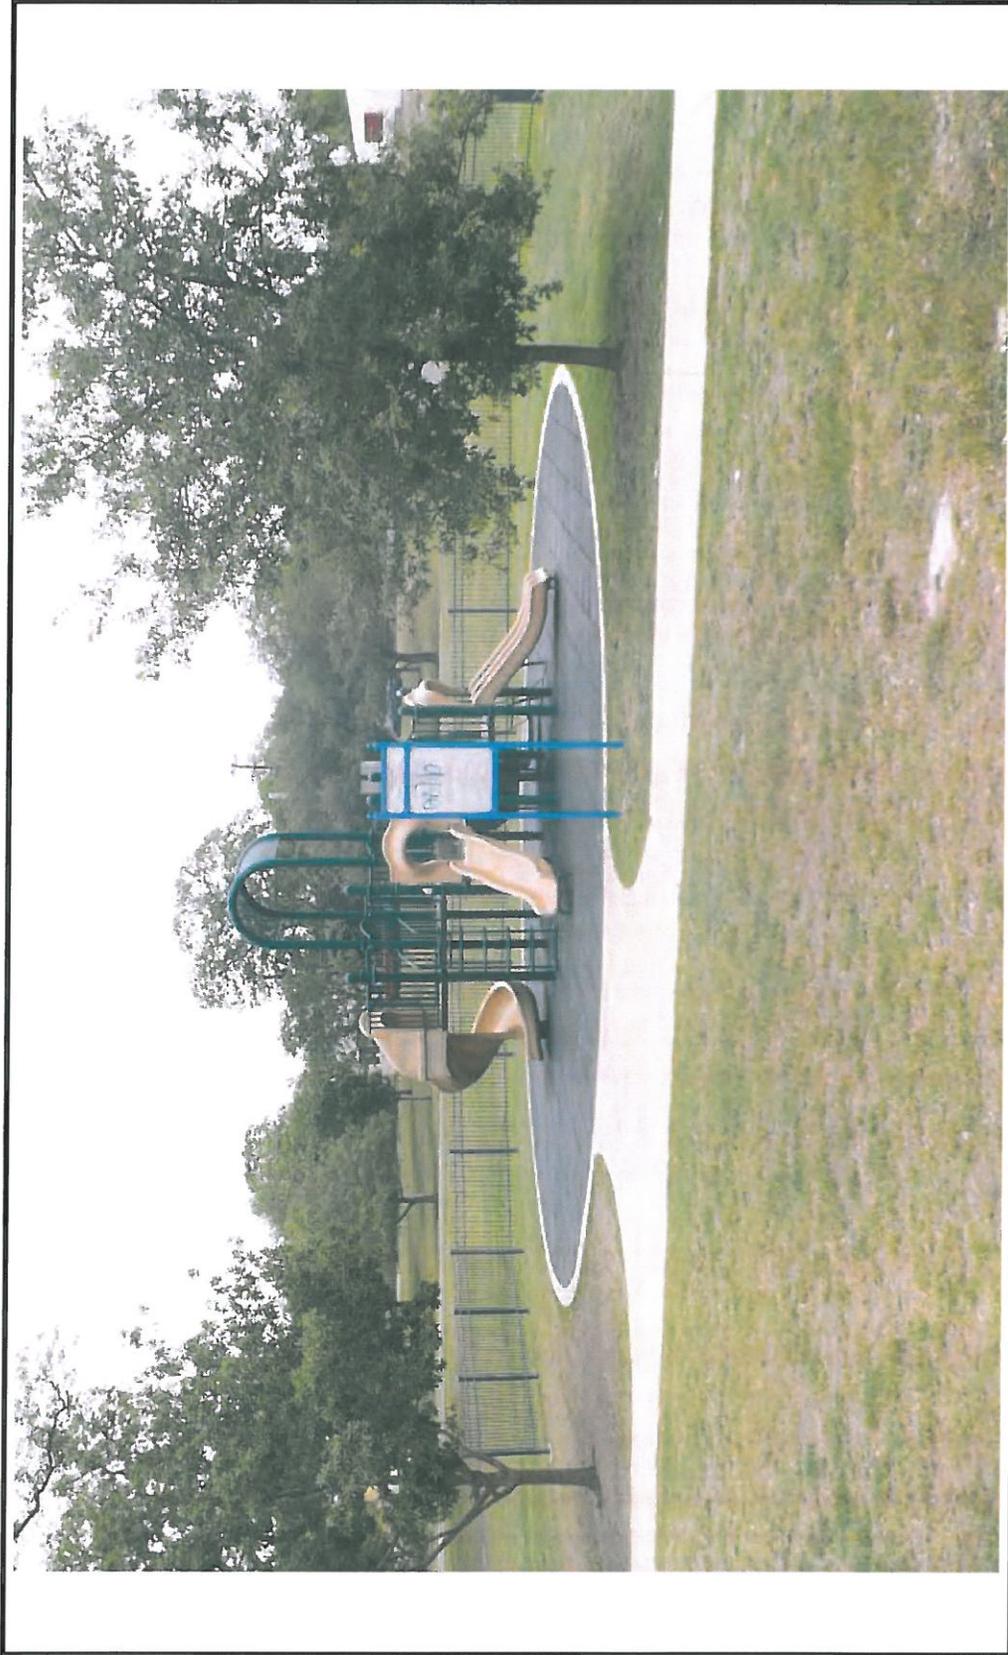
<p>Additional Description:</p> <p>Resource Number 1i is a modern playground with metal and plastic climbing equipment and slides.</p> <p>The playground does not detract from the historic character of Roosevelt Park; however it is recommended as a non-contributing element.</p>

Roosevelt Park playground (Resource 1i), looking northeast.

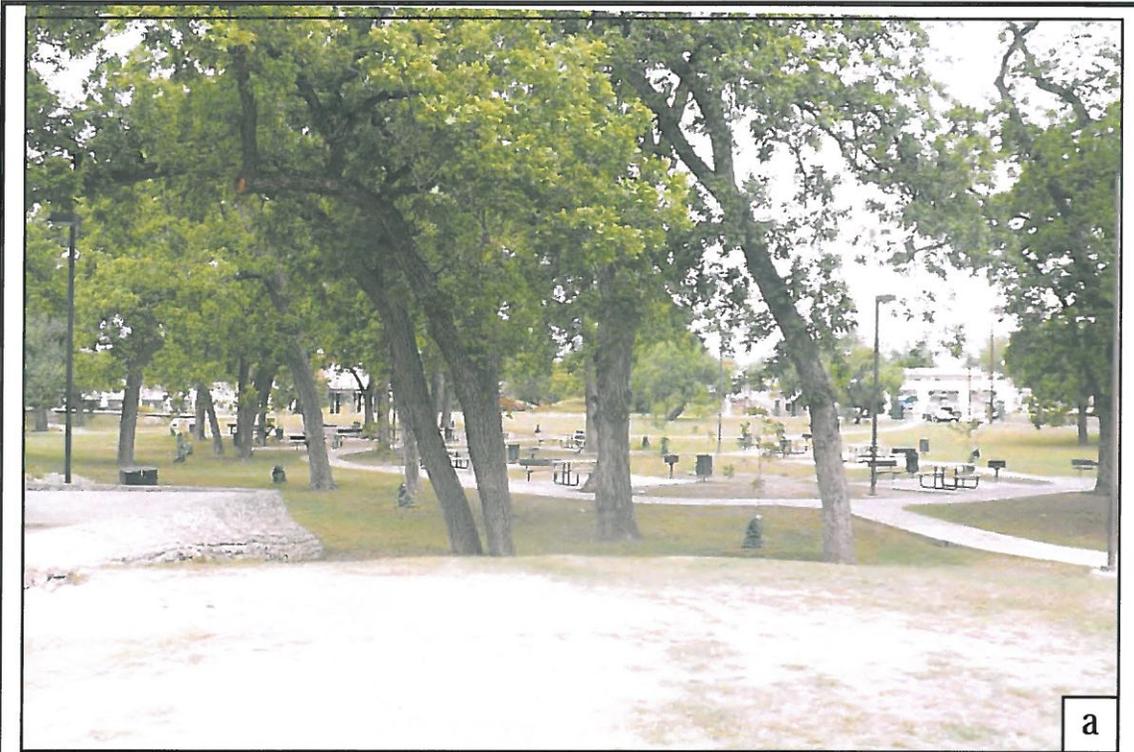
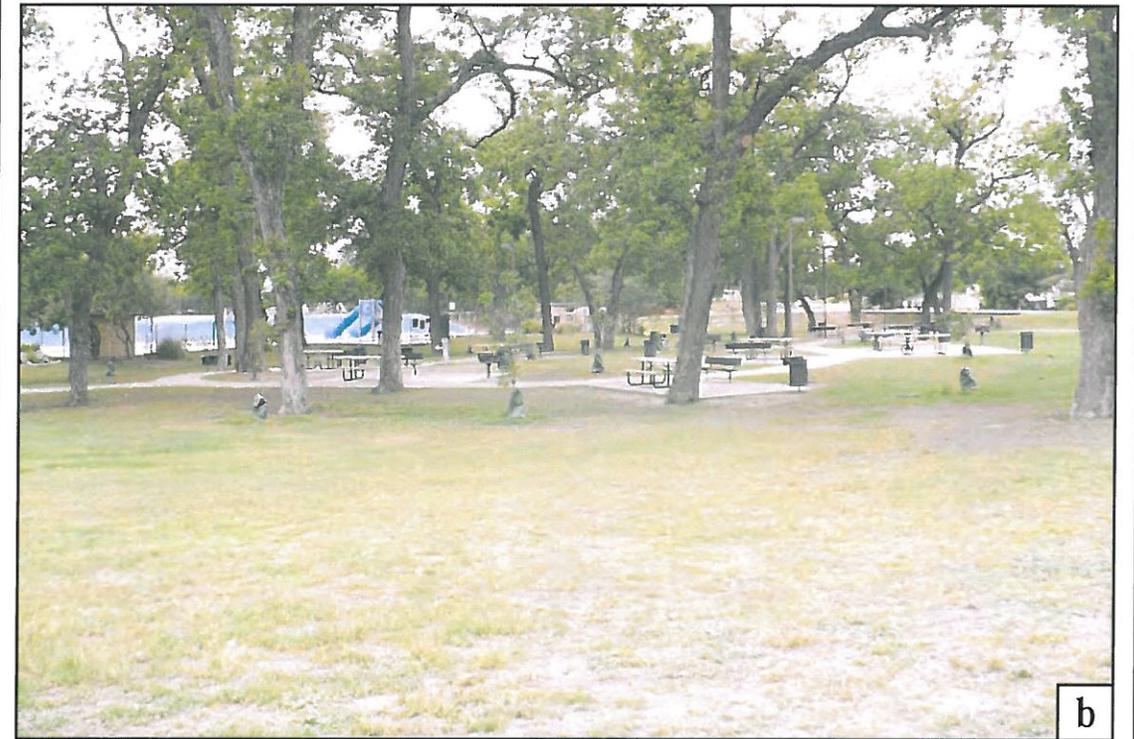
<p>Additional Description:</p> <p>Resource Number 1j is a sunken, grassy picnic area containing picnic tables and benches, grills, and trash receptacles. It is shaded with large mature trees.</p> <p>The picnic area is in good condition, retains its historic integrity, and is recommended as a contributing element to Roosevelt Park.</p>

Roosevelt Park picnic area (Resource 1j) looking north (a), and north-northwest (b).
