**ARCHEOLOGICAL AND HISTORIC RESOURCES SURVEY OF TWO
ALTERNATIVE PLAYGROUND LOCATIONS AT ROOSEVELT
PARK IN SAN ANTONIO
BEXAR COUNTY, TEXAS**

City of San Antonio, Texas

Steven W. Ahr and Sherry N. DeFreece Emery
URS Corporation
9400 Amberglen Blvd.
Austin TX 78729

November 2009

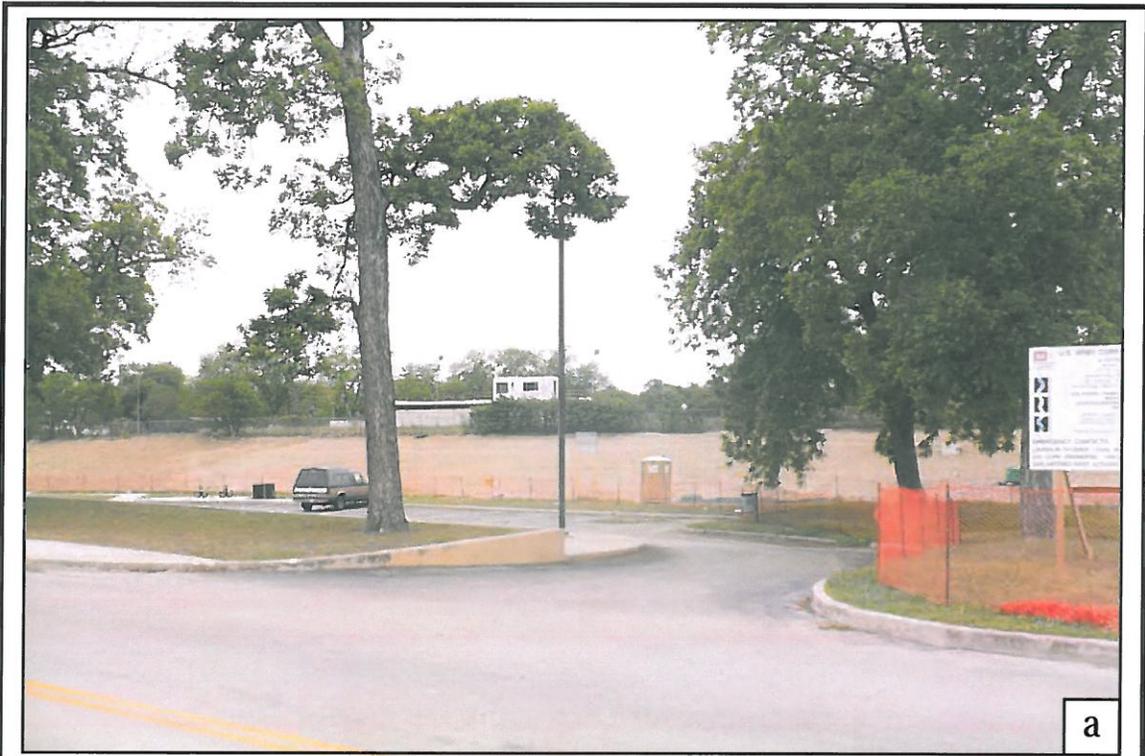
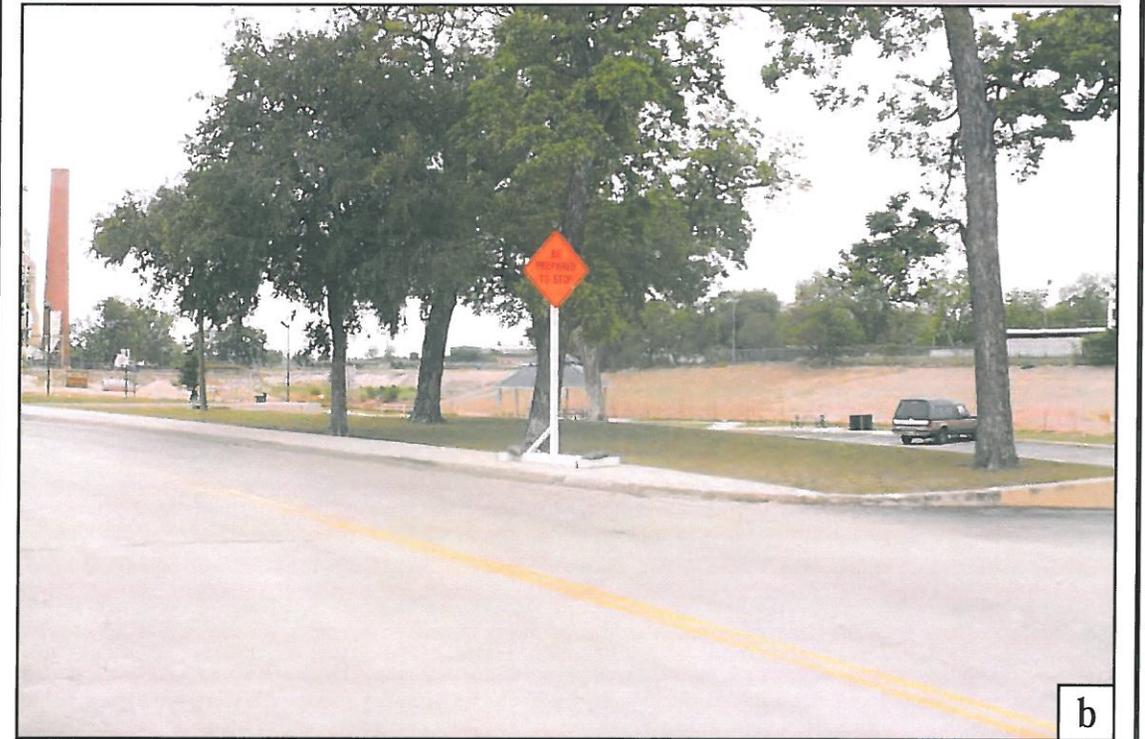
<p>Additional Description:</p> <p>Resource Number 1k is a modern basketball court and associated parking. It is located west of Mission Road along the San Antonio River.</p> <p>The basketball court and parking does not appear to be historically associated with Roosevelt Park. While it is considered part of Roosevelt Park, it is located on a separate parcel than the portion of the park east of Mission Road. It is recommended as a non-contributing element.</p>

Roosevelt Park picnic and basketball court area west of Mission Road (Resource 1k) looking northwest (a), and west (b).

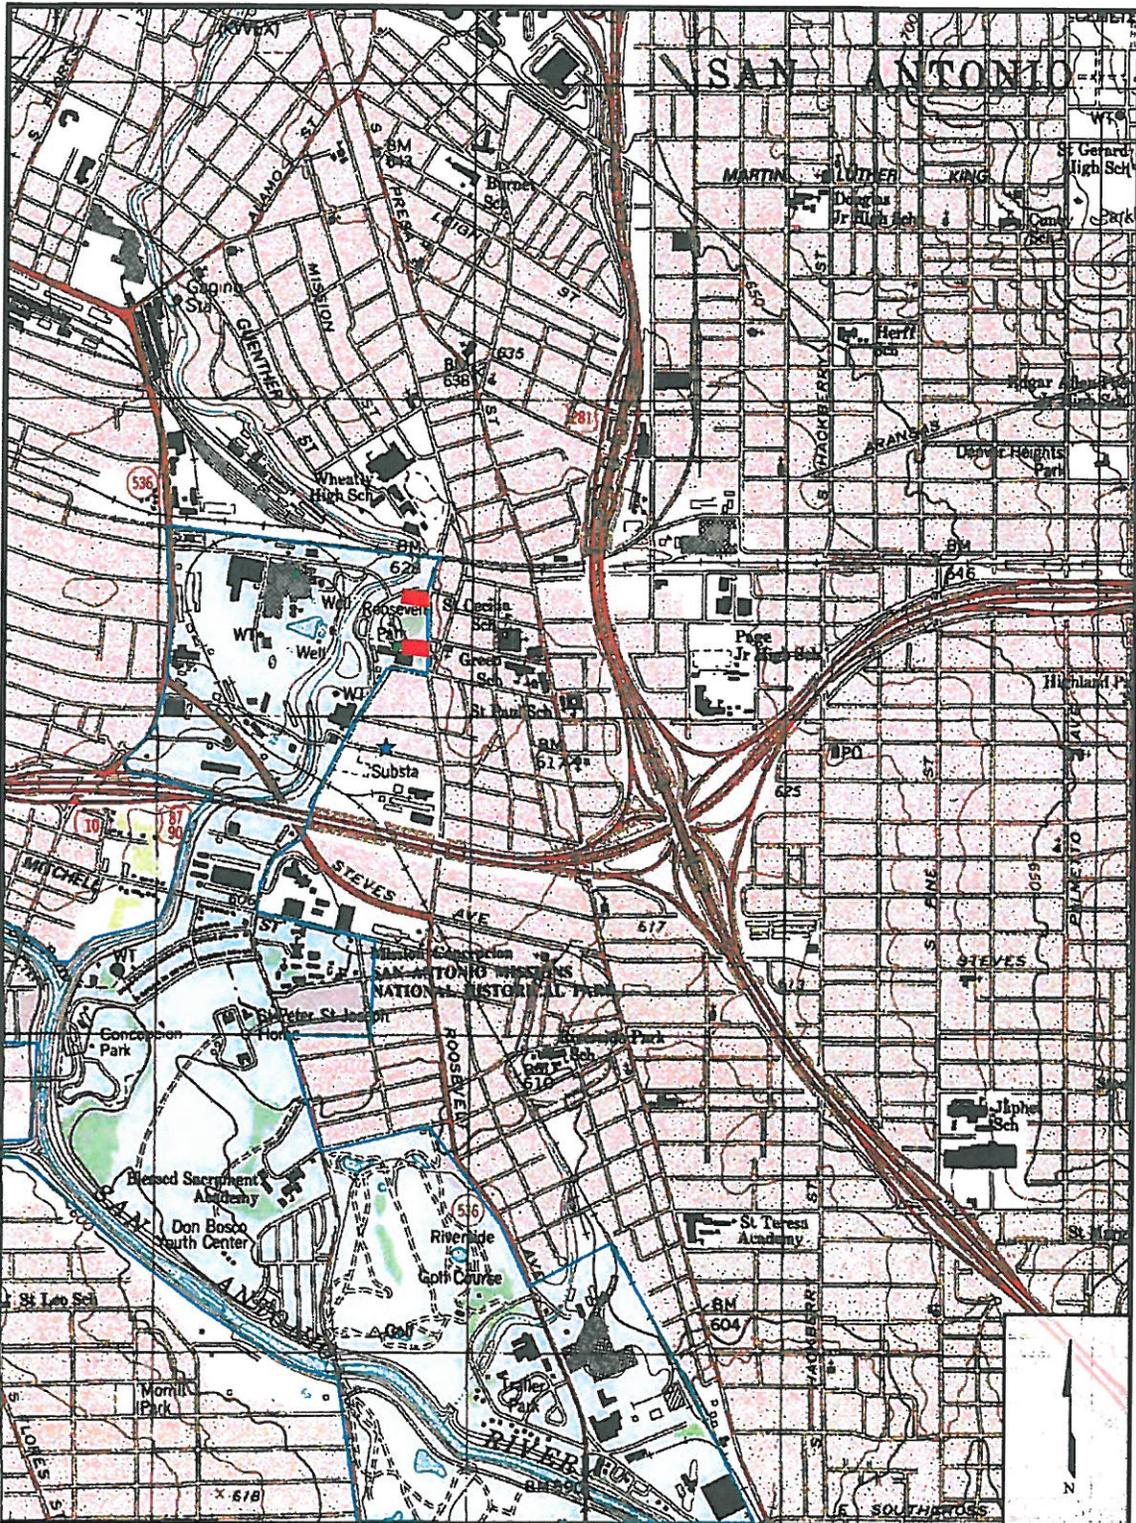
Exhibit 2. Topographic map showing previously documented historic-age resources in the Roosevelt Park project area, shown in red. NRHP district shaded in blue, NRHP property noted with a blue star, and three historic markers noted with green circles.
